SUPERIOR COURT OF CALIFORNIA, COUNTY OF LOS ANGELES

NEW GLENDALE COURTHOUSE

EXISTING COURTHOUSE FEASIBILITY REPORT

MARCH 2, 2012

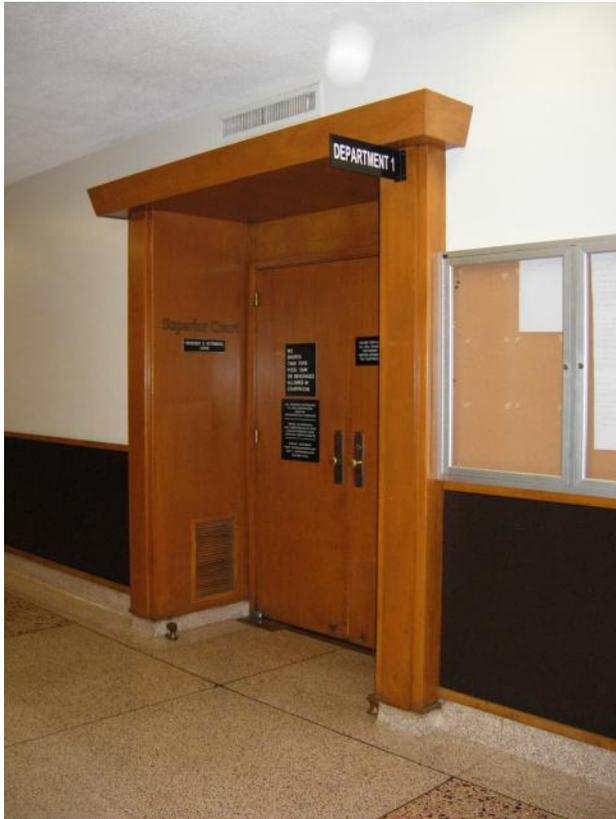
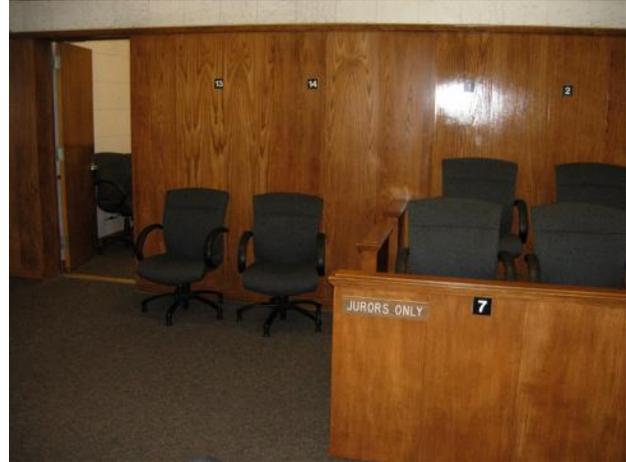
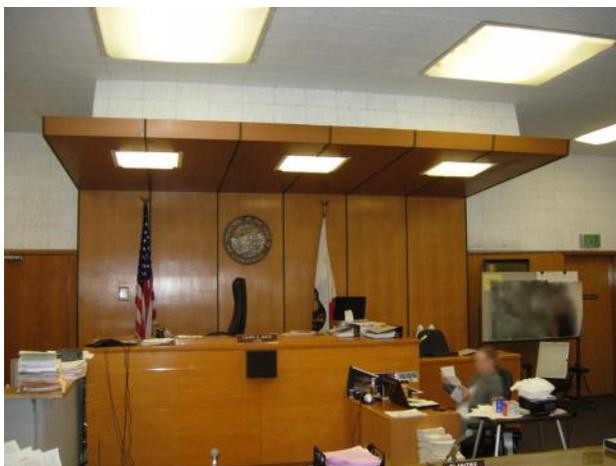
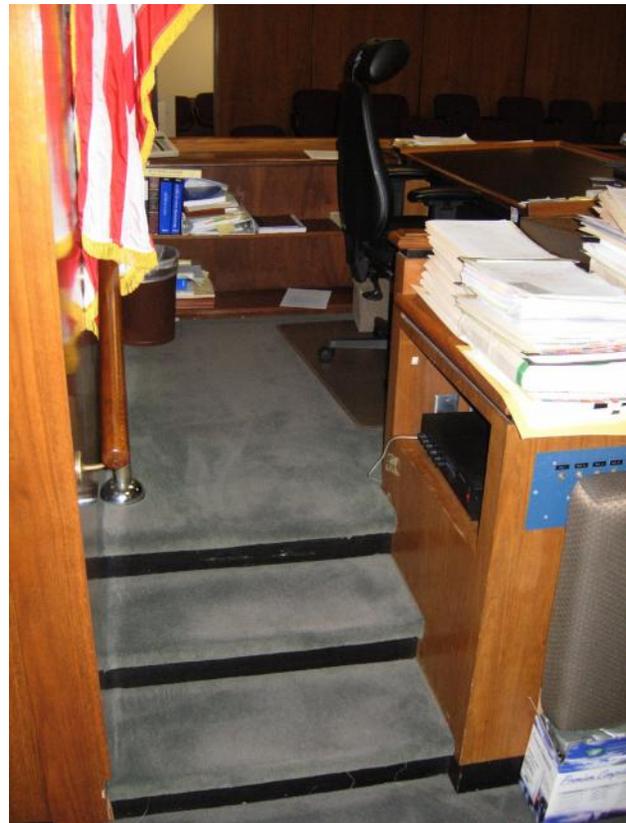
Courtroom Judges Bench, Jury Box, etc

All 5 of the existing judges benches in the main building courtrooms are currently not accessible. The benches are elevated 18" and are accessed via 3 narrow risers, approximately 27" wide. To be brought up to compliance, the steps would need to be replaced with a ramp or a two stop motorized lift. Neither is a viable option due to the small size of the existing courtrooms and both require extensive modifications to the casework to provide a minimum clear accessible width (32" for up to 24" distance; 36" otherwise)

A third option would be to raise the back corridor floor level in some manner or by a ramping system outside the courtroom. This would require an extensive effort to address the 3 different levels: courtroom, witness box and judges bench.

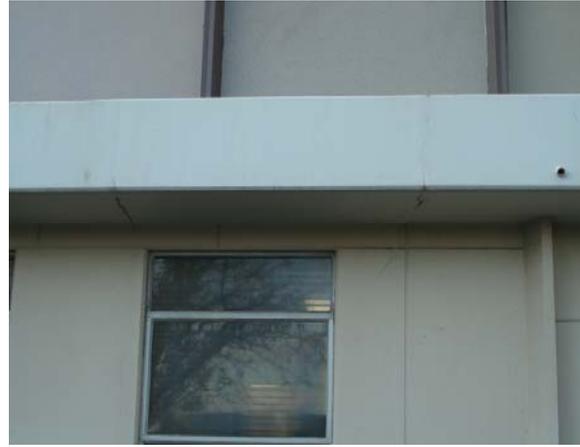
Photo 4: Minor crack development due to water leakage

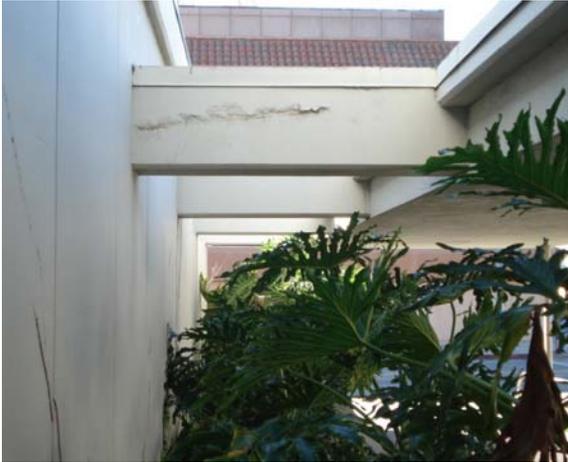
Photo 2: Concrete deterioration observed only at one of the entrance canopy beams

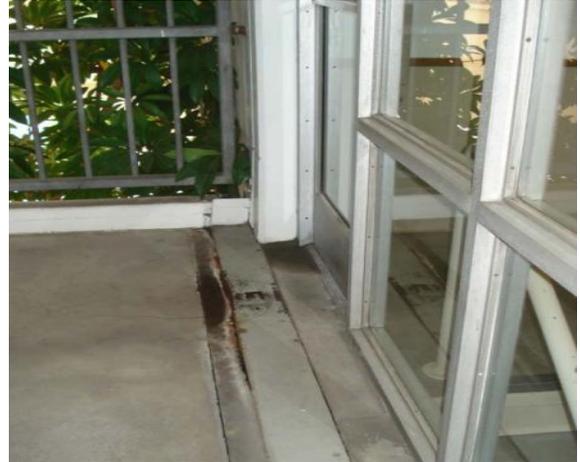
Photo 5: Non conforming separation joint
