Secretary of the Interior's
Standards for Treatment of
Historic Properties

The Secretary of the Interior's Standards
for the Treatment of Historic Properties

with Guidelines for
Preserving, Rehabilitating
Restoring & Reconstructing
Historic Buildings

Kay D. Weeks and Anne E. Grimmer

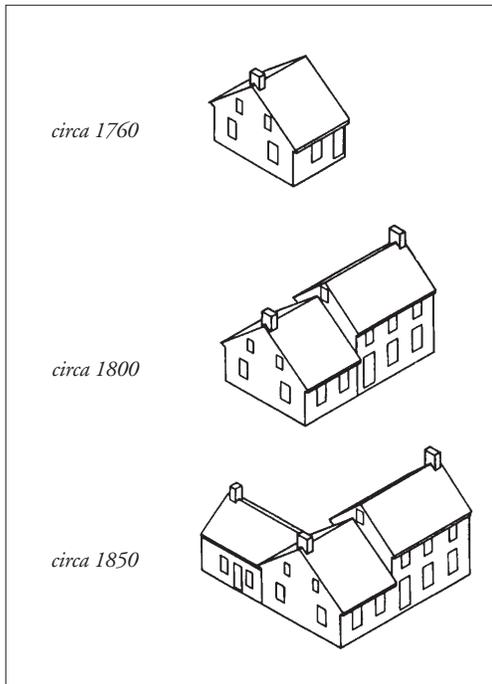
This three-part drawing shows the evolution of a farm house over time. Such change is part of the history of the place and is respected within the treatment, Preservation. Drawing: Center for Historic Architecture and Engineering, University of Delaware (adapted from Preservation Brief 35: Understanding Old Buildings).

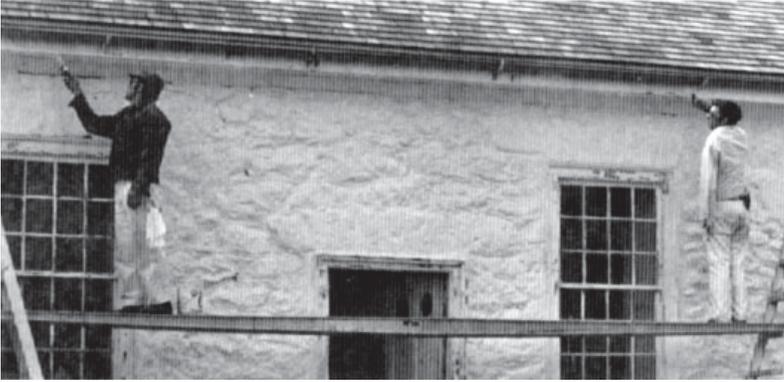
Adequate protection and maintenance of a historic building is an ongoing commitment. Here, two workers are priming and repainting exterior stone and wood trim. If surface treatments are neglected, more extensive repair and replacement will be required. Each loss further undermines a building's historic integrity.

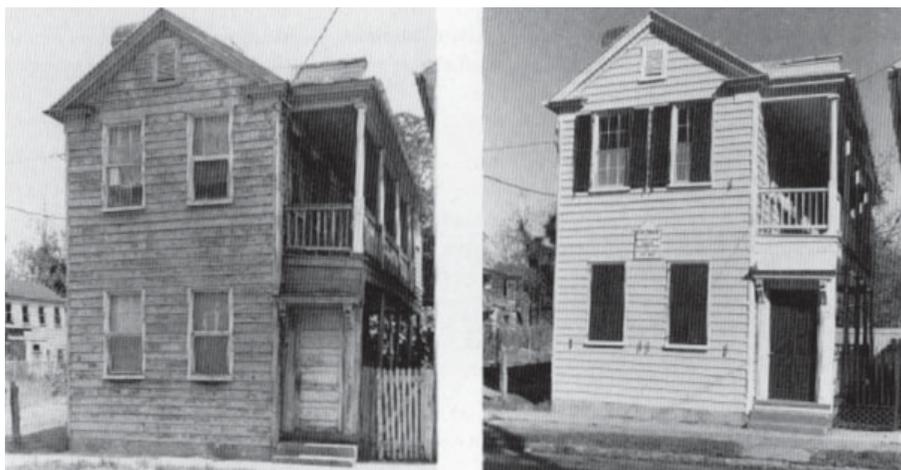
Maximizing retention of historic materials and features is the primary goal of Preservation as demonstrated here in these “before” and “after” photographs. Aside from some minor repairs and limited replacement of deteriorated material, work on this house consisted primarily of repainting the wood exterior. Photos: Historic Charleston Foundation.

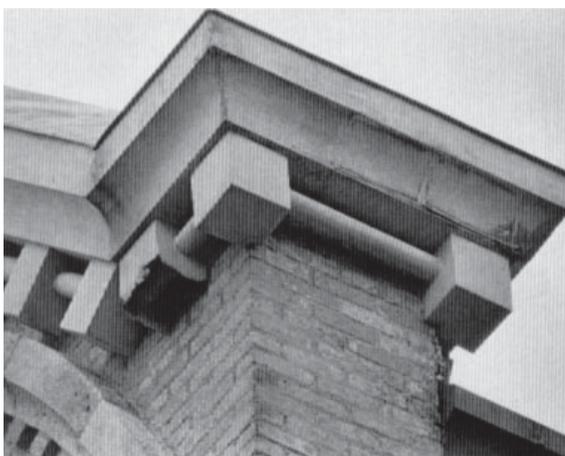
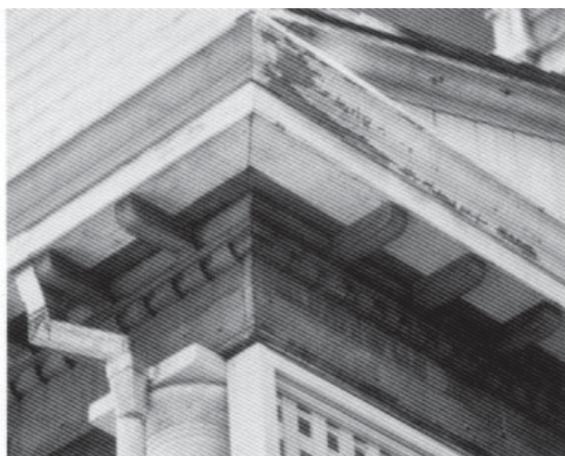
Two examples of “limited replacement in kind” point out an appropriate scope of work within the treatment, Preservation. (a) One metal modillion that has sustained damage from a faulty gutter will need to be replaced; and (b) targeted repairs to deteriorated wood cornice elements (fascia board and modillions) meant that most of the historic materials were retained in the work.

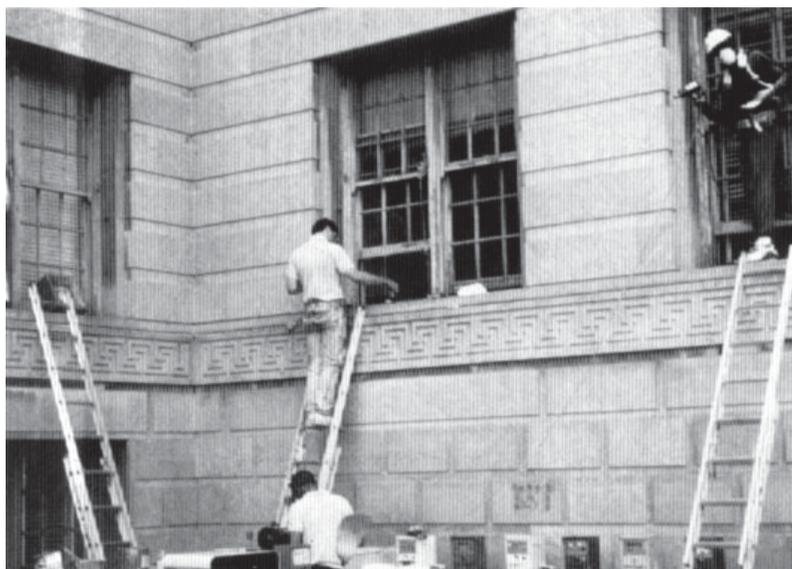
Preserving a building's historic windows generally involves scraping, sanding, and re-painting. While some repair work will most likely be undertaken within the scope of work on this institutional building, replacement of the window units is usually not an appropriate Preservation treatment. Photo: Chuck Fisher.

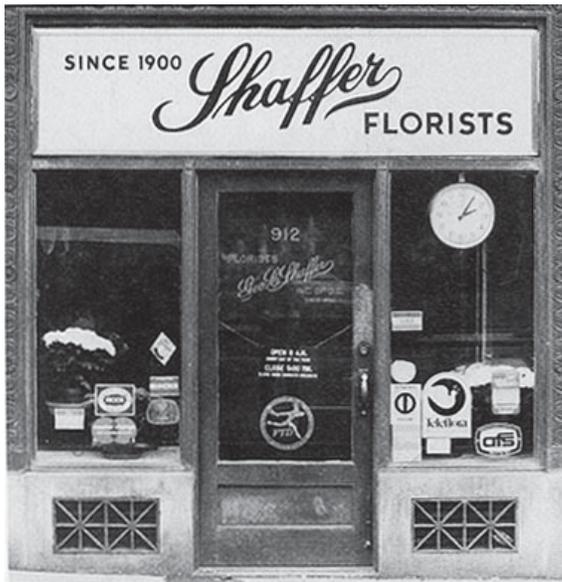
The original form and features of this 1920s storefront have been retained through Preservation. Photo: David W. Look, AIA.

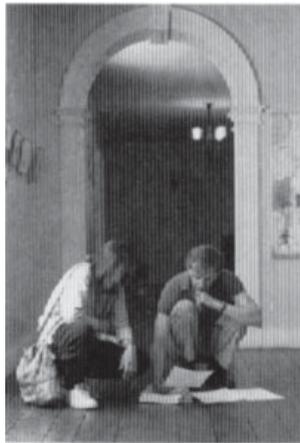
Careful documentation of a building's physical condition is the critical first step in determining an appropriate level of intervention. (a) This may include relating the historical research to existing materials and features; or (b) documenting a particular problem such as this cracked ceiling. Photo (a): Jean E. Travers; Photo (b): Lee H. Nelson, FAIA.

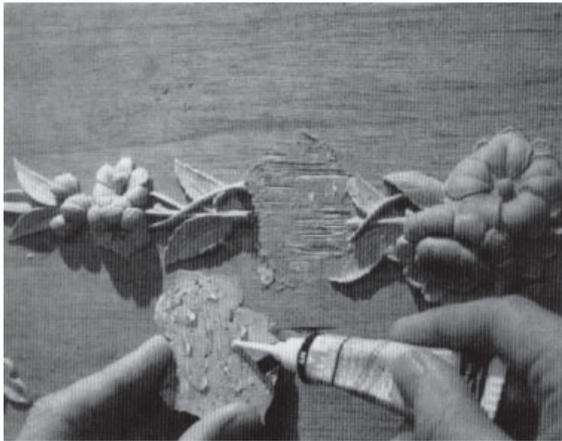
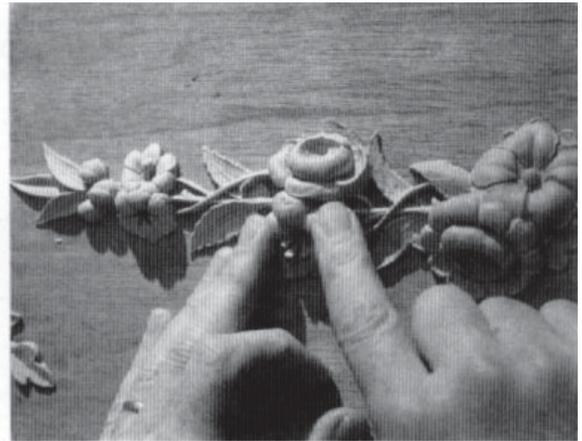
In Preservation, an appropriate level of intervention is established prior to work in order to maximize retention of historic materials.

- (a) *A conservator is applying adhesive to 19th century composition ornament that has delaminated from its wood substrate.*
(b) *The compo fragment is carefully held in place until the quick-setting adhesive takes hold. Photos: Jonathan Thornton.*

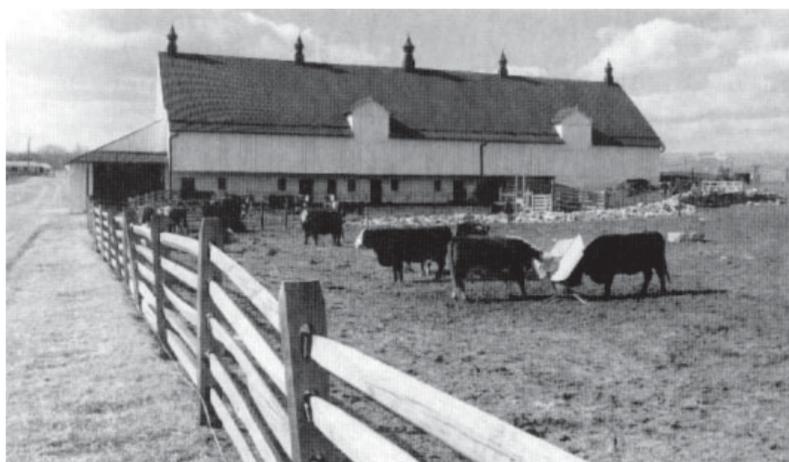
The goal of Preservation is to retain the historic form, materials, and features of the building and its site as they have changed—or evolved—over time. This bank barn was built in the 1820s, then enlarged in 1898 and again in 1914. Today, it continues its role as a working farm structure as a result of sensitive preservation work. This included foundation re-grading; a new gutter system; structural strengthening; and replacement of a severely deteriorated metal roof. Photo: Jack E. Boucher, HABS.

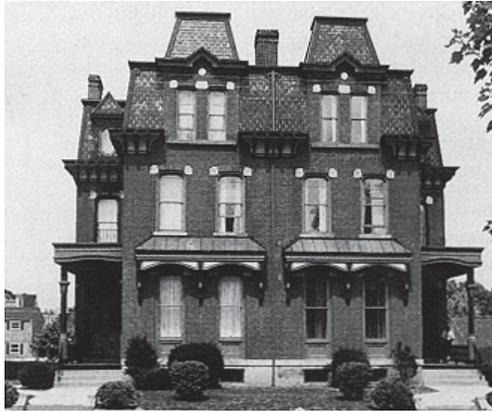
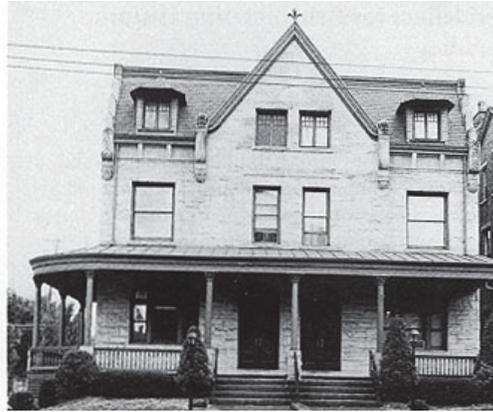
Originally built as single-family, semi-detached duplexes, these houses were rehabilitated for a new use as rental apartments. While some alteration to non-significant interior features and spaces was necessary in each one, the exteriors were essentially preserved. Photos: Mistick, Inc.

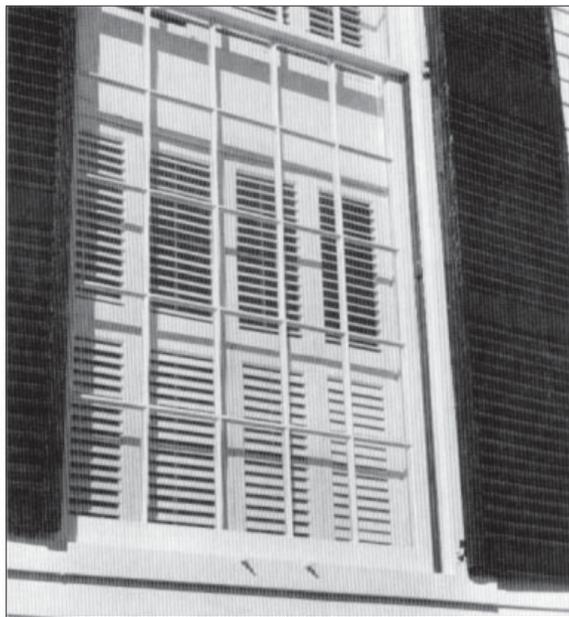
According to the Standards for Rehabilitation, existing historic materials should be protected, maintained and repaired. In an exemplary project, the windows and shutters of this historic residence were carefully preserved.

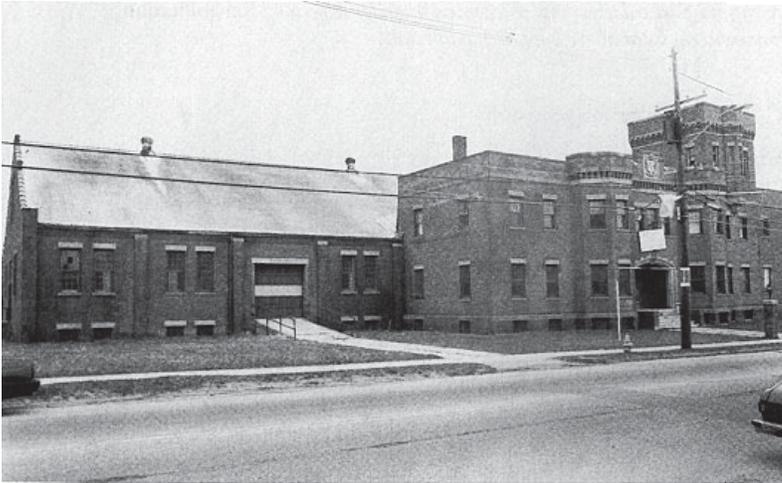
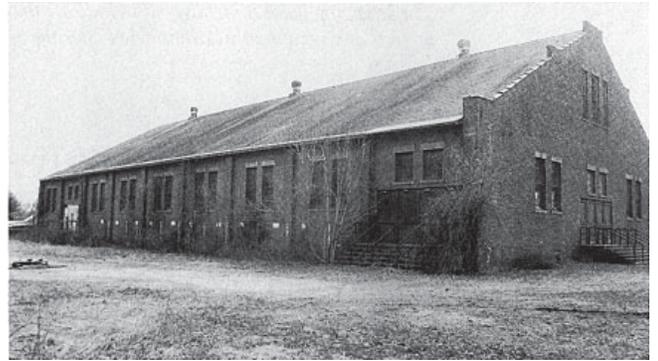
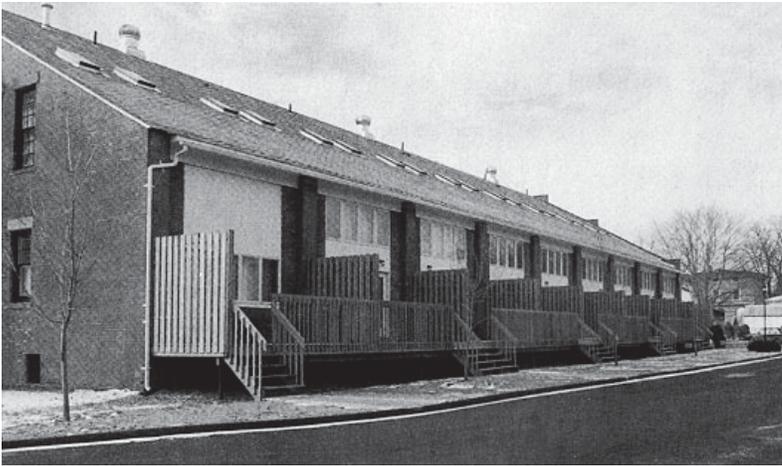
(a) An armory complex was rehabilitated for rental housing. (b) This view of the rear elevation shows the paired, nine-over-nine wood sash windows and high sills that characterized the building. (c) After inappropriate rehabilitation work, the same rear elevation is shown with new skylights added to the roof, prefabricated panels filling the former brick areas, and new wood decks and privacy fences. Because the work changed the historic character, the project did not meet the Standards.

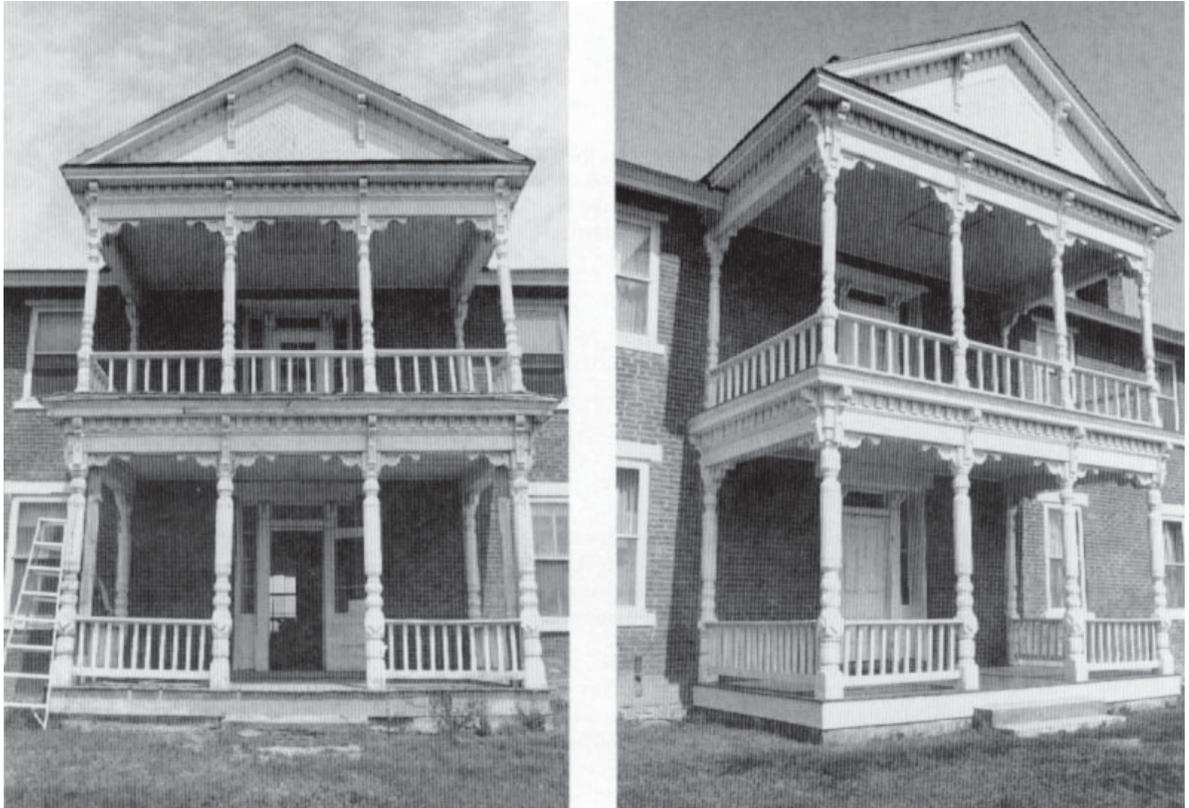
In Rehabilitation, deteriorated features should be repaired, whenever possible, and replaced when the severity of the damage makes it necessary. Here, a two-story porch is seen prior to treatment (left). The floor boards are rotted out and the columns are in a state of collapse, supported only by crude, temporary shafts. Other components are in varying stages of decay. Appropriate work on the historic porch (right) included repairs to the porch rails; and total replacement of the extensively deteriorated columns and floor boards. Some dismantling of the porch was necessary.

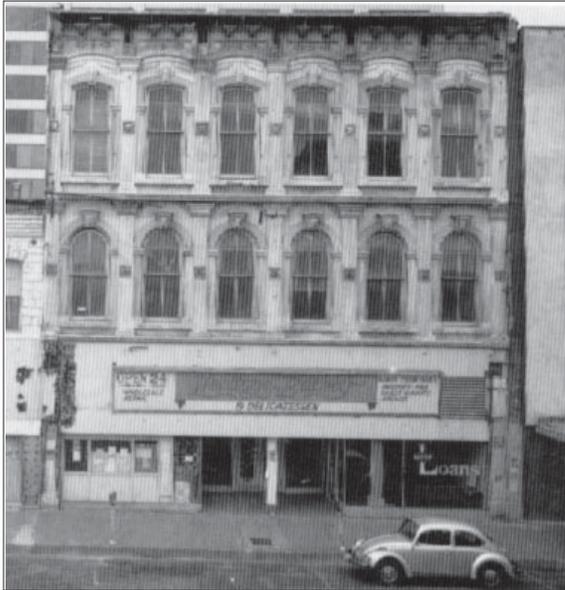
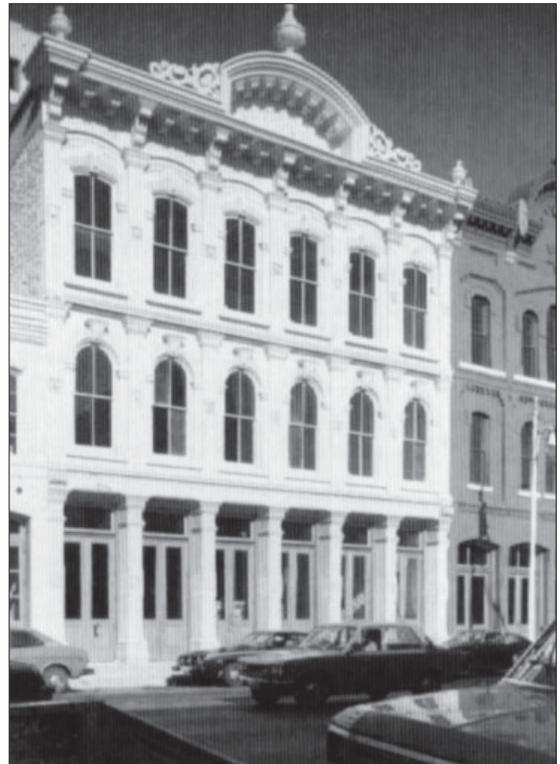
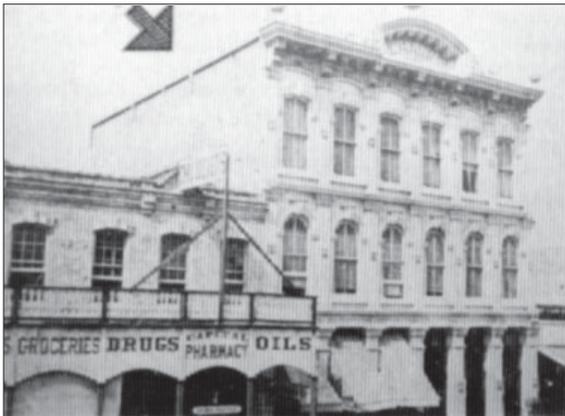
In the treatment, Rehabilitation, one option for replacing missing historic features is to use pictorial documentation and/or physical evidence to re-create the historic feature. (a) In this example, the ornamental cornice of an 1866 limestone building was missing; and the ground level storefront had been extensively altered. (b) and (c) Based on the availability of photographic and other documentation, the owners were able to accurately restore the cornice and storefront to their historic configuration. A substitute material, fiberglass, was used to fabricate the missing pressed metal cornice, an acceptable alternative in this project. All work met the Standards.

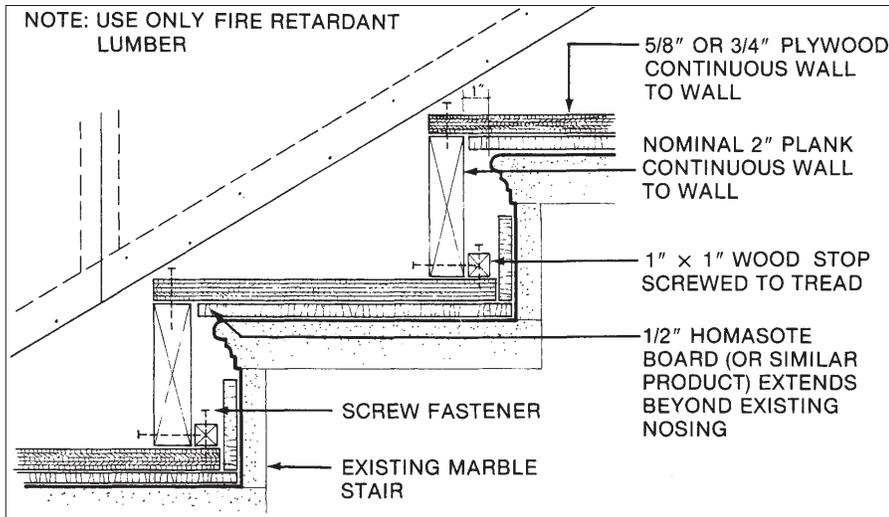
Historic features that characterize a building should always be protected from damage during rehabilitation work. The drawing shows how a resilient, temporary stair covering was applied over the existing marble staircase. Drawing: National Park Service staff, based on material originally prepared by Emery Roth and Sons, P.C.

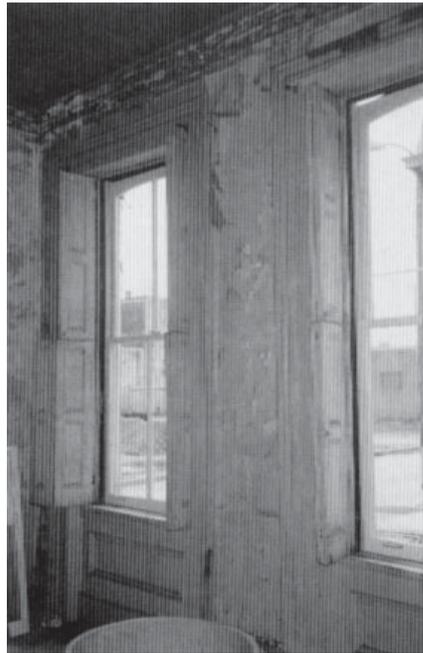
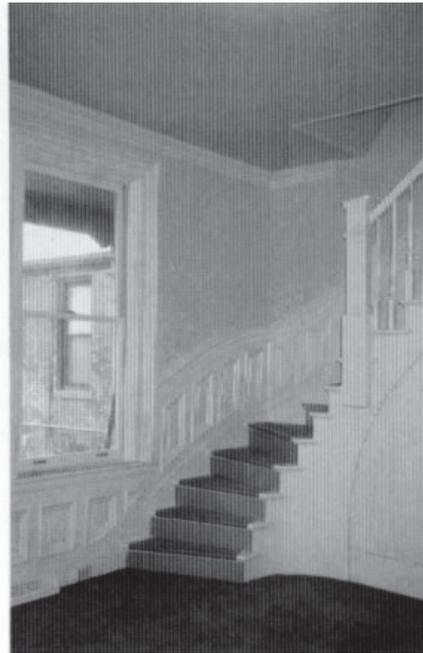
Rehabilitating historic dwelling units often includes some level of lead-paint hazard abatement. Whenever lead-base paint begins to peel, chip, craze, or otherwise comes loose (a), it should be removed in a manner that protects the worker as well as the immediate environment. In this example (b), the deteriorating lead-paint was removed throughout the apartment building and a compatible primer and finish paint applied.
Photos: Sharon C. Park, AIA.

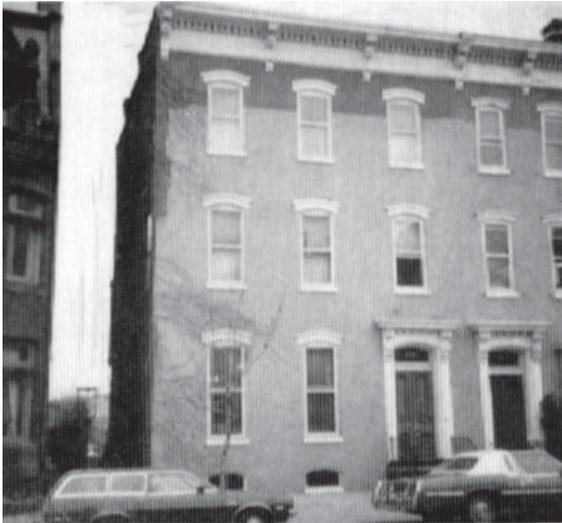
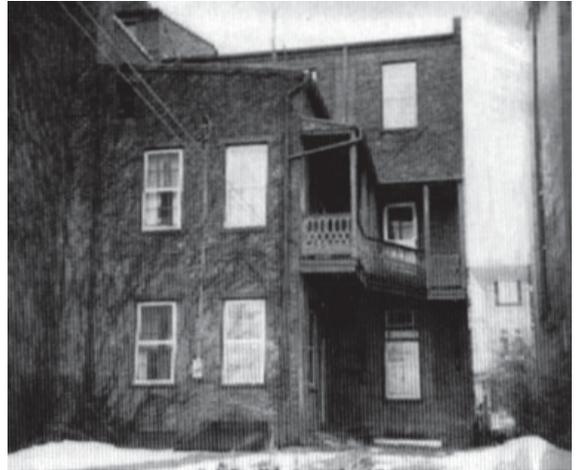
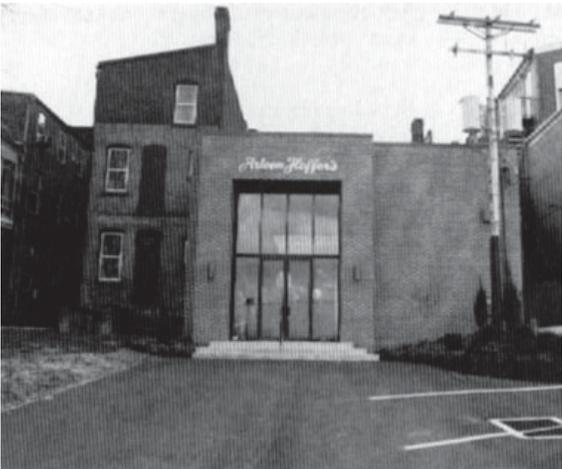
If a rear elevation of a historic building is distinctive and highly visible in the neighborhood, altering it may not meet the Standards. (a and b) This 3-story brick rowhouse featured a second story gallery and brick kitchen wing characteristic of other residences in the district which backed onto a connecting roadway. (c) In the rehabilitation, the wing and gallery were demolished and a large addition constructed that severely impacted the building's historic form and character.

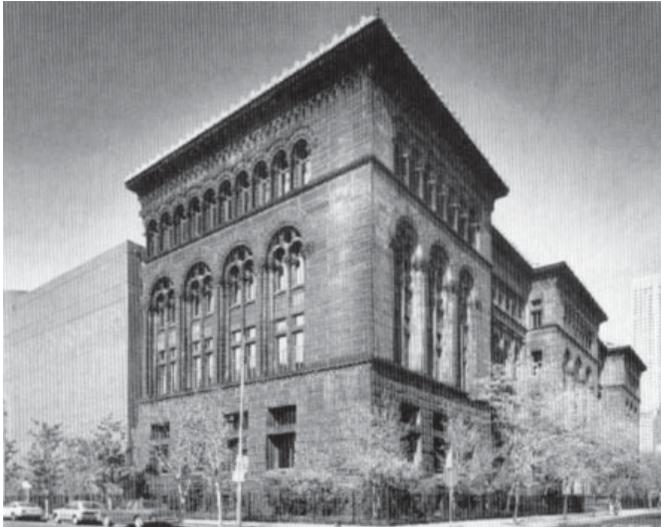
Rehabilitation, like Preservation, acknowledges a building's change over time; the retention and repair of existing historic materials and features is thus always recommended. However, unlike Preservation, the dual goal of Rehabilitation is to—respectfully—add to or alter a building in order to meet new use requirements. This downtown Chicago library was expanded in 1981 when additional space was required with light and humidity control for the rare book collection. The compatible 10-story wing was linked to the historic block on side and rear elevations. Its simple design is compatible with the historic form, features, and detailing; old and new are clearly differentiated. Photo: Dave Clifton.

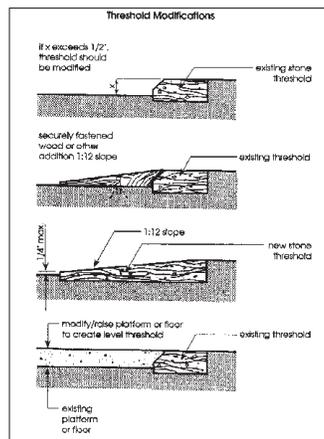
Making a building accessible to the public is a requirement under the Americans with Disabilities Act of 1990, whatever the treatment. Full, partial, or alternative approaches to accessibility depends upon the historical significance of a building and the ability to make changes. In these examples, thresholds that exceed allowable heights were modified several ways to increase accessibility, without jeopardizing the historic character. Drawing: Uniform Federal Accessibility Standard (UFAS) Retrofit Manual.

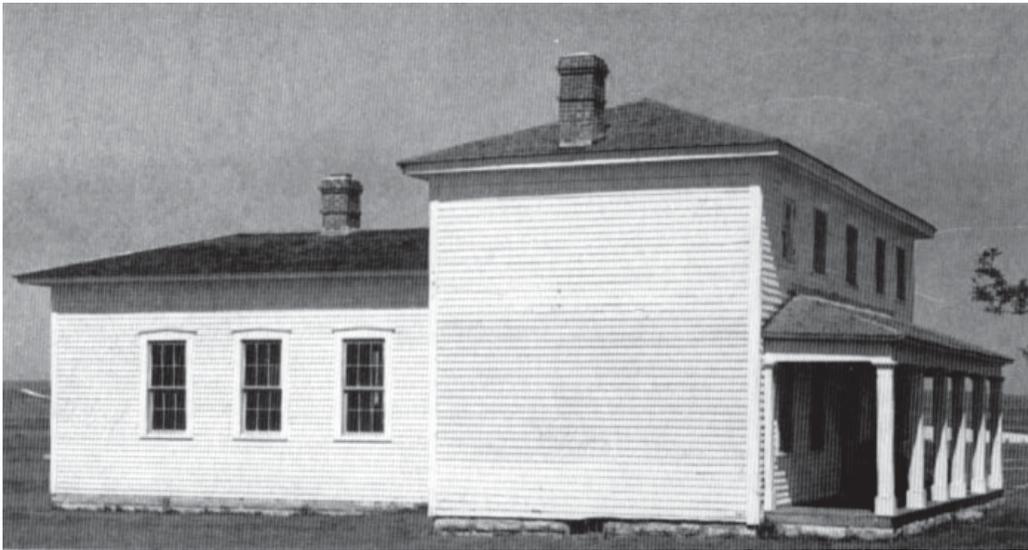
In a project at Fort Hays, Kansas, the wood frame officers' quarters were restored to the late 1860s—their period of significance. This included replacing a missing kitchen ell, chimneys, porch columns, and cornice, and closing a later window opening in the main block. The building and others in the museum complex is used to interpret frontier history.

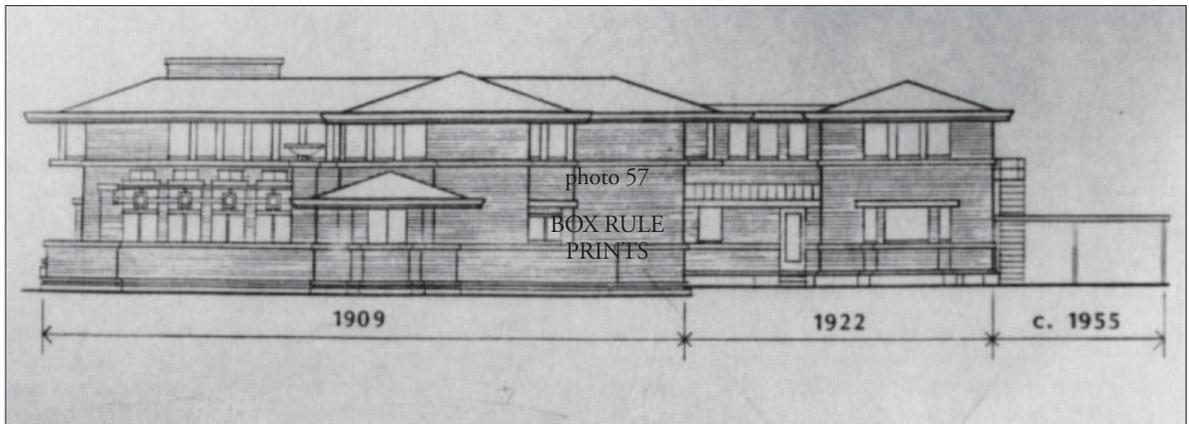
The Meyer May House in Grand Rapids, Michigan, was designed by Frank Lloyd Wright and built in 1909. In 1922, May added to the house for an expanding family. After the May occupancy, the house was altered for use as apartments, with a carport added in 1955. In the 1980s restoration, the Wright's original design was deemed more significant than May's later changes, and, as a result, the additions were removed and the house returned to its 1909 appearance. Drawing: Martha L. Werenfels, ALA.

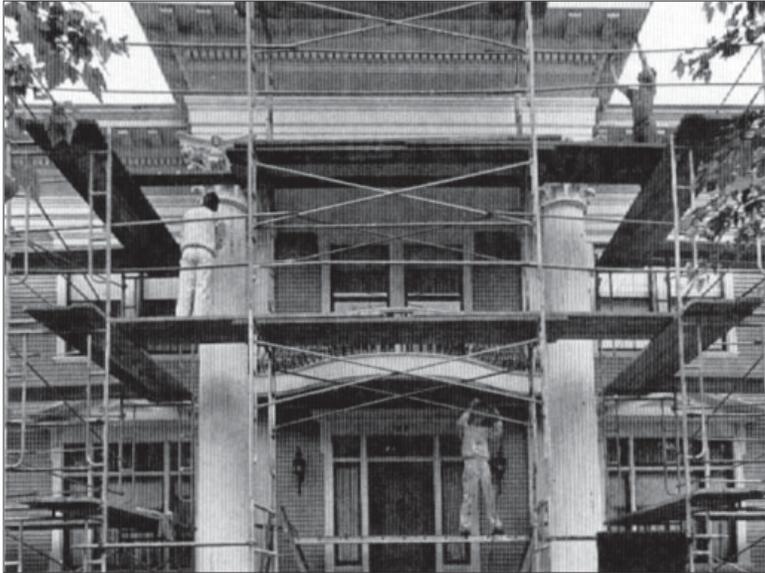
Ongoing work at this house focuses on the maintenance and repair of exterior wood features from the restoration period. After scraping and sanding, the wood was painted in colors documented to the Restoration period. Photo: ©Mary Randlett, 1992.

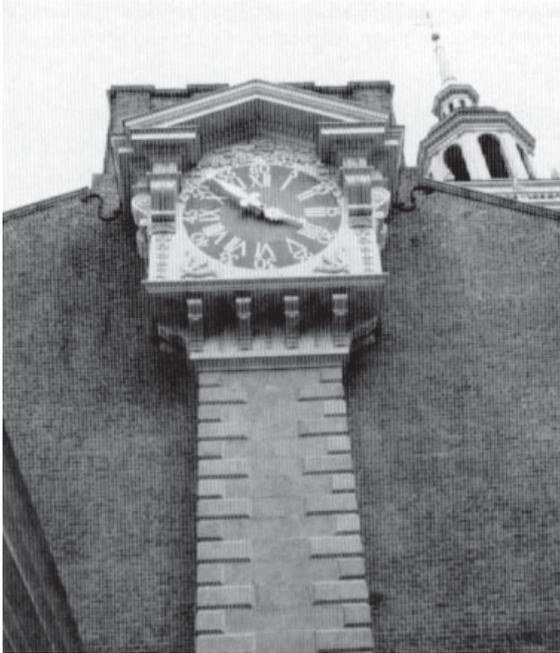
The Standards for Restoration call for the repair of existing features from the restoration period as well as the re-creation of missing features from the period. In some instances, when missing features are replaced, substitute materials may be considered if they convey the appearance of the historic materials. In this example at Philadelphia's Independence Hall, the clock was re-built in 1972-73 using cast stone and wood with fiberglass and polyester bronze ornamentation. Photo: Lee H. Nelson, FAIA.

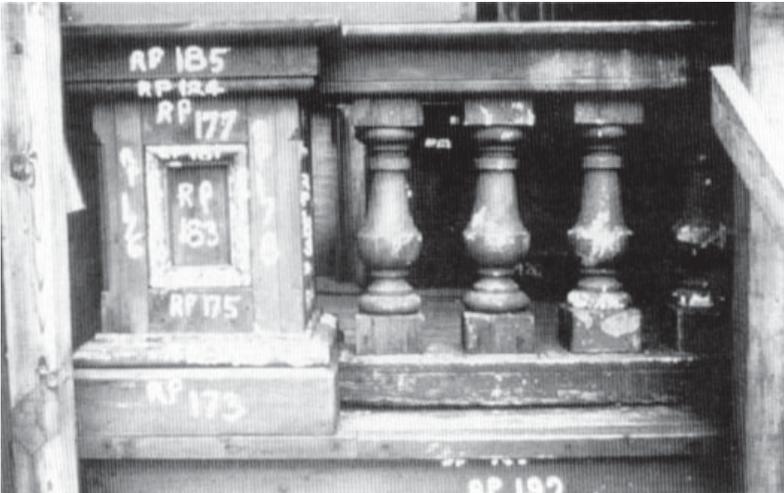
Portions of the small porch on an Italianate mansion were carefully numbered prior to Restoration. Some original elements were restored in place, while others had to be removed for repair, then reinstalled. Any element too deteriorated to save was replaced with a new one replicated to match the original design. Photo: Morgan W. Phillips.

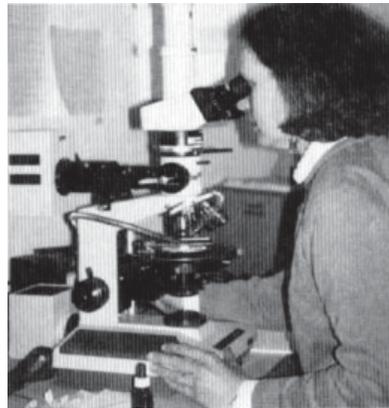
A complete paint investigation often needs to be conducted during Restoration. Paint samples are carefully collected onsite. In the laboratory, an ultra violet light is used to identify pigment and binding media. Paint samples are then photographed. Physical evidence documented through laboratory research provides a sound basis for an accurate restoration of painted finishes, such as the complex stencilling pictured here. Photo left: Courtesy, Alexis Elza; Photo right: Courtesy, Andrea Gilmore.

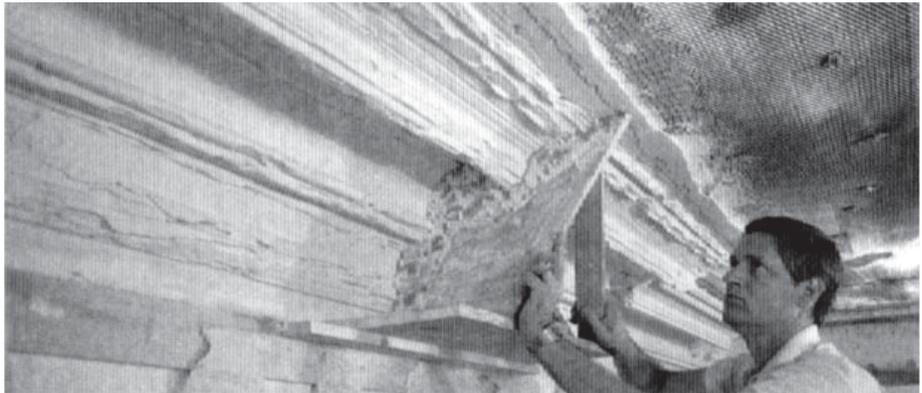
The missing plaster cornice was restored as part of an overall project to return a residence to its original appearance. The traditional method of producing a cornice is unchanged today. Photo: Old-House Journal.

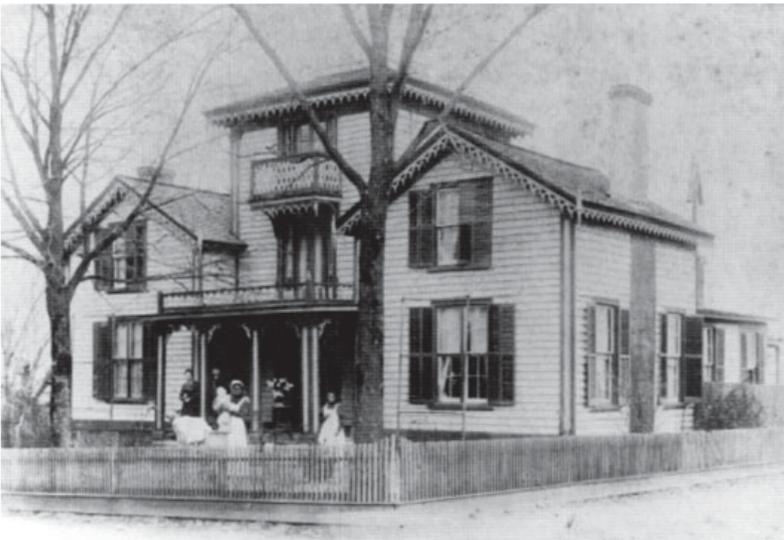
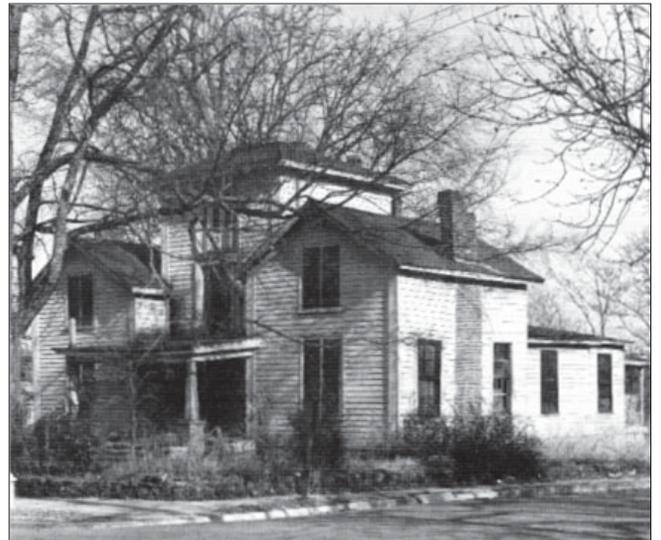
This ca. 1900 photograph (left) would be invaluable to guide restoration of the deteriorated house (right) to its documented earlier appearance, complete with decorative trim, shutters, polychromed exterior, and fencing. Photos: Courtesy, North Carolina Department of Archives and History.

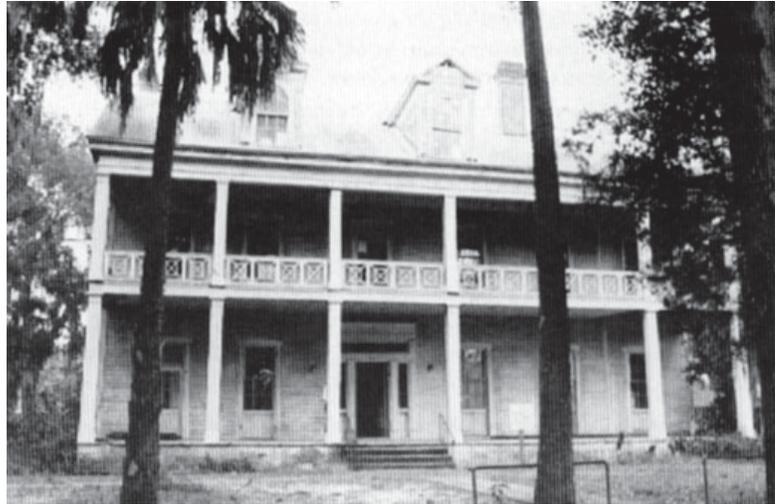
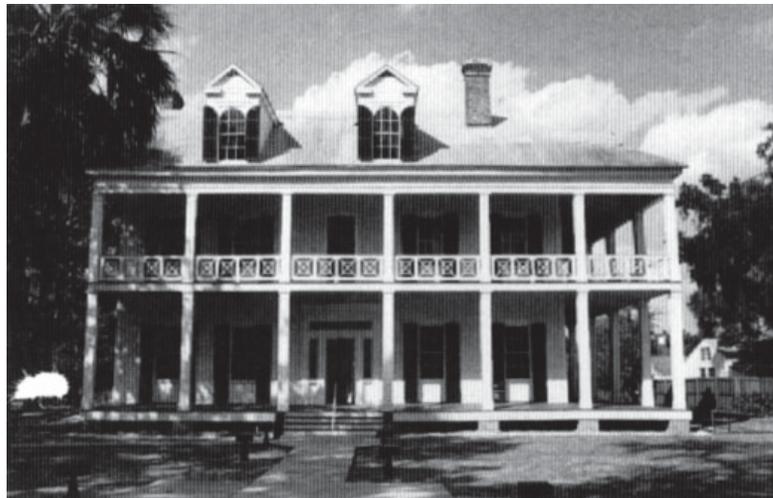
The Bronson-Mulholland House in Palatka, Florida, ca. 1845, is shown (a) before and (b) after the treatment, Restoration. Over the years the east (far right) side of the veranda had been filled in as a sixth bay. During the restoration, this later infill was removed and the east veranda, together with its flooring, stairs, and foundation, restored. Photo: City of Palatka, Community Development Department.

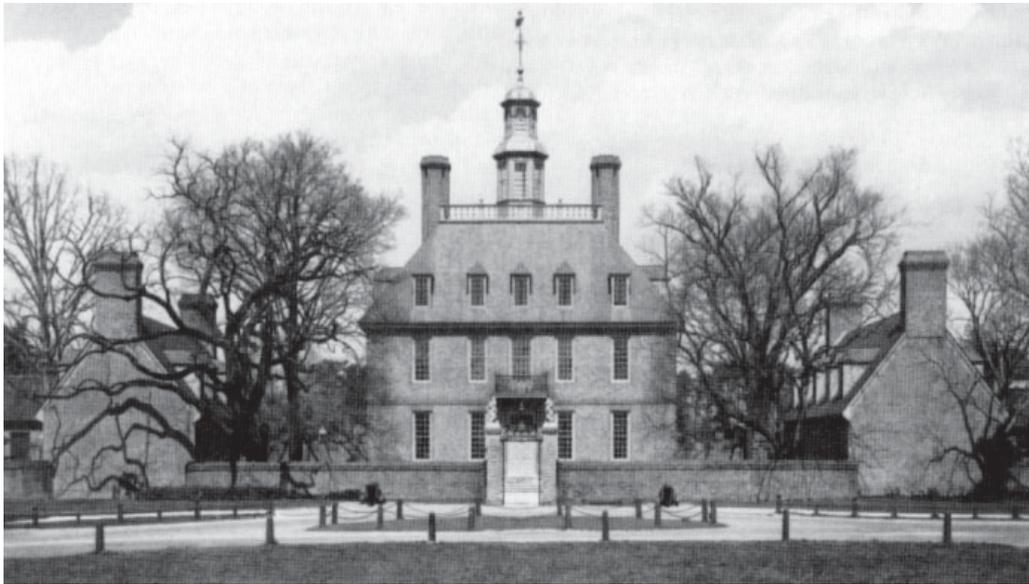
*In the 1930s reconstruction of the 18th century Governor's Palace at Colonial Williamsburg, Virginia, the archeological remains of the brick foundation were carefully preserved in situ, and serve as a base for the reconstructed walls.
Photo: The Colonial Williamsburg Foundation.*

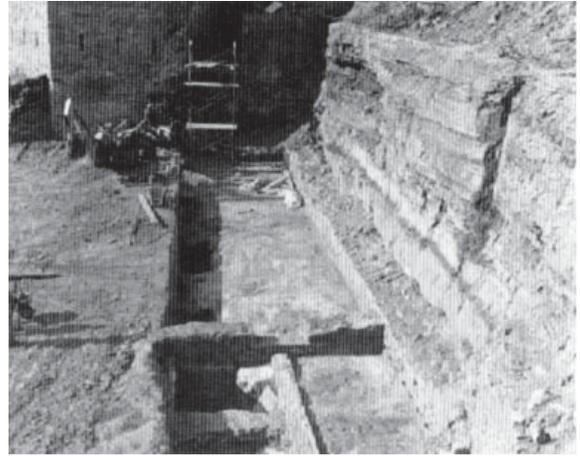
Reconstruction should generally be based on an extensive archeological investigation, as was done here to re-create a non-surviving commissary building at Fort Snelling.

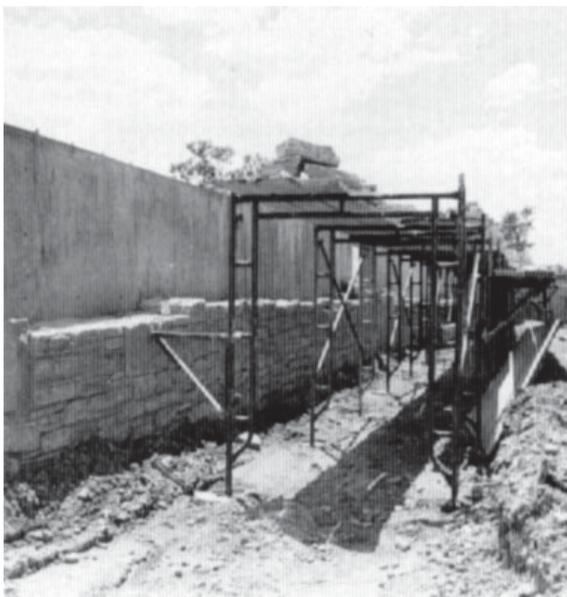
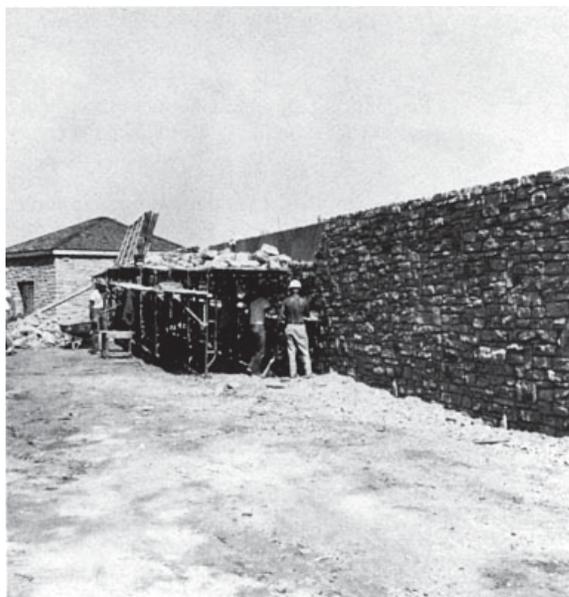
(a) and (b). Two photos illustrate the use of contemporary construction materials and techniques within the treatment, Reconstruction. Because Reconstruction is employed to portray a significant earlier time, usually for interpretive purposes, substitute materials may be appropriate if they are able to convey the historic appearance.

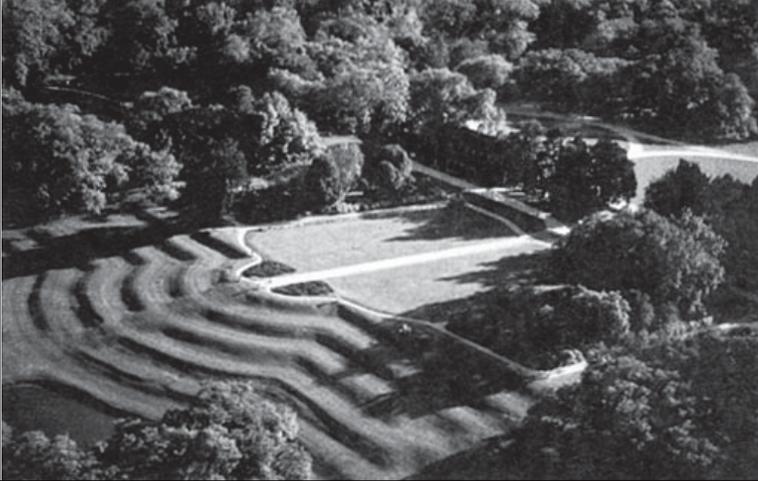
The spacious grounds at Middleton Place, near Charleston, South Carolina, constitute the first landscaped garden in America. The molded terraces, originally constructed in the 18th century, were largely reconstructed in the early 20th century based on extant remains and other documentary evidence. Photo: Middleton Place.

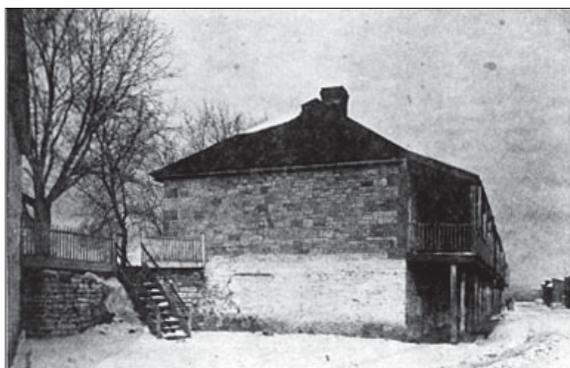
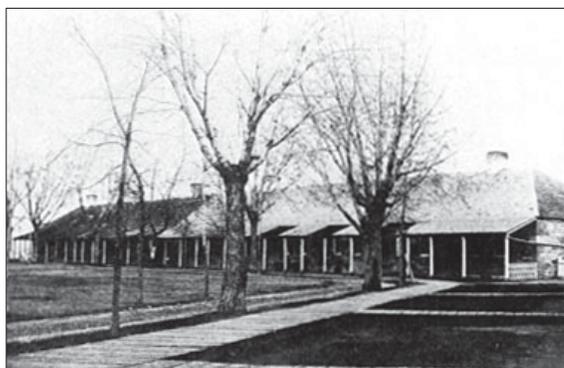
(a) and (b). Two views of the Officers' Quarters at Fort Snelling (ca. 1885 to 1900) not only provide information on the materials and form of the historic block, they document the wooden walkways and other landscape features such as stairs, railings, and tree placement. Historical and pictorial evidence would need to be combined with specific physical evidence in order to make the case for Reconstruction as a treatment.

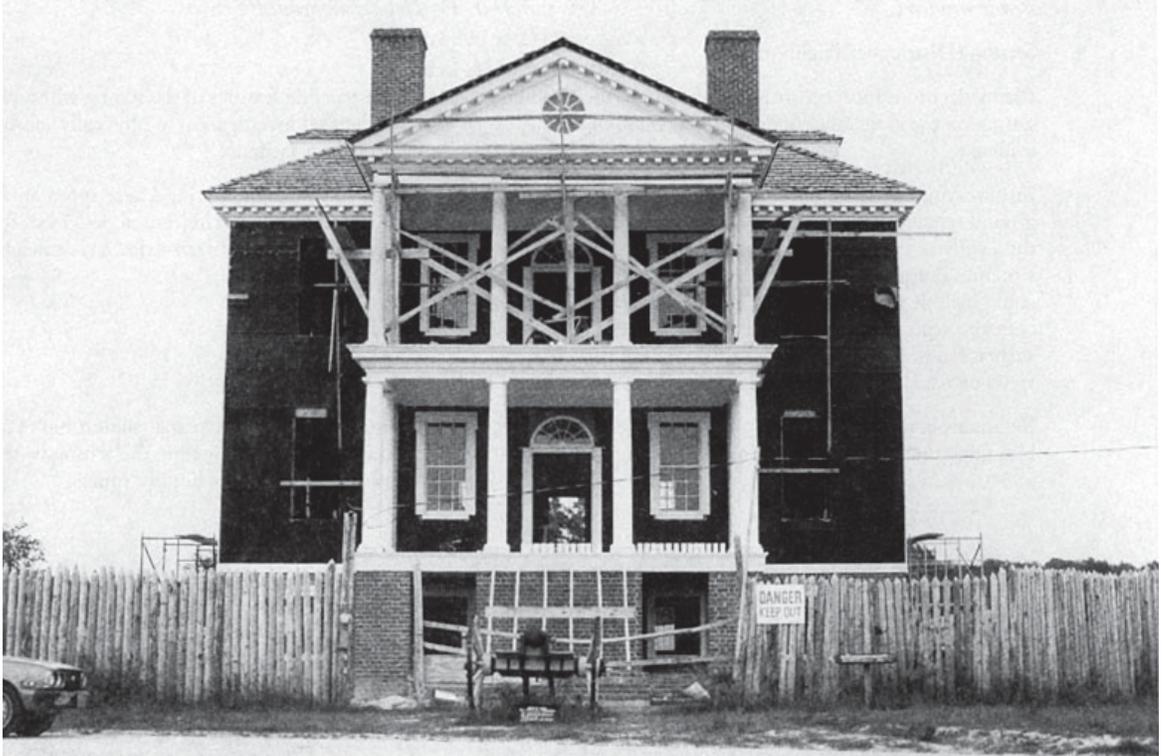
The 1778 Kershaw House, which served as British Headquarters during the Revolutionary War, was burned by Union troops in 1865. In the early 1970s, the house was reconstructed as part of Camden Battlefield, Camden, South Carolina. Built expressly for interpretive purposes, it serves as an illustrative reminder of a past event of national significance. The Standards for Reconstruction call for any re-created building to be clearly identified as a contemporary depiction. This is most often done by means of an exterior sign or plaque, or through an explanatory brochure or exhibit. A guide may inform visitors as well. Photo: Richard Frear.

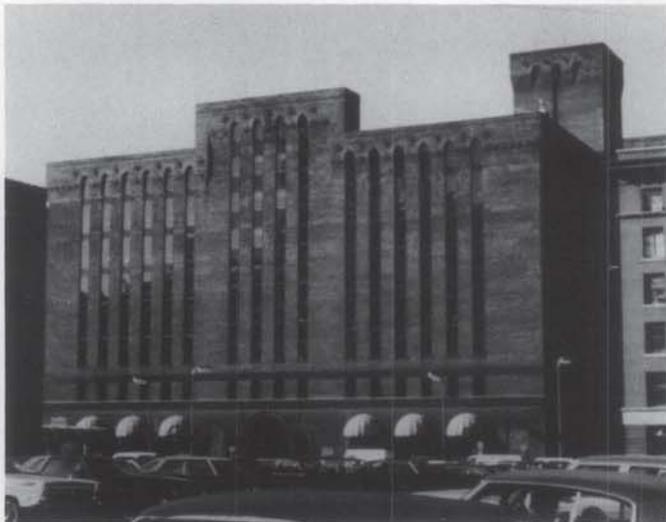
Overall Visual Character: Shape

The shape of a building can be an important aspect of its overall visual character. The building illustrated here, for example, has a distinctive horizontal box-like shape with the middle portion of the box projecting up an extra story. This building has other visual aspects that help define its overall character, including the pattern of vertical bands of windows, the decorative horizontal bands which separate the base of the building from the upper floors, the dark brown color of the brick, the large arched entranceway, and the castle-like tower behind the building.

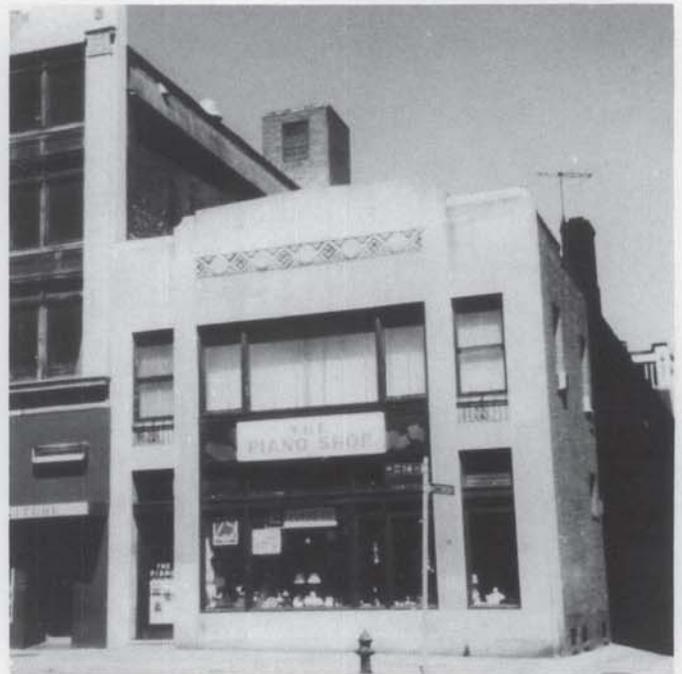
Overall Visual Character: Shape

It should not be assumed that only large or unusual buildings have a shape that is distinctive or identifiable. The front wall of this modest commercial building has a simple three-part shape that is the controlling aspect of its overall visual character. It consists of a large center bay with a two story opening that combines the storefront and the windows above. The upward projecting parapet and the decorative stonework also relate to and emphasize its shape. The flanking narrow bays enframe the side windows and the small iron balconies, and the main entrance doorway into the store. Any changes to the center portion of this three-part shape, could drastically affect the visual character of this building. Photo by Emogene A. Bevitt

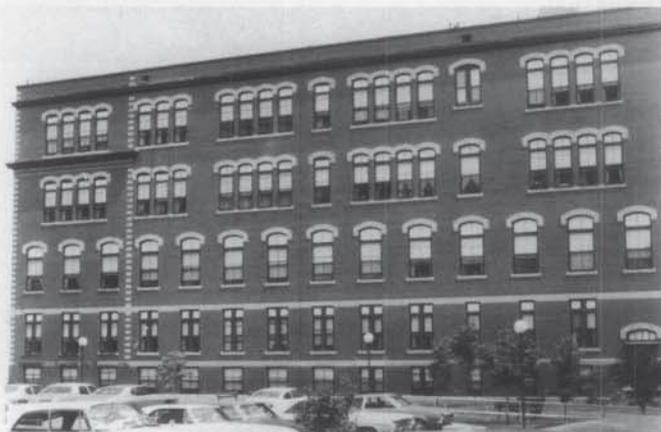
Overall Visual Character: Openings

Window and door openings can be important to the overall visual character of historic buildings. This view shows only part of a much larger building, but the windows clearly help define its character, partly because of their shape and rhythm: the upper floor windows are grouped in a 4,3,4,1,4 rhythm, and the lower floor windows are arranged in a regular 1,1,1,... rhythm. The individual windows are tall, narrow and arched, and they are accented by the different colored arched heads, which are connected where there are multiple windows so that the color contrast is a part of its character. If additional windows were inserted in the gap of the upper floors, the character would be much changed, as it would if the window heads were painted to match the color of the brick walls. Photo by Susan I. Dynes

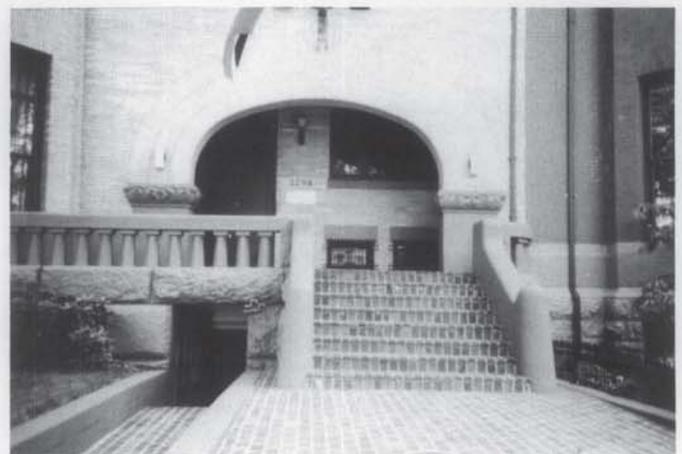
Overall Visual Character: Openings

The opening illustrated here dominates the visual character of this building because of its size, shape, location, materials, and craftsmanship. Because of its relation to the generous staircase, this opening places a strong emphasis on the principal entry to the building. Enclosing this arcade-like entry with glass, for example, would materially and visually change the character of the building. Photo by Lee H. Nelson.
