Secretary of the Interior's
Standards for Treatment of
Historic Properties

The Secretary of the Interior's Standards
for the Treatment of Historic Properties

with Guidelines for
Preserving, Rehabilitating
Restoring & Reconstructing
Historic Buildings

Kay D. Weeks and Anne E. Grimmer

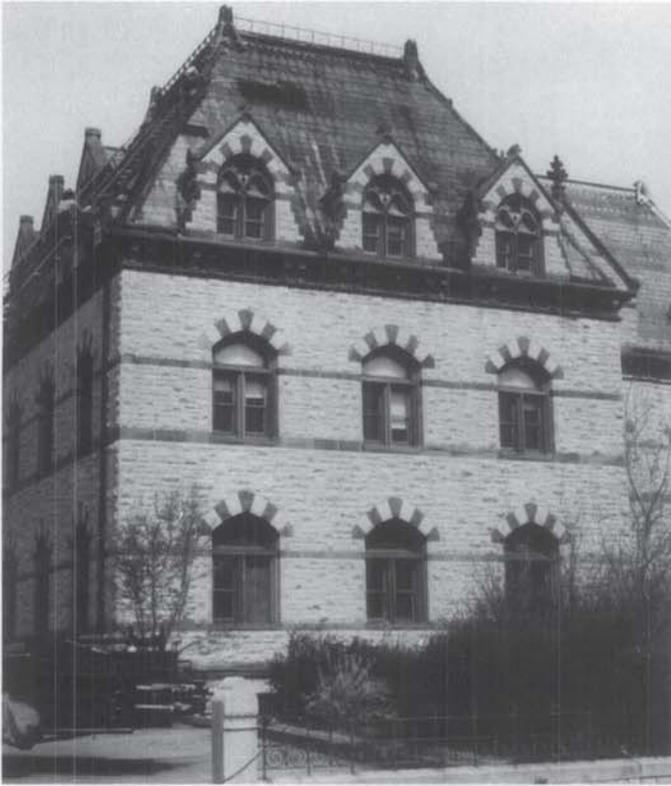
Overall Visual Character: Roof and Related Features

This building has a number of character-defining aspects which include the windows and the decorative stonework, but certainly the roof and its related features are visually important to its overall visual character. The roof is not only highly visible, it has elaborate stone dormers, and it also has decorative metalwork and slatework. The red and black slates of differing sizes and shapes are laid in patterns that extend around the roof of this large and freestanding building. Any changes to this patterned slatework, or to the other roofing details would damage the visual character of the building. Photo by Laurie R. Hammel

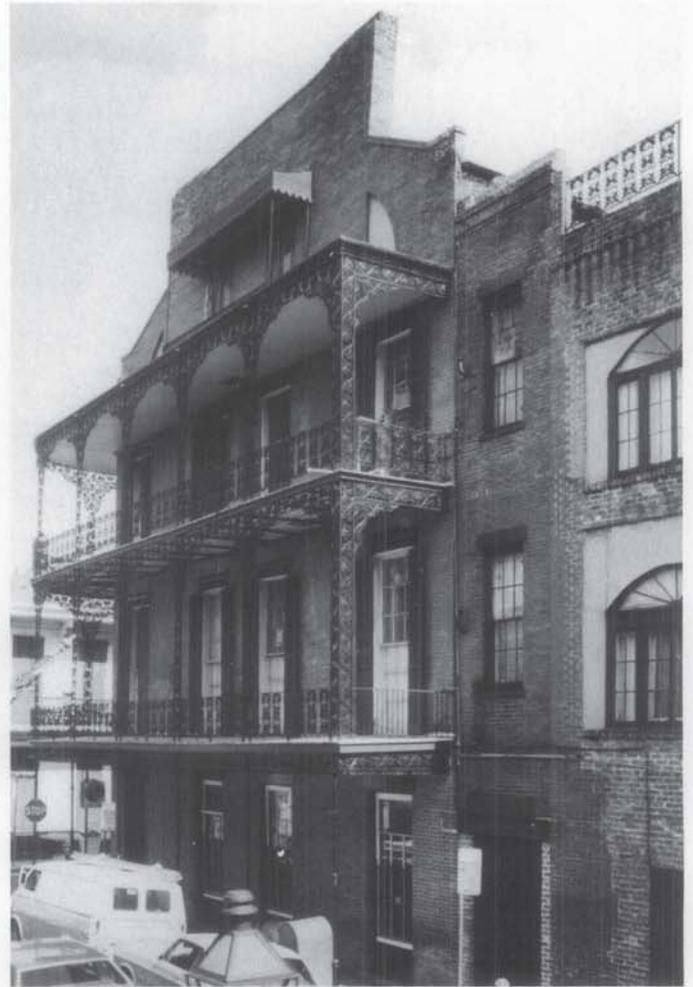
Overall Visual Character: Projections

A projecting porch or balcony can be very important to the overall visual character of almost any building and to the district in which it is located. Despite the size of this building (3 1/2 stories), and its distinctive roofline profile, and despite the importance of the very large window openings, the lacy wrap-around iron balcony is singularly important to the visual character of this building. It would seriously affect the character to remove the balcony, to enclose it, or to replace it with a balcony lacking the same degree of detail of the original material. Photo by Baird M. Smith

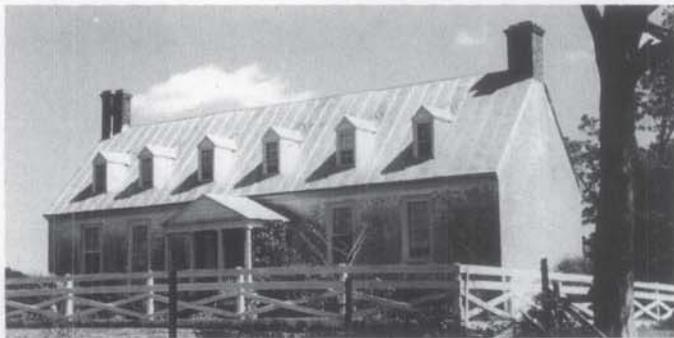
Overall Visual Character: Roof and Related Features

On this building, the most important visual aspects of its character are the roof and its related features such as the dormers and chimneys. The roof is important to the visual character because its steepness makes it highly visible, and its prominence is reinforced by the patterned tinwork, the six dormers and the two chimneys. Changes to the roof or its features, such as removal or alterations to the dormers, for example, would certainly change the character of this building. This does not discount the importance of its other aspects, such as the porch, the windows, the brickwork, or its setting; but the roof is clearly crucial to understanding the overall visual character of this building as seen from a distance. Photo by Lee H. Nelson

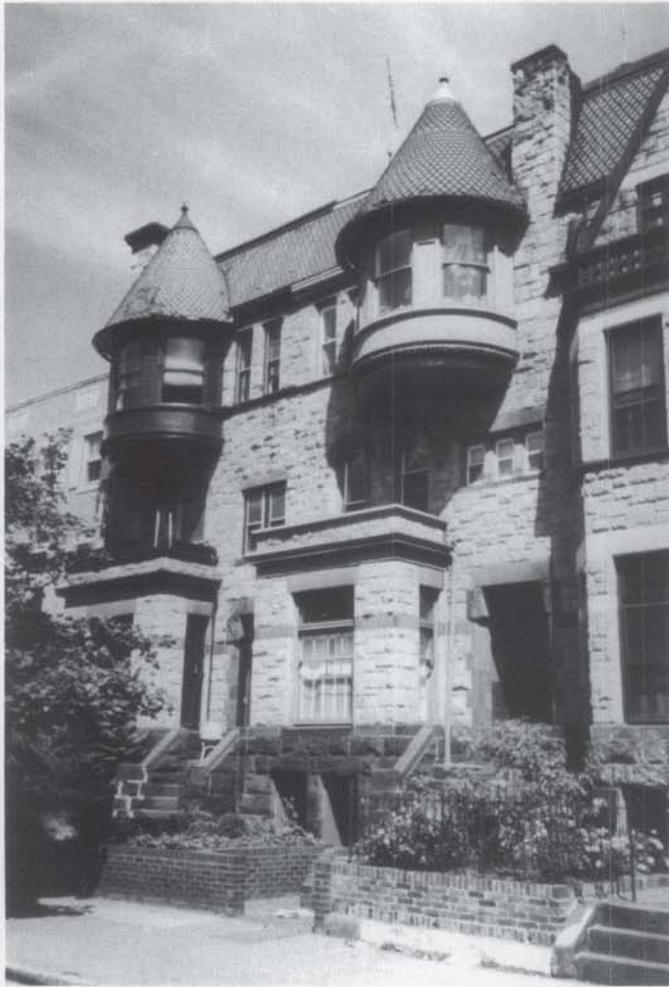
Overall Visual Character: Projections

Since these are row houses, any evaluation of their visual exterior character is necessarily limited to the front and rear walls; and while there are a number of things competing for attention in the front, it is the half round projecting bays with their conical roofs that contribute most prominently to the visual character. Their removal would be a devastating loss to the overall character, but even if preserved, the character could be easily damaged by changes to their color (as seen in the left bay which has been painted a dark color), or changes to their windows, or changes to their tile roofs. Though these houses have other fine features that contribute to the visual character and are worthy of preservation, these half-round bays demonstrate the importance of projecting features on an already rich and complex facade. Because of the repetitive nature of these projecting bays on adjacent row houses, along with the buildings' size, scale, openings, and materials, they also contribute to the overall visual character of the streetscape in the historic district. Any evaluation of the visual character of such a building should take into account the context of this building within the district. Photo by Lee H. Nelson

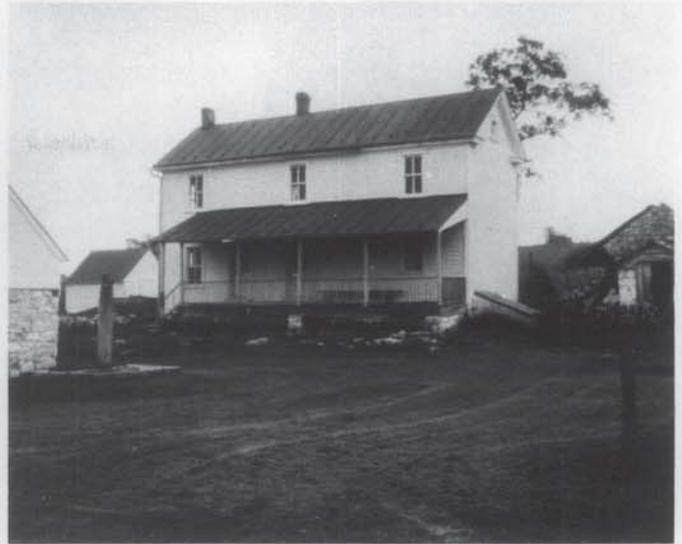
Overall Visual Character: Projections

Many buildings have projecting features such as porches, bay windows, or overhanging roofs, that help define their overall visual character. This projecting porch because of its size and shape, and because it copies the pitch and material of the main roof, is an important contributor to the visual character of this simple farmhouse. The removal or alteration of this porch would drastically alter the character of this building. If the porch were enclosed with wood or glass, or if gingerbread brackets were added to the porch columns, or if the tin roof was replaced with asphalt, or if the porch railing was opened to admit a center stairway, the overall visual character could be seriously damaged. Although this projecting porch is an important feature, almost any other change to this house, such as changes to the window pattern, or changes to the main roof, or changes to the setting, would also change its visual character. Photo by Hugh C. Miller

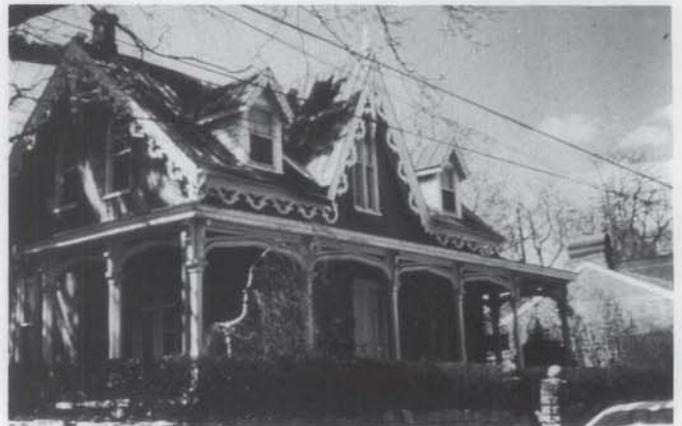
Overall Visual Character: Trim

If one were to analyze the overall shape or form of this building, it would be seen that it is a gable-roofed house with dormers and a wrap-around porch. It is similar to many other houses of the period. It is the wooden trim on the eaves and around the porch that gives this building its own identify and its special visual character. Although such wooden trim is vulnerable to the elements, and must be kept painted to prevent deterioration; the loss of this trim would seriously damage the overall visual character of this building, and its loss would obliterate much of the close-up visual character so dependent upon craftsmanship for the moldings, carvings, and the see-through jigsaw work. Photo by Hugh C. Miller

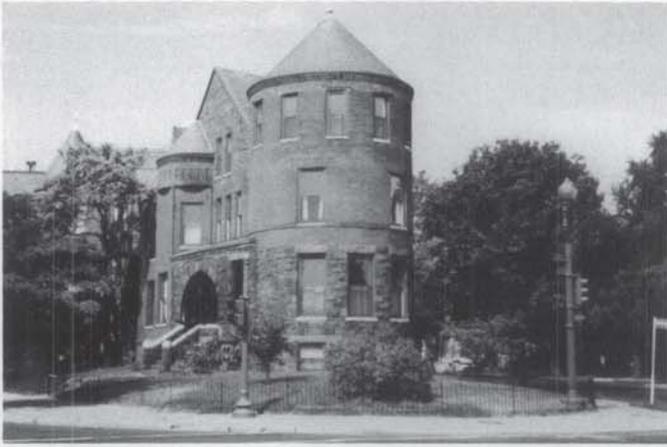
Overall Visual Character: Setting

In the process of identifying the overall visual character, the aspect of setting should not be overlooked. Obviously, the setting of urban row houses differs from that of a mansion with a designed landscape. However, there are many instances where the relationship between the building and its place on the streetscape, or its place in the rural environment, in other words its setting, may be an important contributor to its overall character.

In this instance, the corner tower and the arched entryway are important contributors to the visual character of the building itself, but there is also a relationship between the building and the two converging streets that is also an important aspect of this historic building. The curb, sidewalk, fence, and the yard interrelate with each other to establish a setting that is essential to the overall visual character of the historic property. Removing these elements or replacing them with a driveway or parking court would destroy an important visual aspect. Photo by Lee H. Nelson

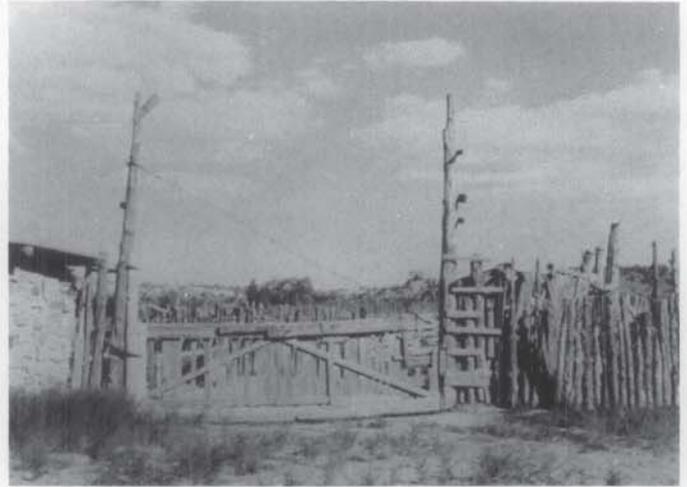
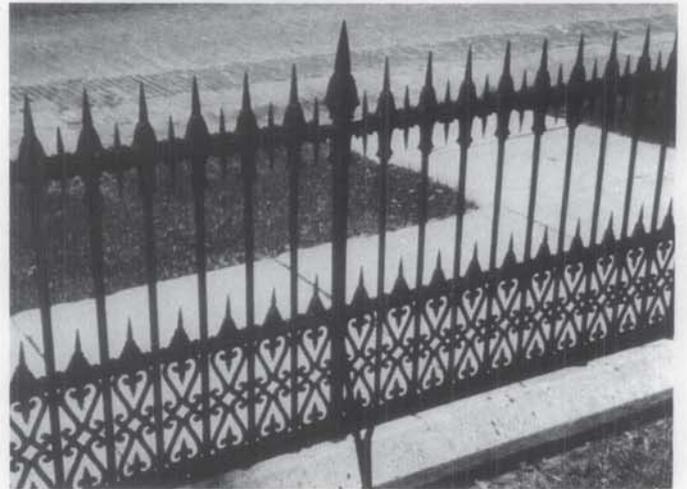
Overall Visual Character: Setting

Among the various visual aspects relating to the setting of an historic property are such site features as gardens, walks, fences, etc. This can include their design and materials. There is a dramatic difference in the visual character between these two fence constructions—one utilizing found materials with no particular regard to their uniformity of size or placement, and the other being a product of the machine age utilizing cast iron components assembled into a pattern of precision and regularity. If the corral fence were to be repaired or replaced with lumberyard materials its character would be dramatically compromised. The rhythm and regularity of the cast iron fence is so important to its visual character that its character could be altered by accidental damage or vandalism, if some of the fence top spikes were broken off thus interrupting the rhythm or pattern. Photos by Lee H. Nelson

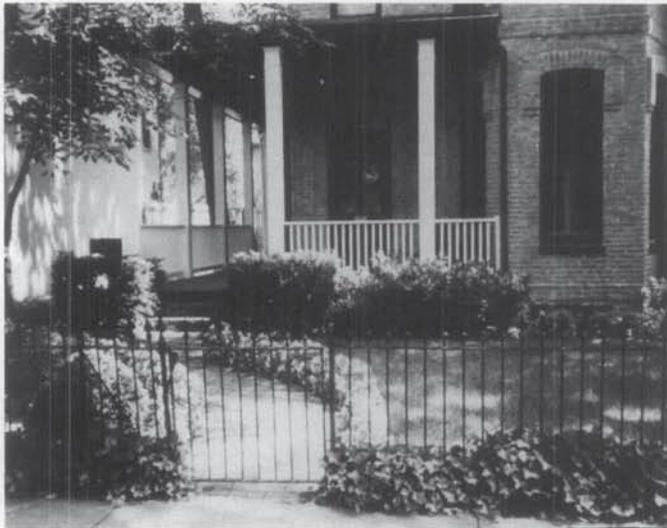
Overall Visual Character: Setting

Even architecturally modest buildings frequently will have a setting that contributes to their overall character. In this very urban district, set-backs are the exception, so that the small front yard is something of a luxury, and it is important to the overall character because of its design and materials, which include the iron fence along the sidewalk, the curved walk leading to the porch, and the various plantings. In a district where parking spaces are in great demand, such front yards are sometimes converted to off-street parking, but in this instance, that would essentially destroy its setting and would drastically change the visual character of this historic property. Photo by Lee H. Nelson

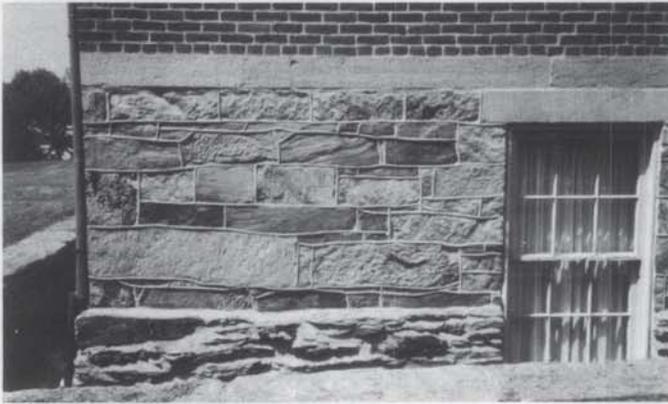
Arm's Length Visual Character: Materials

At arm's length, the visual character is most often determined by the surface qualities of the materials and craftsmanship; and while these aspects are often inextricably related, the original choice of materials often plays the dominant role in establishing the close-range character because of the color, texture, or shape of the materials.

In this instance, the variety and arrangement of the materials is important in defining the visual character, starting with the large pieces of broken stone which form the projecting base for the building walls, then changing to a wall of roughly rectangular stones which vary in size, color, and texture, all with accentuated, projecting beads of mortar, then there is a rather precise and narrow band of cut and dressed stones with minimal mortar joints, and finally, the main building walls are composed of bricks, rather uniform in color, with fairly generous mortar joints. It is the juxtaposition and variety of these materials (and of course, the craftsmanship) that is very important to the visual character. Changing the raised mortar joints, for example, would drastically alter the character at arm's length. Photo by Lee H. Nelson

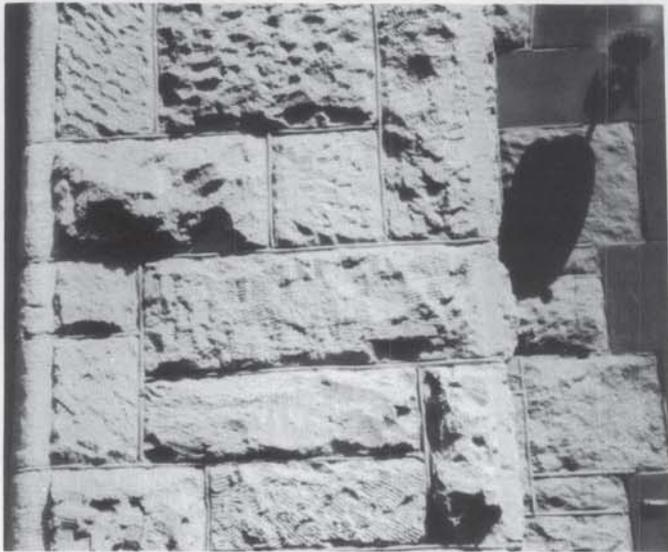
Arm's Length Visual Character: Craft Details

There are many instances where craft details dominate the arm's length visual character. As seen here, the craft details are especially noticeable because the stones are all of a uniform color, and they are all squared off, but their surfaces were worked with differing tools and techniques to create a great variety of textures, resulting in a tour-de-force of craft details. This texture is very important at close range. It was a deliberately contrived surface that is an important contributor to the visual character of this building. Photo by Lee H. Nelson

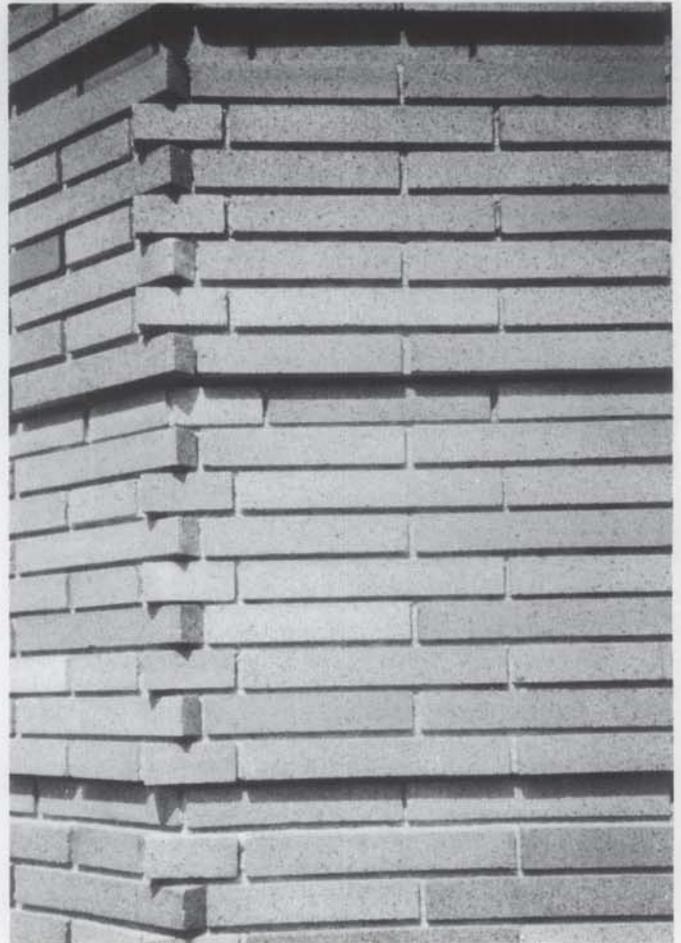
Arm's Length Visual Character: Craft Details

The arm's length visual character of this building is a combination of the materials and the craft details. Most of the exterior walls of this building consist of early 20th century Roman brick, precisely made, unusually long bricks, in varying shades of yellow-brown, with a noticeable surface spotting of dark iron pyrites. While this brick is an important contributor to the visual character, the related craft details are perhaps more important, and they consist of: unusually precise coursing of the bricks, almost as though they were laid up using a surveyor's level; a row of recessed bricks every ninth course, creating a shadow pattern on the wall; deeply recessed mortar joints, creating a secondary pattern of shadows; and a toothed effect where the bricks overlap each other at the corner of the building. The cumulative effect of this artisantry is important to the arm's length visual character, and it is evident that it would be difficult to match if it were damaged, and the effect could be easily damaged through insensitive treatments such as painting the brickwork or by careless repointing. Photo by Lee H. Nelson

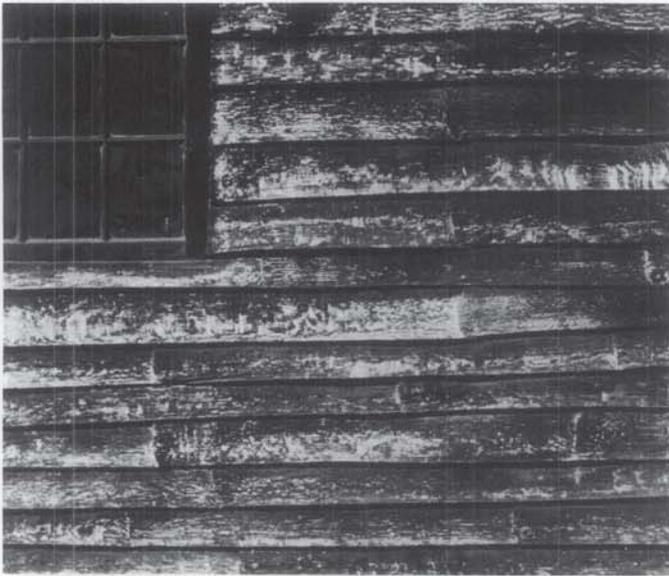
Arm's Length Visual Character: Craft Details

On some buildings, there are subtle aspects of visual character that cannot be perceived from a distance. This is especially true of certain craft details that can be seen only at close range. On this building, it is easily understood that the narrow, unpainted, and weathered clapboards are an important aspect of its overall visual character; but at close range there are a number of subtle but very important craft details that contribute to the handmade quality of this building, and which clearly differentiate it from a building with machine sawn clapboards. The clapboards seen here were split by hand and the bottom edges were not dressed, so that the boards vary in width and thickness, and thus they give a very uneven shadow pattern. Because they were split from oak that is unpainted, there are occasional wavy rays in the wood that stand against the grain. Also noticeable is the fact that the boards are of relatively short lengths, and that they have feather-edged ends that overlap each other, a detail that is very different from butted joints. The occasional large nail heads and the differential silver-gray weathering add to the random quality of the clapboards. All of these qualities contribute to the arm's length visual character. Photo by Lee H. Nelson

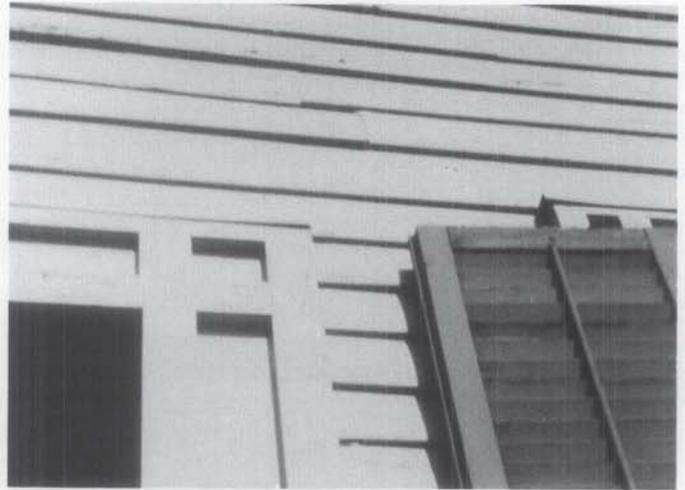
Arm's Length Visual Character: Craft Details

While hand-split clapboards are distinctive visual elements in their own way, machine-sawn and painted wood siding is equally important to the overall visual character in most other instances. At arm's length, however, the machine sawn siding may not be so distinctive; but there might be other details that add visual character to the wooden building, such as the details of wooden trim and louvered shutters around the windows (as seen here), or similar surface textures on other buildings, such as the saw marks on wall shingles, the joints in leaded glass, decorative tinwork on a rain conductor box, the rough surface of pebble-dash stuccowork, or the pebbly surface of exposed aggregate concrete. Such surfaces can only be seen at arm's length and they add to the visual character of a historic building. Photo by Hugh C. Miller

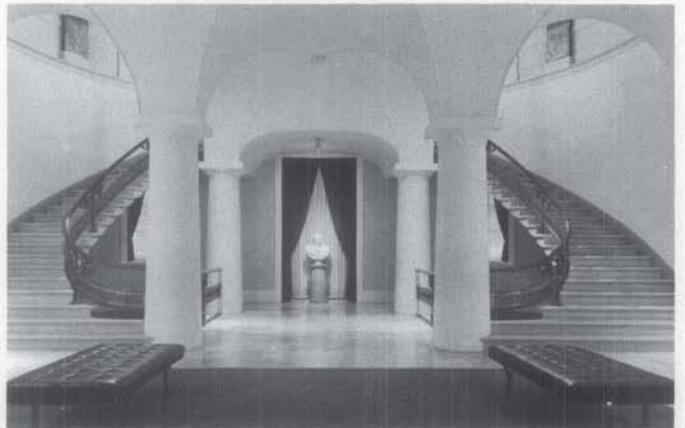
Interior Visual Character: Individually Important Spaces

In assessing the interior visual character of any historic building, it is necessary to ask whether there are spaces that are important to the character of this particular building, whether the building is architecturally rich or modest, or even if it is a simple or utilitarian structure.

The character of the individually important space which is illustrated here is a combination of its size, the twin curving staircases, the massive columns and curving vaulted ceilings, in addition to the quality of the materials in the floor and in the stairs. If the ceiling were to be lowered to provide space for heating ducts, or if the stairways were to be enclosed for code reasons, the shape and character of this space would be damaged, even if there was no permanent physical damage. Such changes can easily destroy the visual character of an individually important interior space. Thus, it is important that the visual aspects of a building's interior character be recognized before planning any changes or alterations. Photo by National Portrait Gallery

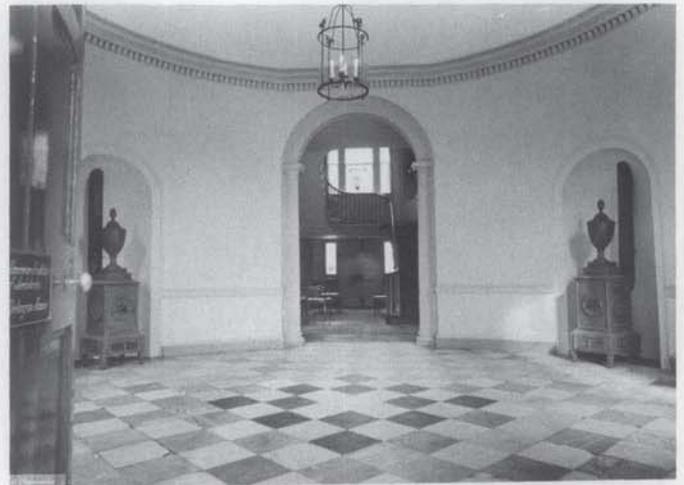
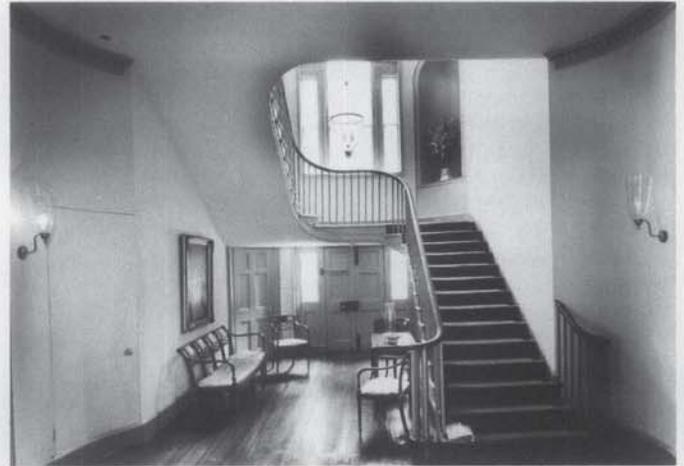
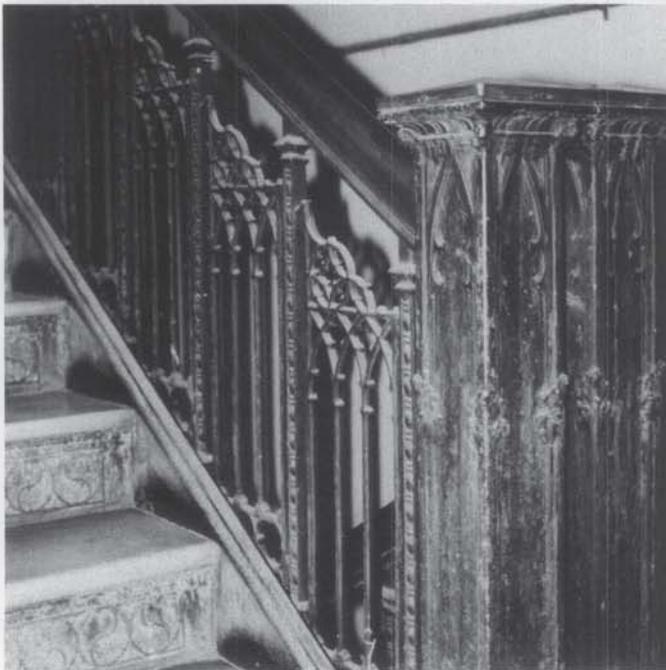
The stairway is the third part of this sequence of related spaces, and it provides continuing access to the upper floors.

These related spaces are very important in defining the interior character of this building. Almost any change to these spaces, such as installing doors between the vestibule and the hallway, or enclosing the stair would seriously impact their character and the way that character is perceived. Top photo by Mel Chamowitz, others by John Tennant

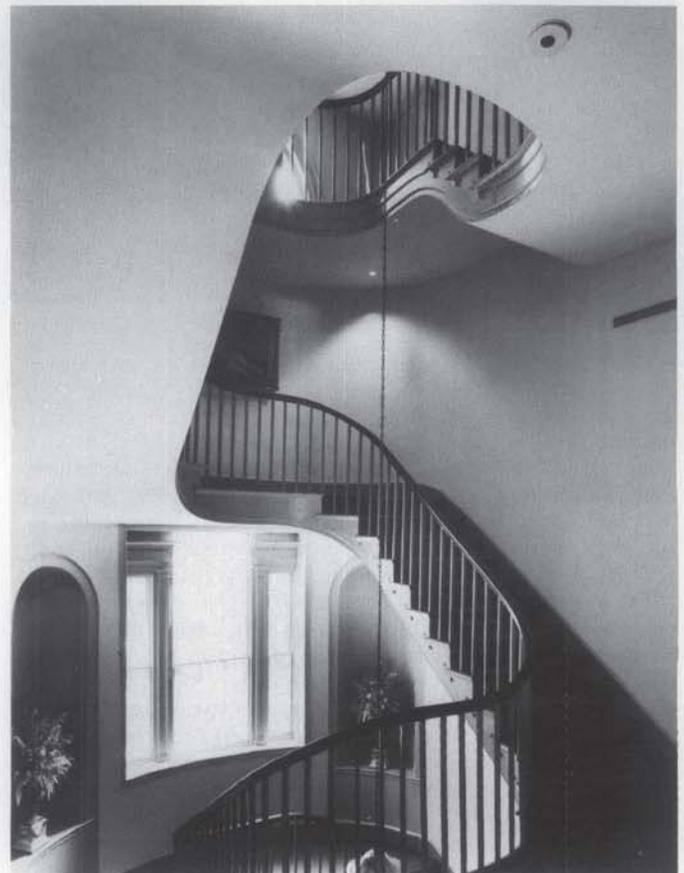
Interior Visual Character: Interior Features

Interior features are three-dimensional building elements or architectural details that are an integral part of the building as opposed to furniture. Interior features are often important in defining the character of an individual room or space. In some instances, an interior feature, like a large and ornamental open stairway may dominate the visual character of an entire building. In other instances, a modest iron stairway (like the one illustrated here) may be an important interior feature, and its preservation would be crucial to preserving the interior character of the building. Such features can also include the obvious things like fireplace mantles, plaster ceiling medallions, or panelling, but they also extend to features like hardware, lighting fixtures, bank tellers cages, decorative elevator doors, etc. Photo by David W. Look

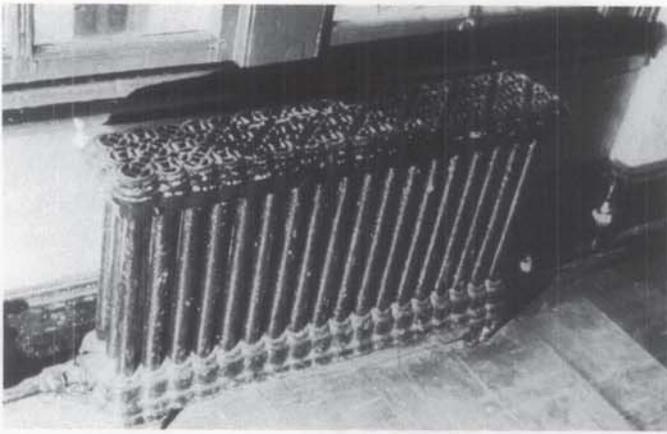
Interior Visual Character: Interior Features

Modern heating or cooling devices usually add little to the interior character of a building; but historically, radiators, for instance, may have contributed to the interior character by virtue of their size or shape, or because of their specially designed bases, piping, and decorative grillage or enclosures. Sometimes they were painted with several colors to highlight their integral, cast-in details. In more recent times, it has been common to overpaint and conceal such distinctive aspects of earlier heating and plumbing devices, so that we seldom have the opportunity to realize how important they can be in defining the character of interior rooms and spaces. For that reason, it is important to identify their character-defining potential, and consider their preservation, retention, or restoration. Photo by David W. Look

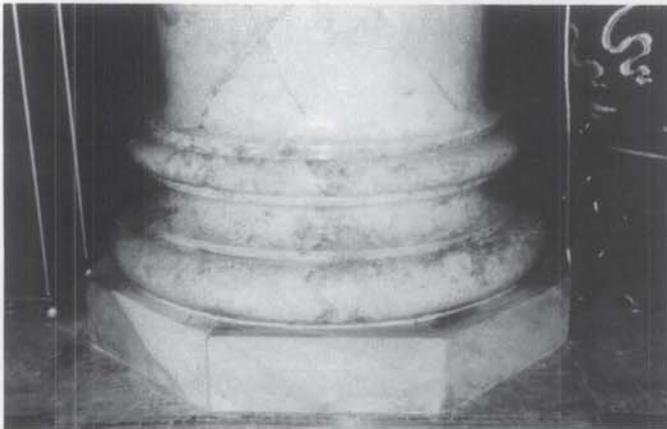
Interior Visual Character: Surface Materials and Finishes

When identifying the visual character of historic interior spaces one should not overlook the importance of those materials and finishes that comprise the surfaces of walls, floors and ceilings. The surfaces may have evidence of either hand-craft or machine-made products that are important contributors to the visual character, including patterned or inlaid designs in the wood flooring, decorative painting practices such as stenciling, imitation marble or wood grain, wallpapering, tinwork, tile floors, etc.

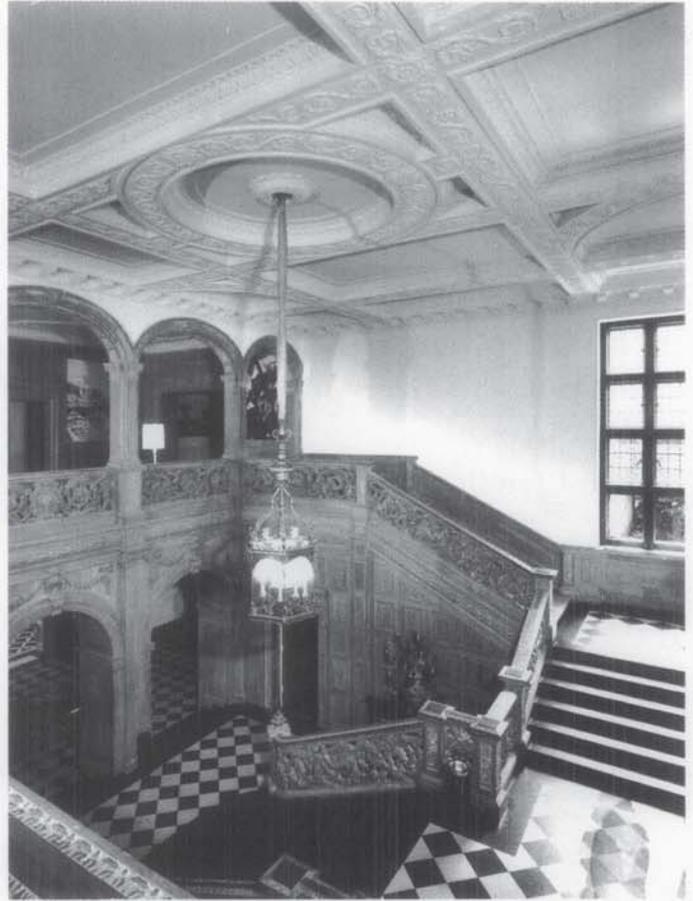
Figure 1. This architect-designed interior reflects early 20th century American taste: the checkerboard tile floor, wood wainscot, coffered ceiling, and open staircase are richly detailed and crafted by hand. Not only are the individual architectural features worthy of preservation, but the planned sequence of spaces—entry hall, stairs, stair landings, and loggia—imparts a grandeur that is characteristic of high style residences of this period. This interior is of Greystone, Los Angeles, California. Photography for HABS by Jack E. Boucher

Figure 5. The interior of a simply detailed worker's house of the 19th century may be as important historically as the richly ornamented interior seen in figure 1. Although the interior of this house has not been properly maintained, the wide baseboards, flat window trim, and four-panel door are characteristic of workers' housing during this period and deserve retention during rehabilitation.

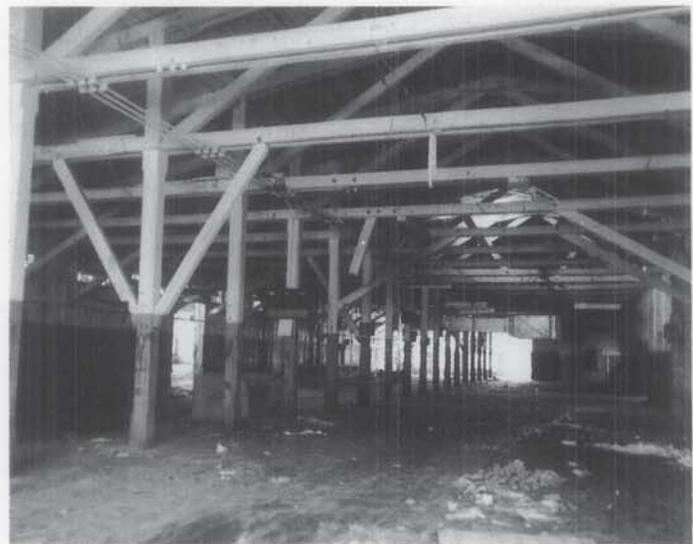
Figure 2. The interiors of mills and industrial buildings frequently are open, unadorned spaces with exposed structural elements. While the new uses to which this space could be put are many—retail, residential, or office—the generous floor-to-ceiling height and exposed truss system are important character-defining features and should be retained in the process of rehabilitation.

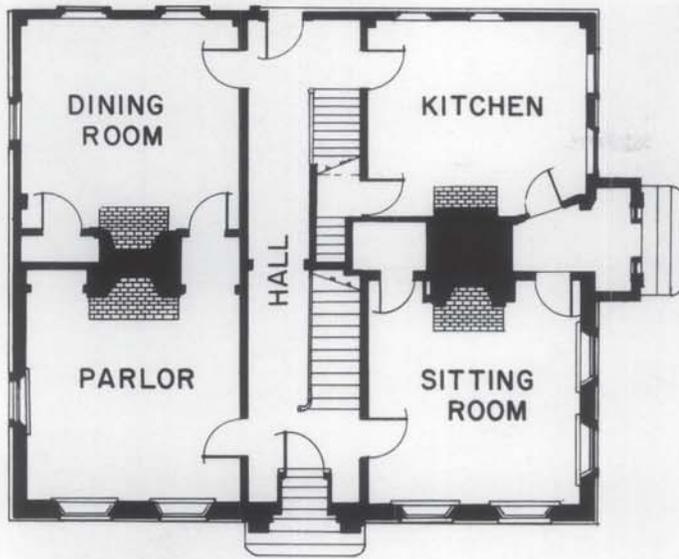
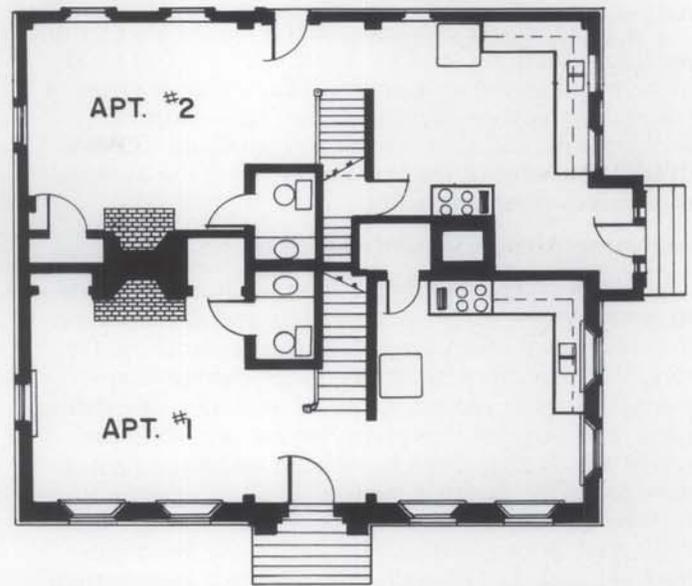
Figure 3. The floor plan at left is characteristic of many 19th century Greek Revival houses, with large rooms flanking a central hall. In the process of rehabilitation, the plan (at right) was drastically altered to accommodate two duplex apartments. The open stair was replaced with one that is enclosed, two fireplaces were eliminated, and Greek Revival trim around windows and doors was removed. The symmetry of the rooms themselves was destroyed with the insertion of bathrooms and kitchens. Few vestiges of the 19th century interior survived the rehabilitation. Drawing by Neal A. Vogel

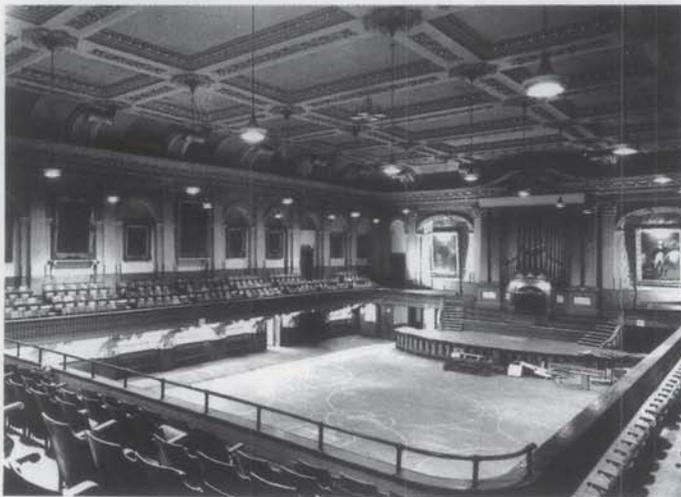
Figure 4. Many institutional buildings possess distinctive spaces or floor plans that are important in conveying the significance of the property. Finding new compatible uses for these buildings and preserving the buildings' historic character can be a difficult, if not impossible, task. One such case is Mechanics Hall in Worcester, Massachusetts, constructed between 1855 and 1857. This grand hall, which occupies the entire third floor of the building, could not be subdivided without destroying the integrity of the space.

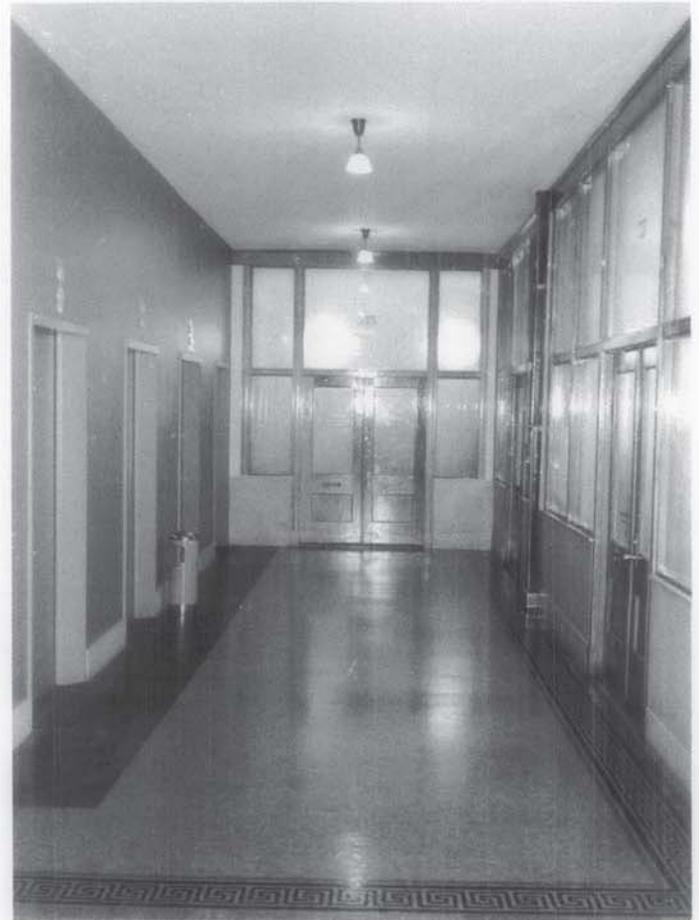
Figure 6. This corridor, located in the historic Monadnock Building in Chicago, has glazed walls, oak trim, and marble wainscoting, and is typical of those found in late 19th and early 20th century office buildings. Despite the simplicity of the features, a careful attention to detail can be noted in the patterned tile floor, bronze mail chute, and door hardware. The retention of corridors like this one should be a priority in rehabilitation projects involving commercial buildings.

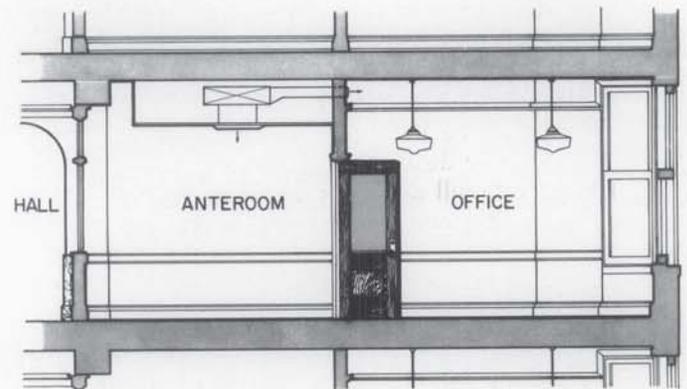
Figure 7. When the Monadnock Building was rehabilitated, architects retained the basic floor plan on the upper floors consisting of a double-loaded corridor with offices opening onto it. The original floor-to-ceiling height in the corridors and outside offices—the most important spaces—was maintained by installing needed air conditioning ductwork in the less important anterooms. In this way, the most significant interior spaces were preserved intact. Drawing by Neal A. Vogel

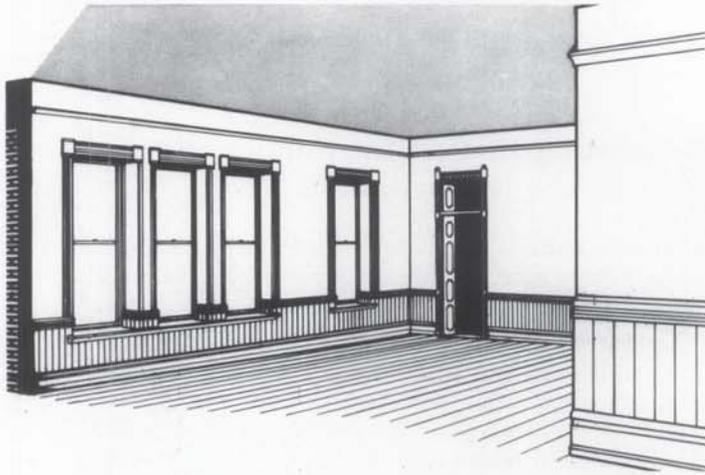
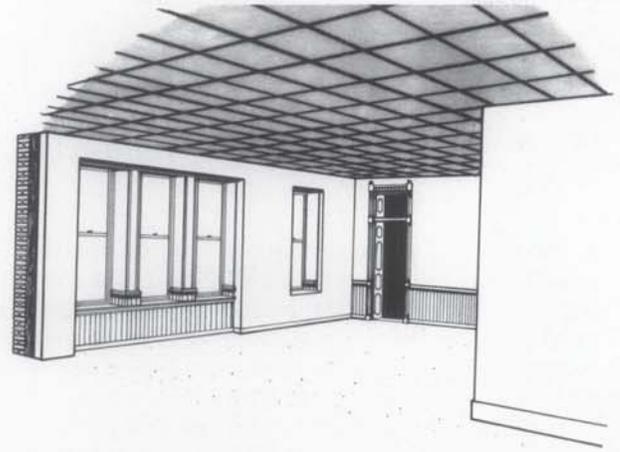
Figure 8. Furring out exterior walls to add insulation and suspending new ceilings to hide ductwork and wiring can change a room's proportions and can cause interior features to appear fragmented. In this case, a school was converted into apartments, and individual classrooms became living rooms, bedrooms, and kitchens. On the left is an illustration of a classroom prior to rehabilitation; note the generous floor-to-ceiling height, wood wainscoting, molded baseboard, picture molding, and Eastlake Style door and window trim. After rehabilitation, on the right, only fragments of the historic detailing survive: the ceiling has been dropped below the picture molding, the remaining wainscoting appears to be randomly placed, and some of the window trim has been obscured. Together with the subdivision of the classrooms, these rehabilitation treatments prevent a clear understanding of the original classroom's design and space. If thermal performance must be improved, alternatives to furring out walls and suspending new ceilings, such as installing insulation in attics and basements, should be considered. Drawings by Neal A. Vogel

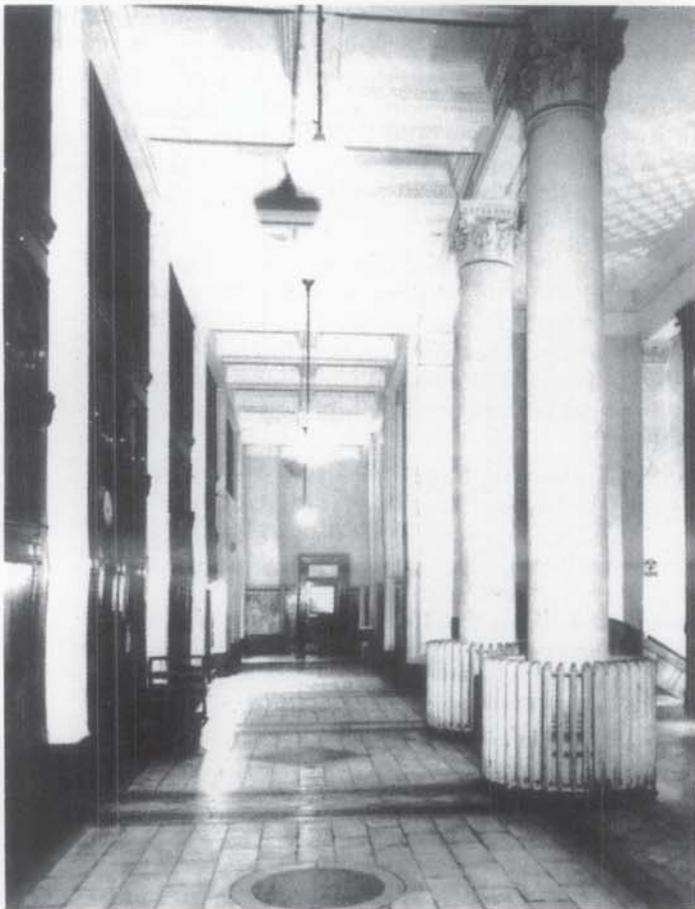
Figure 9. The tangible reminders of early mechanical systems can be worth saving. In this example, in the Old Post Office in Washington, D.C., radiators encircle Corinthian columns in a decorative manner. Note, too, the period light fixtures. These features were retained when the building was rehabilitated as retail and office space. Photo: Historic American Buildings Survey

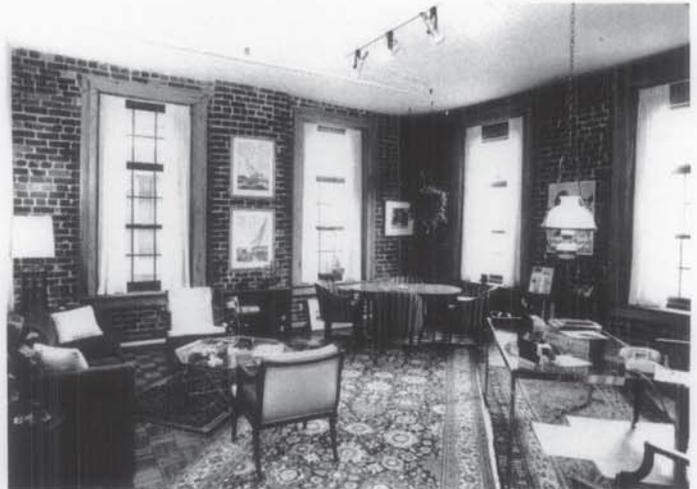
Figure 10. In this case plaster has been removed from perimeter walls, leaving brick exposed. In removing finishes from historic masonry walls, not only is there a loss of historic finish, but raw, unfinished walls are exposed, giving the interior an appearance it never had. Here, the exposed brick is of poor quality and the mortar joints are wide and badly struck. Plaster should have been retained and repaired, as necessary.

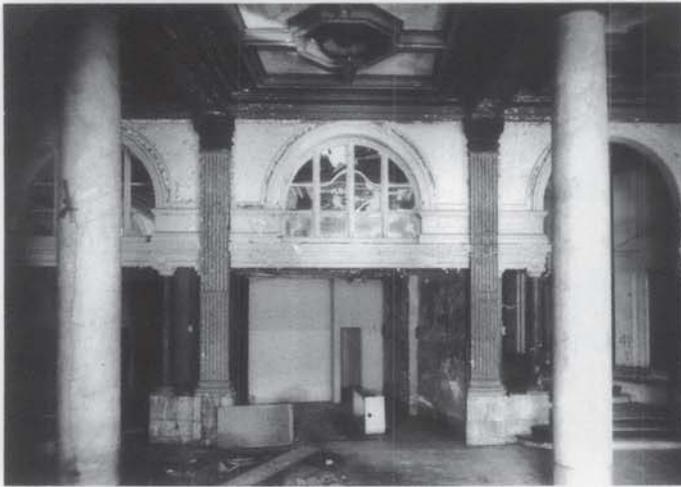
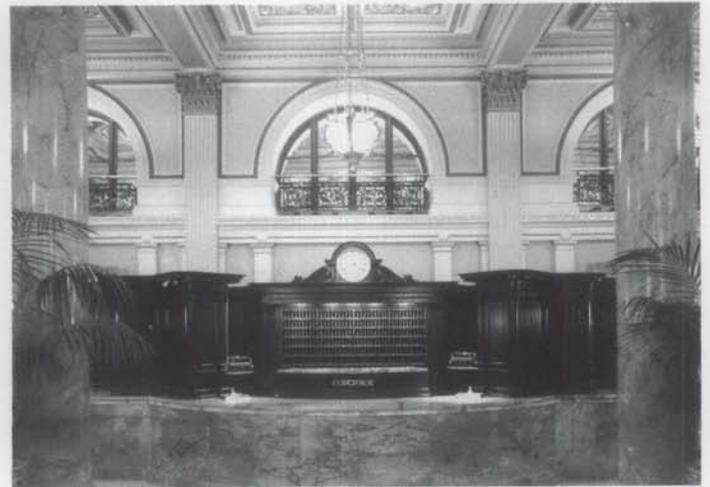
Figure 11. These dramatic "before" and "after" photographs show a severely deteriorated space restored to its original elegance: plaster has been repaired and painted, the scagliola columns have been restored to match marble using traditional craft techniques, and missing decorative metalwork has been re-installed in front of the windows. Although some reorganization of the space took place, notably the relocation of the front desk, the overall historic character of the space has been preserved. These views are of the lobby in the Willard Hotel, Washington, D.C. Credit: Commercial Photographers (left); Carol M. Highsmith (right)
