SUPERIOR COURT OF CALIFORNIA, COUNTY OF LOS ANGELES

NEW GLENDALE COURTHOUSE

EXISTING COURTHOUSE FEASIBILITY REPORT

MARCH 2, 2012

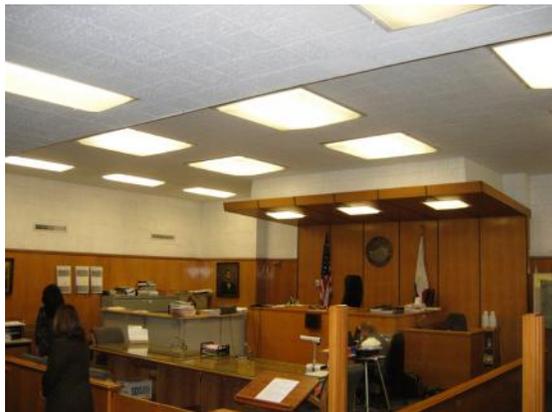
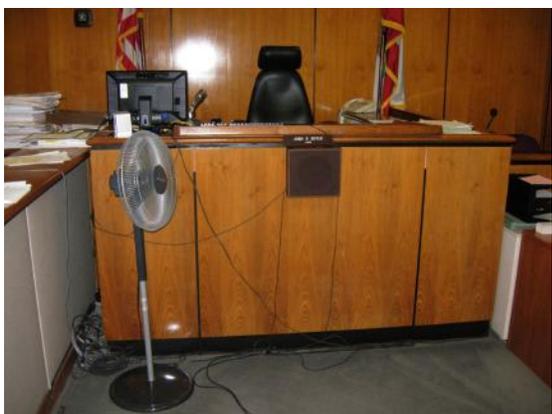
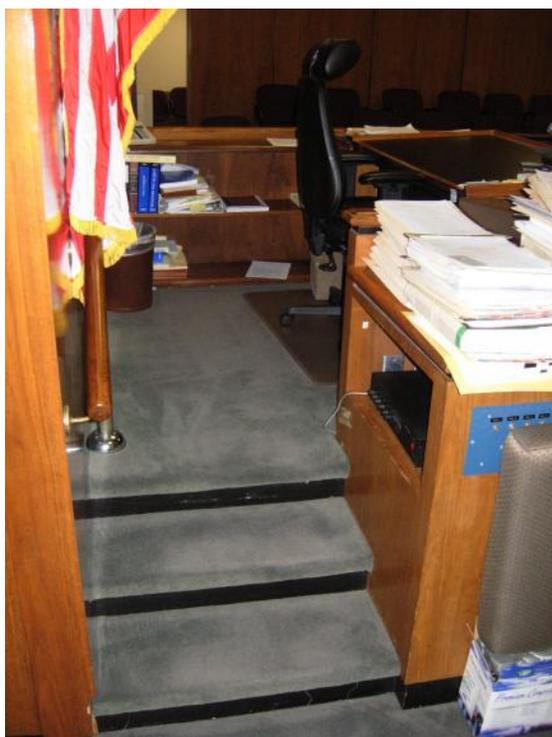
First is courtroom size. As evidenced by the table below, the existing courtrooms are significantly smaller than current standards. The rooms were built to accommodate 53-74 seats in the Spectator area, but with no provisions or clearances for accessibility.

Current trial court standards are for 45-100 spectators depending on type of courtroom. 4 of the courtrooms lack a vestibule. Most of the issues regarding size between old and new however, center on providing universal access to all participants in the process for jurists, jurors, spectators, clerks, litigants and attorneys.

The existing Judges benches in the courtrooms are 65 SF and are on the minimum end of current standards. The bench is accessed by 3 narrow risers, approximately 27" wide. To make the benches accessible would require extensive modifications to the casework and on the interior, which would reduce available square footage within the courtroom further and alter the original mahogany panelling.

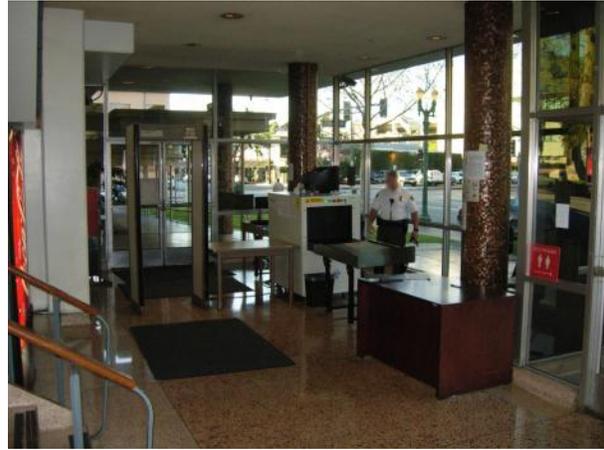
Weapons screening and the subsequent queuing areas by modern standards is 950 SF. The current Entry Lobby & Security Screening area occupies approximately 350 SF, or about 63% deficient.

Considering the narrowness of the existing public concourse, if the screening systems could be laid out dimensionally in width, the proper area would take up nearly the full length of the lobby, rendering it near useless for any other public counter functions. For the entry / lobby / screening area to be compliant with modern standards, it will likely need to move away from the existing entrances to a new position within the complex.

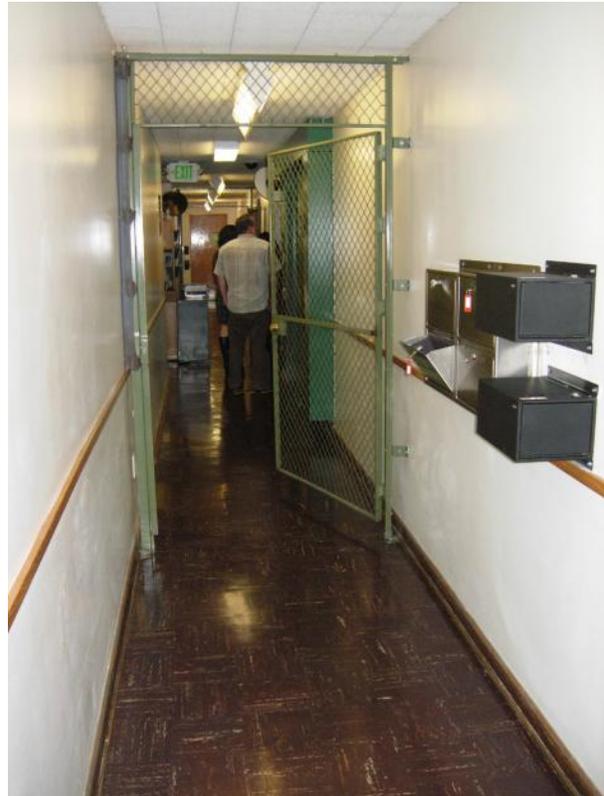
Public Waiting and Queuing

The narrowness of the existing public concourses discussed above also poses a challenge for public waiting outside of courtrooms and queuing at public counters. Originally designed for 5 courtrooms at an average of 1350 SF each, as the facility expands to 8 courtrooms at 1750-2100 SF, the public service capacity and public circulation areas need to logically expand at a similar scale (+200%) to handle increased traffic.

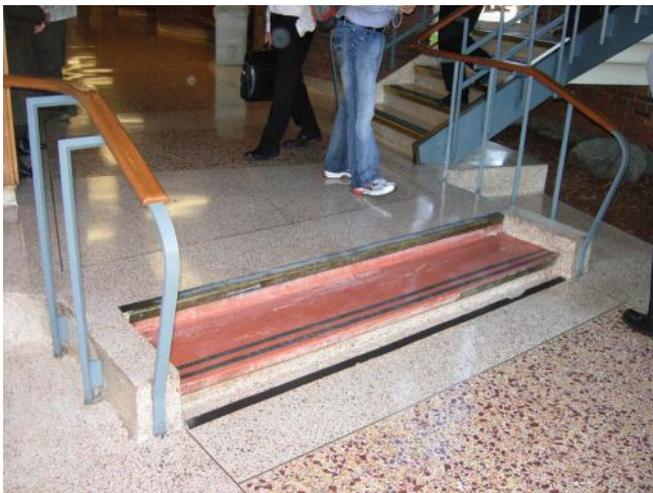
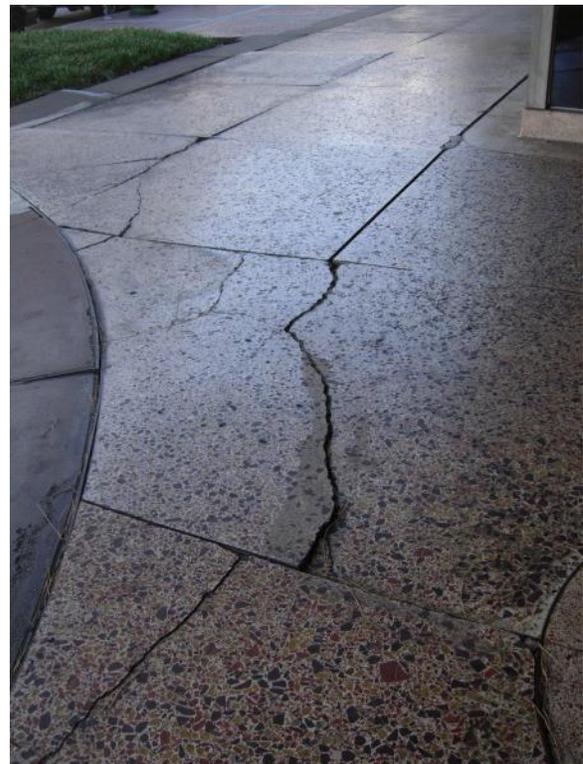
corner, modifications would need to be made to the existing entrance and stair to make them ADA accessible. Currently, there is a 2 riser stair up to the main public concourse. Strategy 2B, the preferred alternative, locates the primary point of entry and security station at this former grand entrance. At this juncture, there is ample room for a compliant entrance that would clearly split secure (to court functions) and unsecure (to public counter) zones. Strategies 3 and 4A rely on creating a new security entrance off the back of the building close to the parking garage, whereas Strategy 4B requires some sacrifice of interiors to create a right-sized weapons screening area.

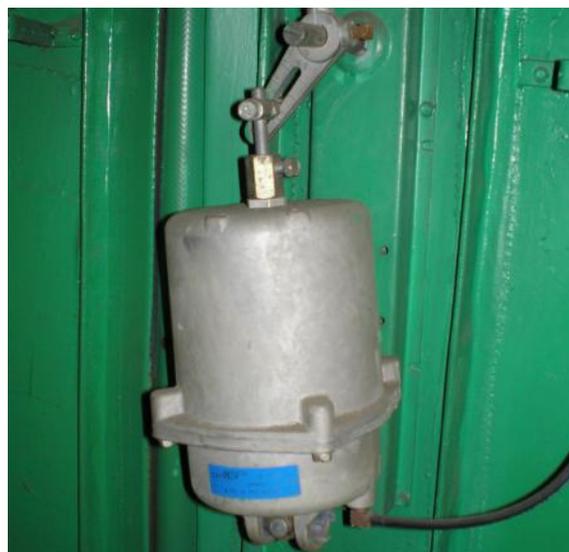
The equipment is primarily controlled through a pneumatic control system, however there are electronic sensors which have been applied to the devices in order to take readings at and to start/stop the motored fans from a centralized but remote county facility where a larger-scale building management system is located. Thermostats within the rooms are still of the pneumatic type, controlling the mixing dampers for the dual duct system.

Figure 5.1 2 Pneumatic damper controllers at the air handlers

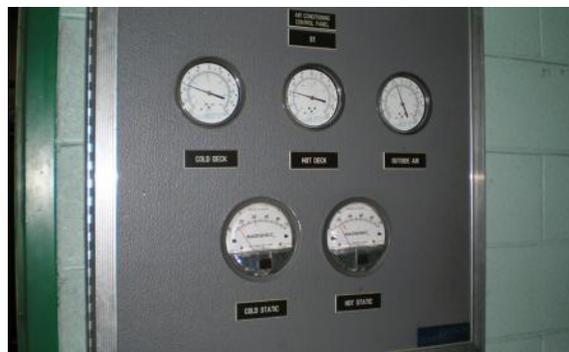
Figure 5.1 3 Local non-electronic monitoring panels

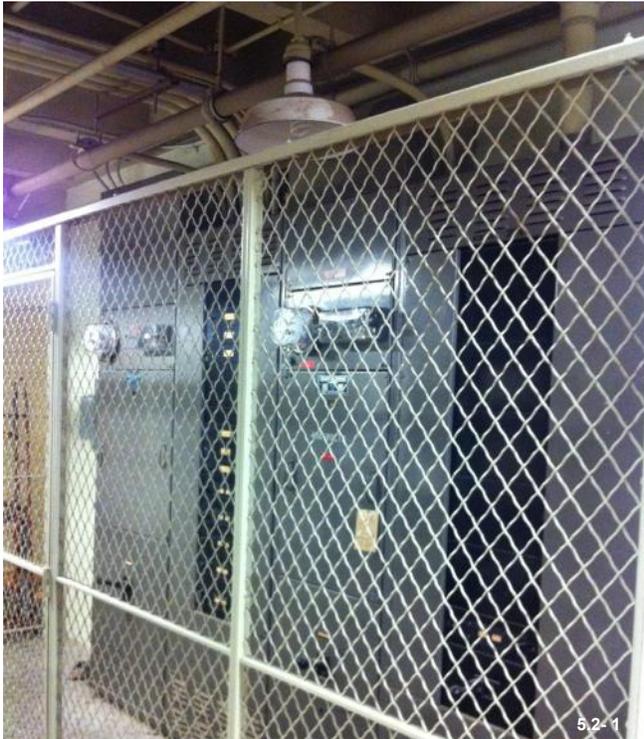
Figure 5.2-1 Main Switchboards by Square D. Original 1956 equipment.

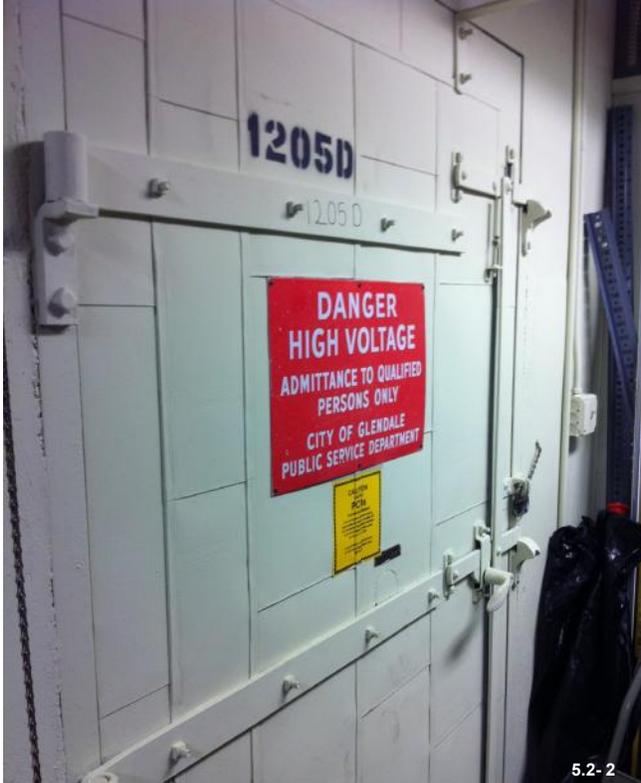
Figure 5.2-2 Existing Utility vault in the basement

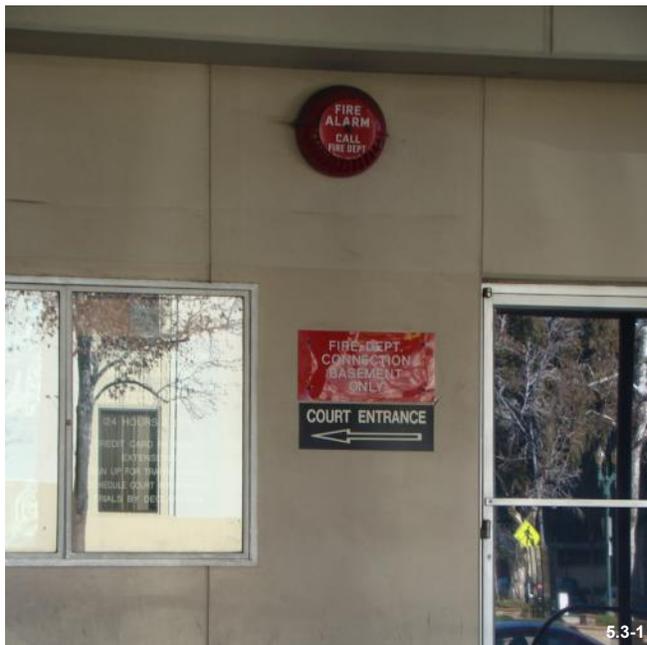
Fire Suppression System. The automatic fire sprinkler system water main is connected to the city water main at East Broadway. The fire water detector check vault is located at East Broadway. An automatic fire sprinkler riser is located at the basement (see figure 5.3-1).

Figure 5.3-1 - Fire Alarm and Fire Department Connection for the Basement

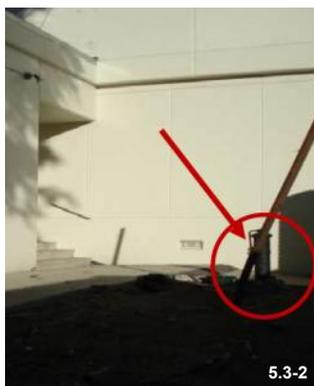
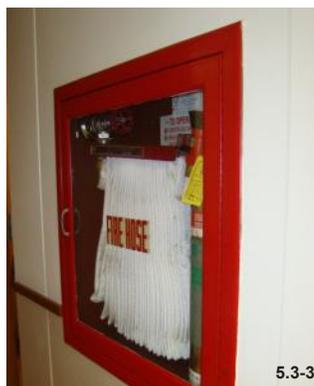
The rest of the building was not covered by automatic fire sprinkler system; however fire hose cabinets were present. These fire hose cabinets are connected to the domestic water distribution. The post indicator valve is located at the west side of the building inside the yard (see Figure 5.3-2).

Figure 5.3-2 - Post Indicator Valve for Fire Hose Cabinets

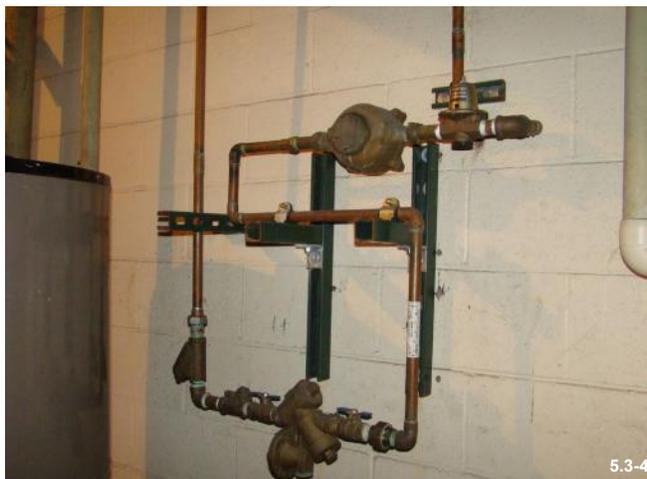
The industrial cold water for the mechanical equipment is passing through the backflow preventer located inside the boiler room at the mechanical penthouse. The sub water meter is provided to record the mechanical water usage (see Figure 5.3-4).

Figure 5.3-4 – Industrial Cold Water's Backflow Preventer and Sub-meter

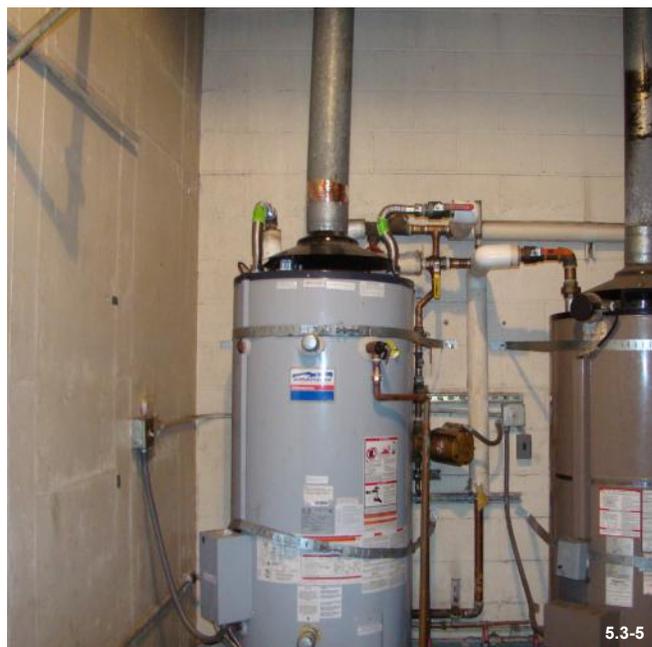
The building domestic hot water is supplied by the two 100 gallons water heaters located at the mechanical penthouse, inside the boiler room (see Figure 5.3-5). One is recently replaced (not connecting to the system yet) and the other one is 14 years old. The domestic hot water circulating pump is also located between two water heaters.

Figure 5.3-5 – Domestic Water Heaters

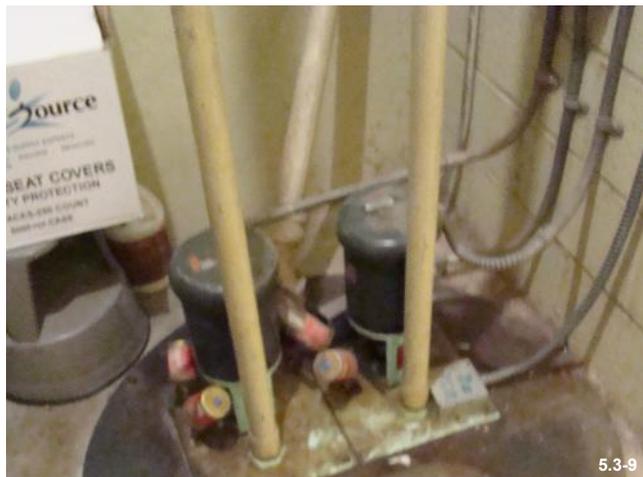
The main sanitary sewer line is connected to the existing 8" sewer line at south side of the building. Most of the sanitary sewer system is by gravity discharge, except the basement area sanitary sewer. There are two 3/4 HP duplex sewage ejectors located at the basement (see Figure 5.3-9 & 10). The old one is located at the basement janitor room and the other is located south side of the IT room. The old ejector mainly served the basement floor drain and auto sprinkler drain. The new one is for the basement toilet room.

Figure 5.3-9 Sewage Ejector

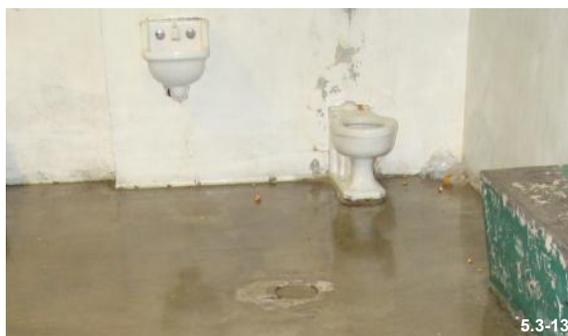
The existing plumbing fixtures are well maintained. However these fixtures are not the water efficient type fixtures. The fixtures inside the holding cells area are not the vandal resistant plumbing fixtures (see Figure 5.3-13). Also the floor drain is located inside cell.

Figure 5.3-13 Holding Cell plumbing fixtures

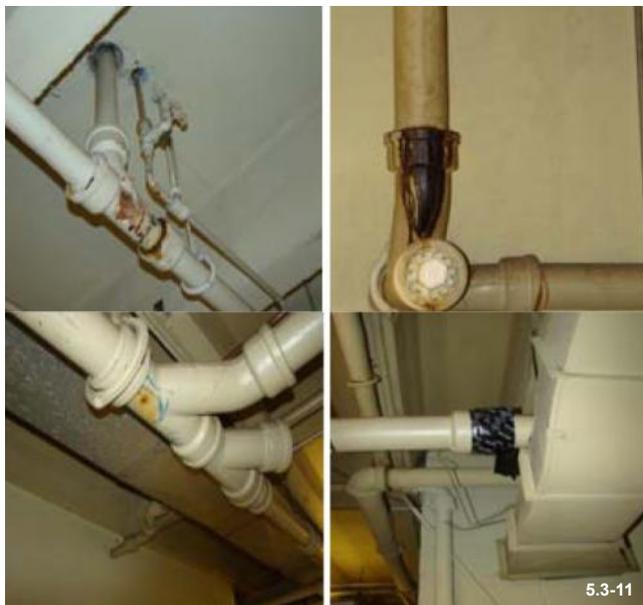
5.3-11

The sanitary waste piping, at basement, has evidence of leaking in multiple locations (See Figure 5.3-11).

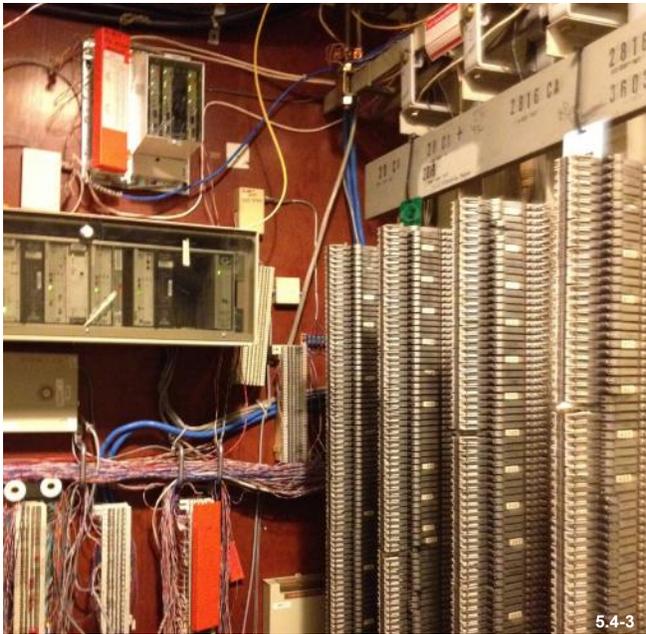
Figure 5.4-3 Unused equipment to be removed (right of photo)

It is recommended that abandoned equipment also be removed.

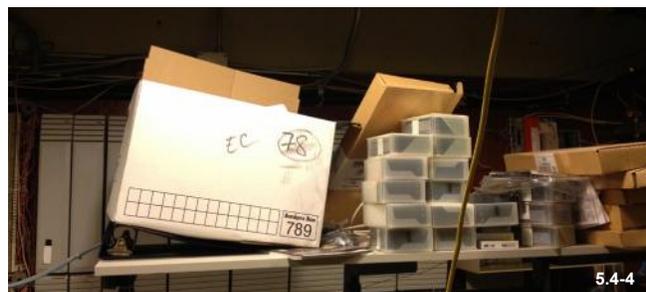
Figure 5.4-4 Storage items in MCR I

MCRs should not be used for storage. Service disruptions can be caused by unauthorized access, falling boxes, etc. Depending on the final use of the building, service disruptions can have significant consequences to the operation and security of the facility.

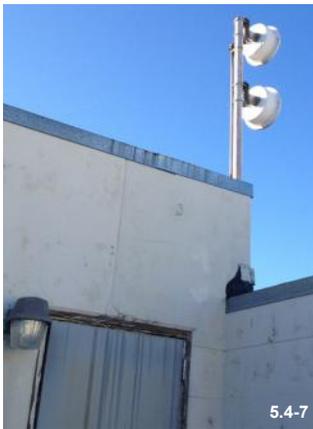
Two locations on the roof were observed with communications antennas; one set of microwave antennas adjacent to the [east] roof stairs was noted to be out of service. On the roof adjacent to the [west] roof door a WiFi link comprised of two patch (flat) antennas was noted, it is assumed this is a link to city facilities across Broadway.

Figure 5.4-7 Out-of-service microwave link

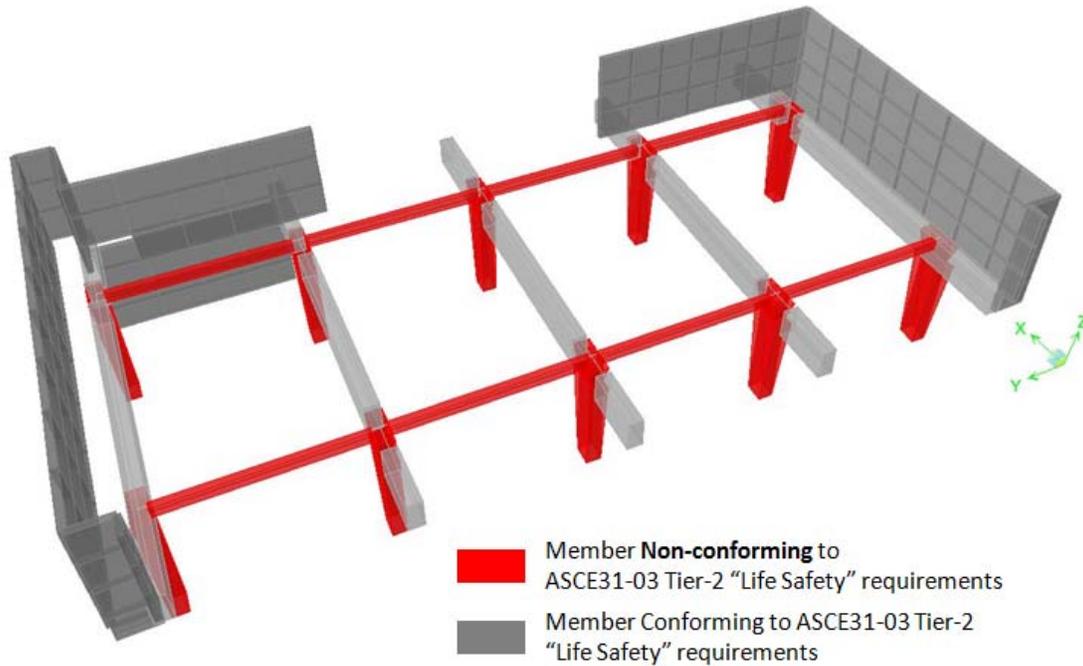
Analysis of the Probation wing revealed that the reinforced concrete bent columns do not conform to the life safety and immediate occupancy criteria outlined in ASCE 31-03 Tier-2 requirements. Figure D-11 and D-12 present the members with non-conforming shear and flexural strengths respectively under "Life Safety" performance criteria. Similarly, Figures D-13 and D-14 present the members with non-conforming shear and flexural strengths respectively under "Immediate Occupancy" performance criteria.

Figure D-11 Probation wing "Life Safety-Standard performance" conformance check for SHEAR behavior of reinforced concrete bent columns and floor beams

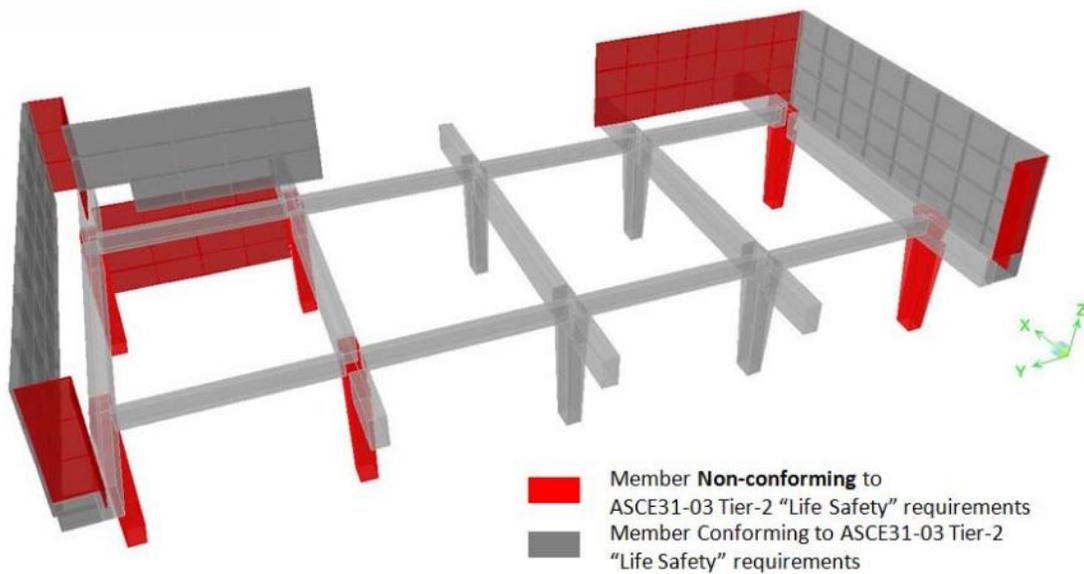
Figure D-12 Probation wing "Life Safety-Standard performance" conformance check for FLEXURAL behavior of reinforced concrete bent columns and floor beams

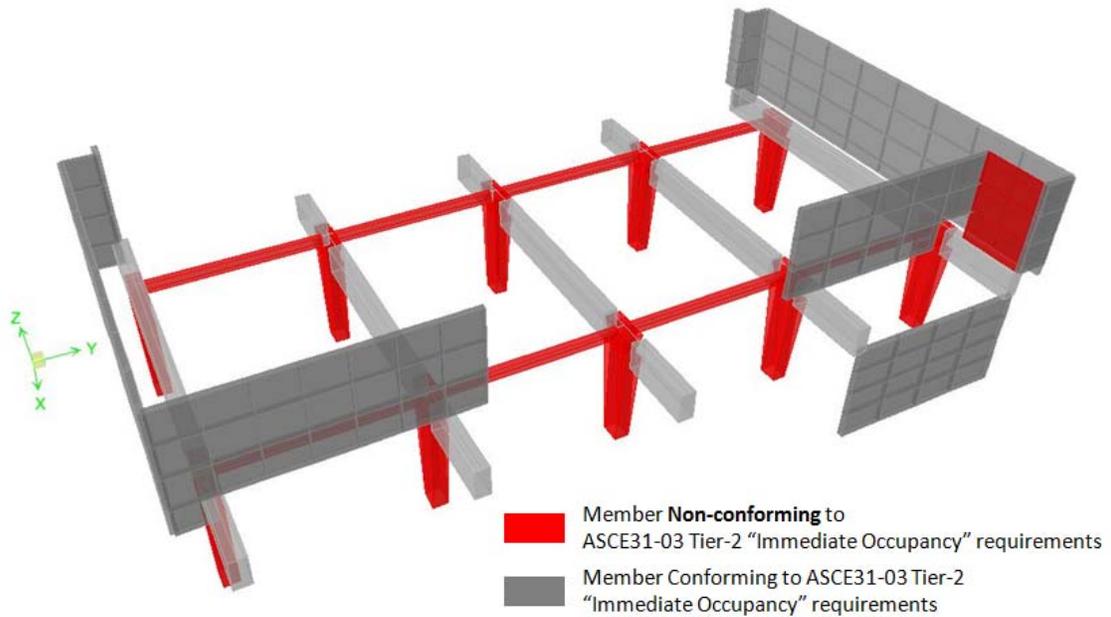
Figure D-13 Probation Wing "Immediate Occupancy-Enhanced performance" conformance check for SHEAR behavior of reinforced concrete bent columns and floor beams

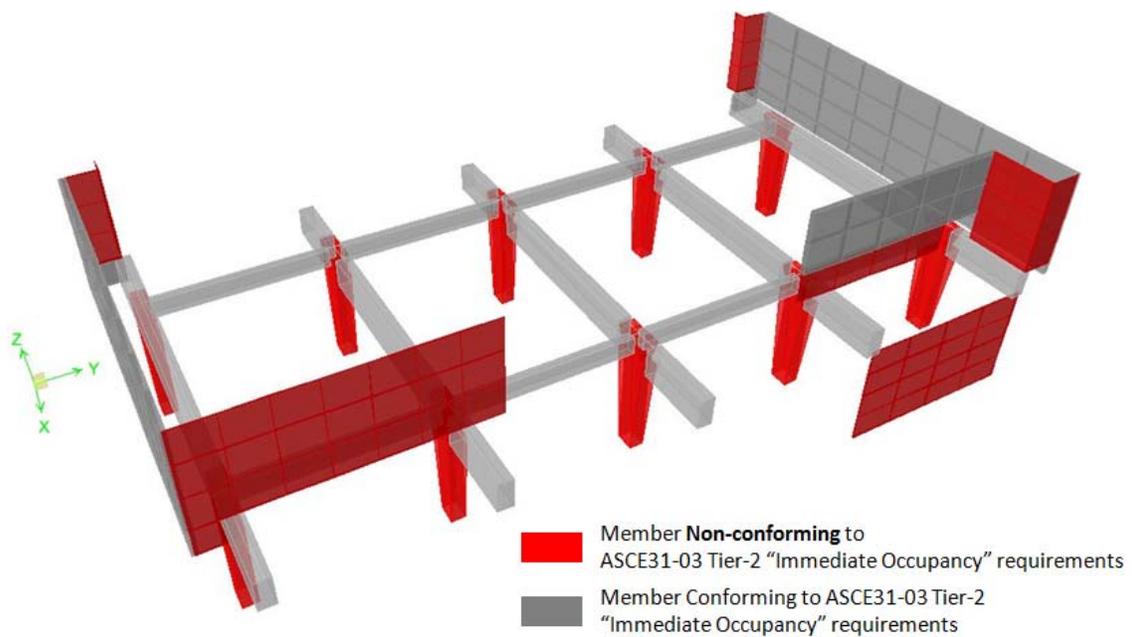
Figure D-14 Probation Wing "Immediate Occupancy-Enhanced performance" conformance check for FLEXURAL behavior of reinforced concrete bent columns and floor beams

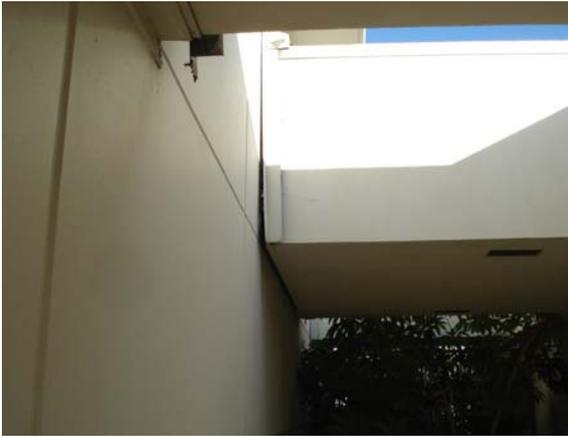
- **Adjacent building:** The clear distance between Probation Wing and Main Building is 4". This is less than 4 percent of the height of the building (7") and hence not adequate per the requirements by ASCE 31-03 Tier-2 (Sec. 4.3.1.2). Please refer to Appendix F, Photos 1 and 5.

Photo 1: Non-conforming building separation joint and residual deflections from past earthquakes

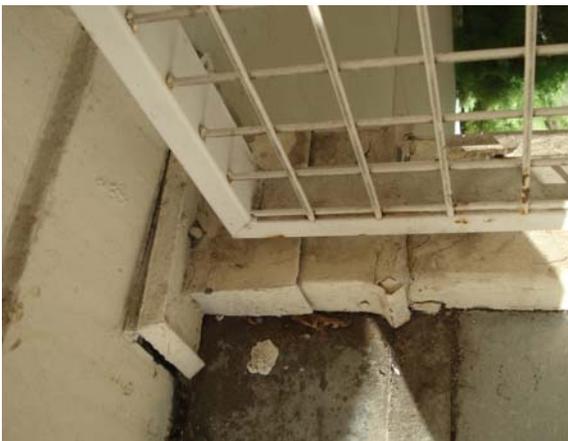
Photo 3: Non-conforming steel anchorage to wall

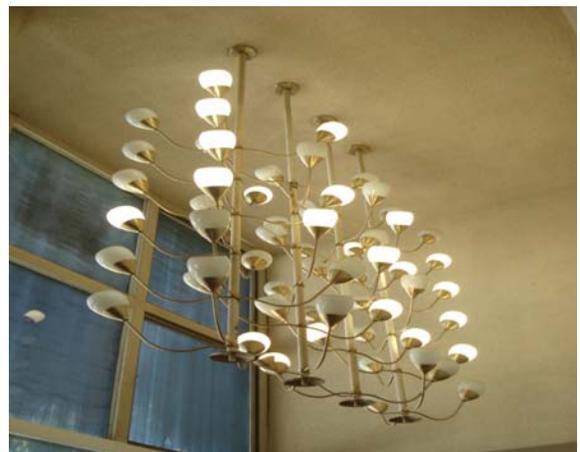
Photo 6: Unrestrained chandelier as a nonstructural non-conformance per ASCE 31-03
