Seismic Renovation Project Feasibility Report

CLEARLAKE BRANCH COURTHOUSE 17-B1

SUPERIOR COURT OF CALIFORNIA, COUNTY OF LAKE

PREPARED BY ARUP JANUARY 22, 2019

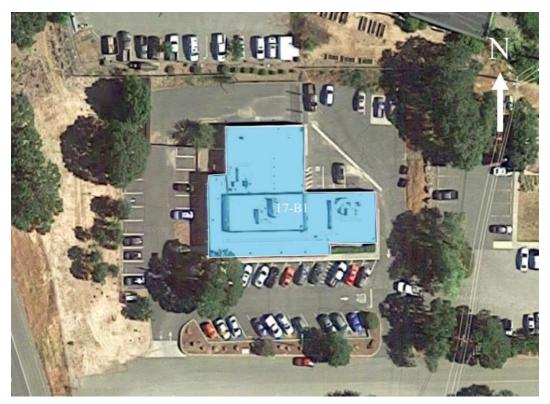
Figure 2. Satellite Image Showing Each Building Segment (Source: USGS)

Figure 1 provides a satellite image of the court building showing its overall configuration and construction. Figure 2 provides a satellite image of the court building overlaid with information about each building segment.
