# **Seismic Renovation Project Feasibility Report**

VAN NUYS COURTHOUSE WEST  
19-AX2

14400 ERWIN ST. MALL, VAN  
NUYS

PREPARED BY ARUP  
JANUARY 22, 2019

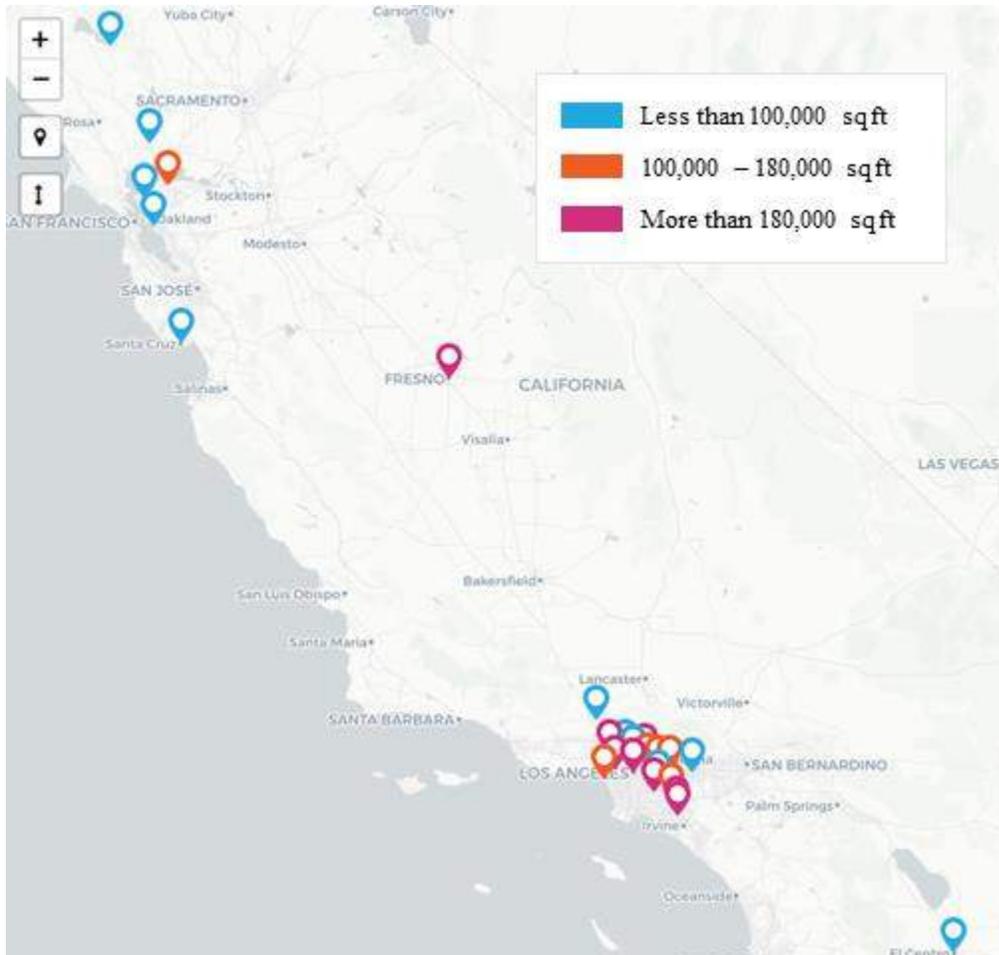
Figure 3. The 26 Court Buildings Assessed in This Seismic Renovation Feasibility Study

One court building was removed during the study due to a lack of structural and architectural drawings. The 26 court buildings studied have a total area of approximately five million gross square feet and comprise 43 building segments. Figure 3 shows the location and area of each court building. Blue pins indicate court buildings smaller than 100,000 square feet, orange indicates between 100,000 and 180,000 square feet, and purple indicates more than 180,000 square feet.

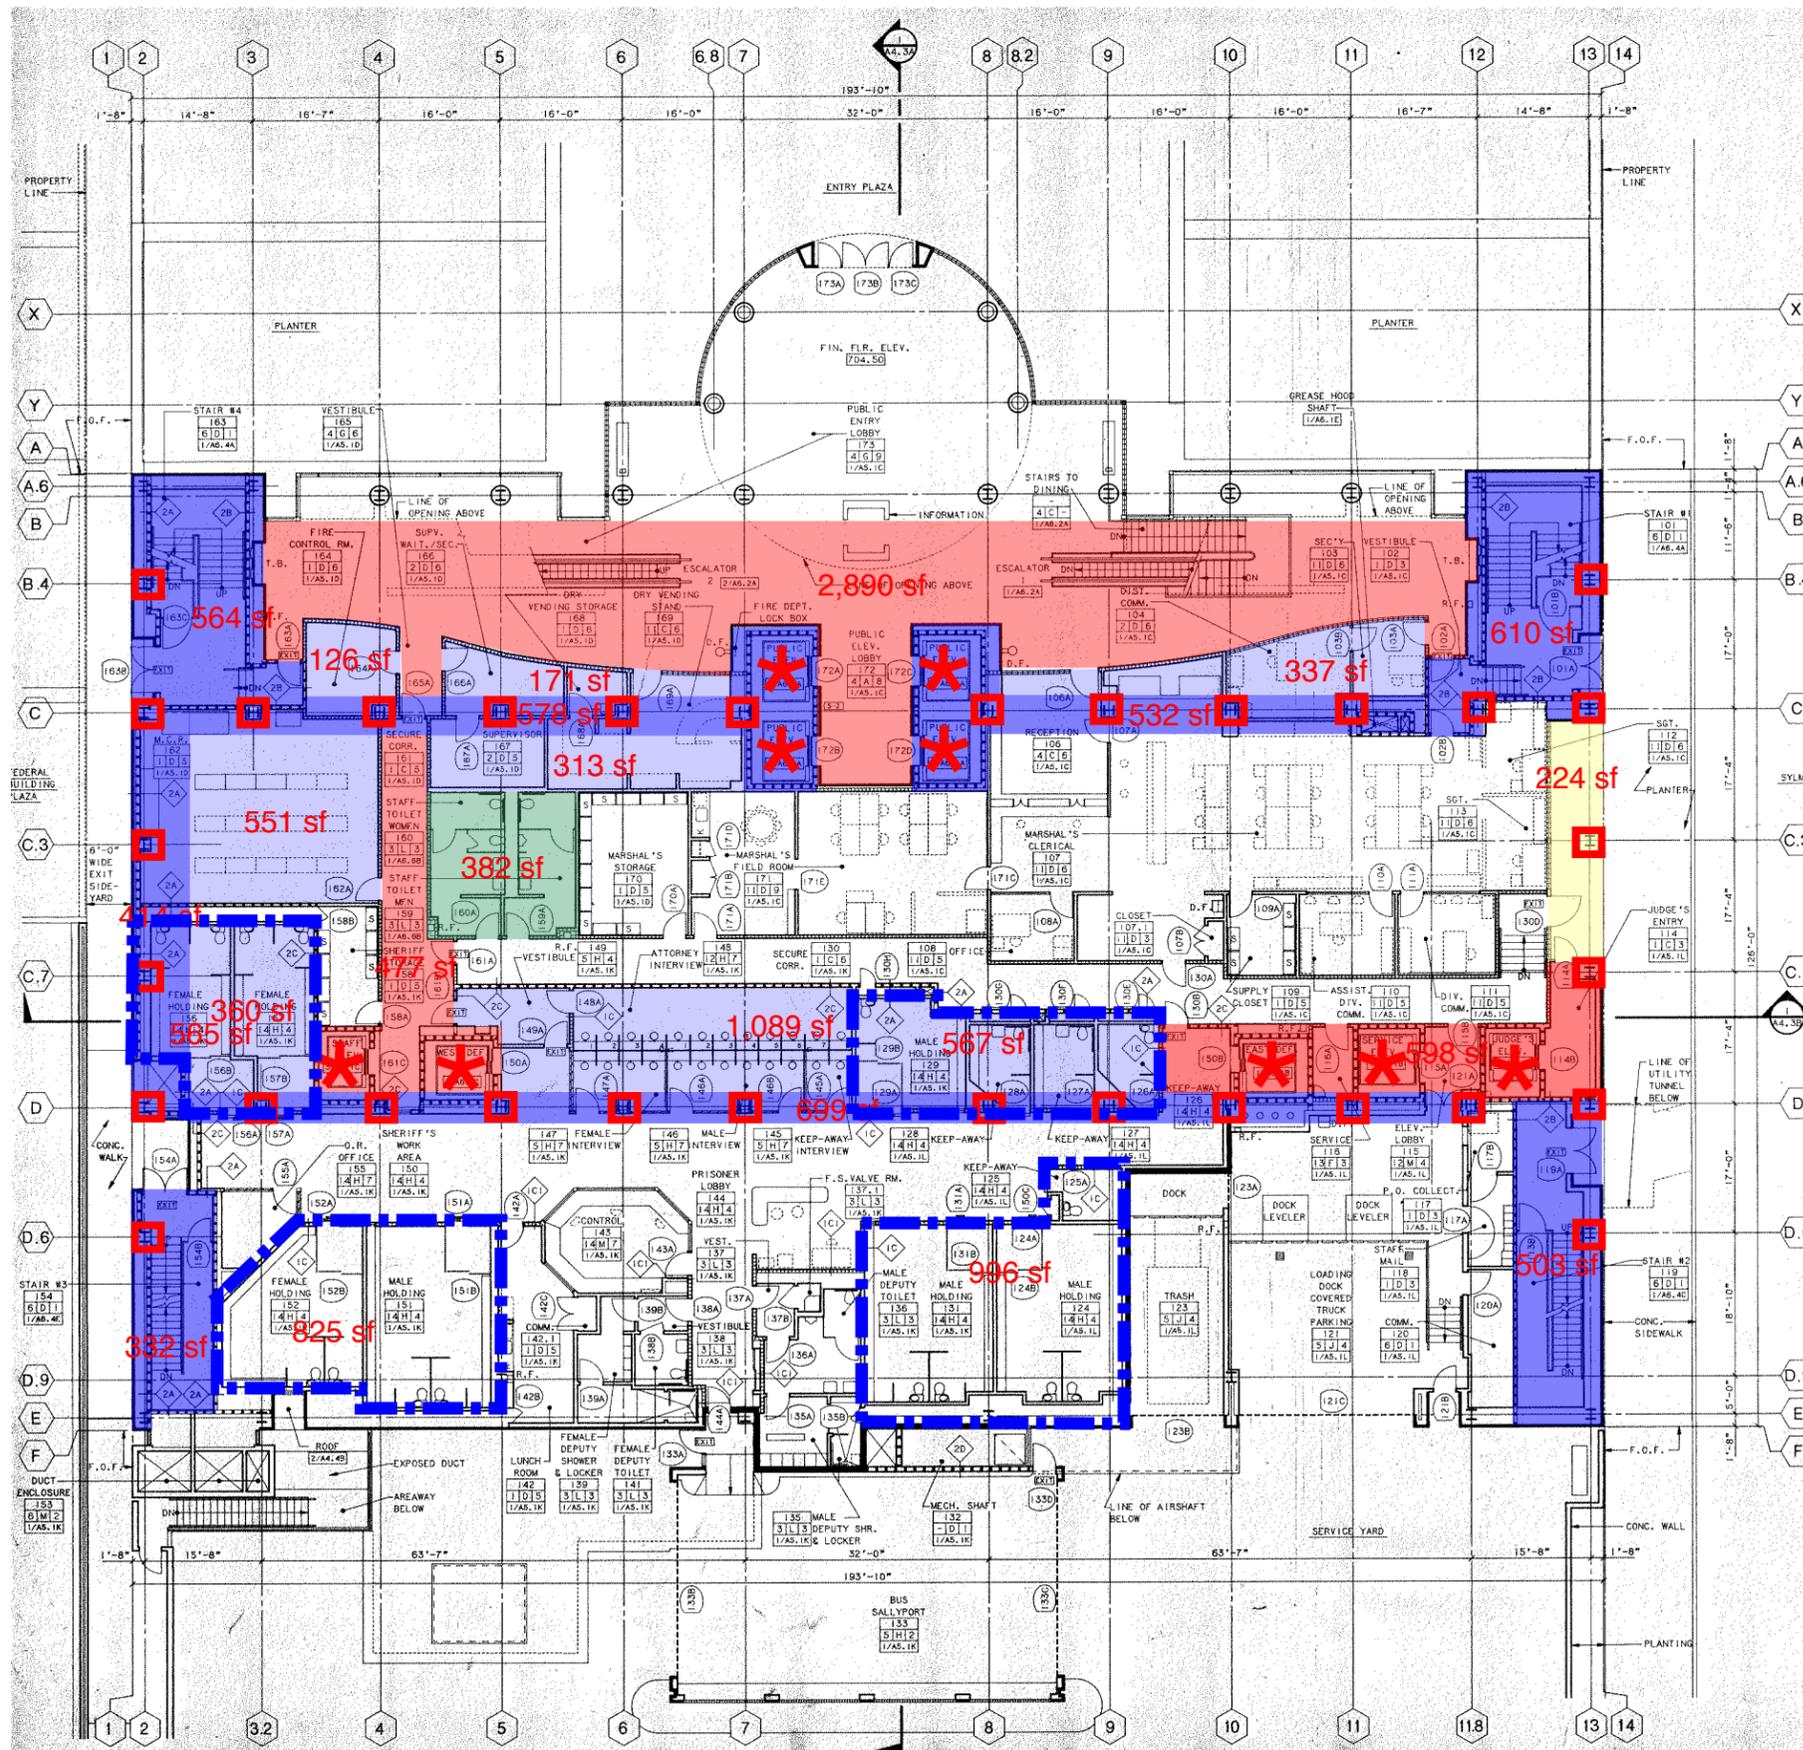
Sketch No:  
**A 1.01 GROUND FLOOR**

- STRUCTURAL RETROFIT FROM INTERIOR
- STRUCTURAL RETROFIT FROM EXTERIOR
- AREA OF REPAIR
- AREA OF FINISH UPGRADES
- UPGRADES TO INTERIOR ACCESSIBLE PATH OF TRAVEL
- UPGRADES TO EXTERIOR ACCESSIBLE PATH OF TRAVEL
- UPGRADES TO TOILET ROOMS
- EXTERIOR REPAIR
- ROOF REPAIR
- ✱ ELEVATOR

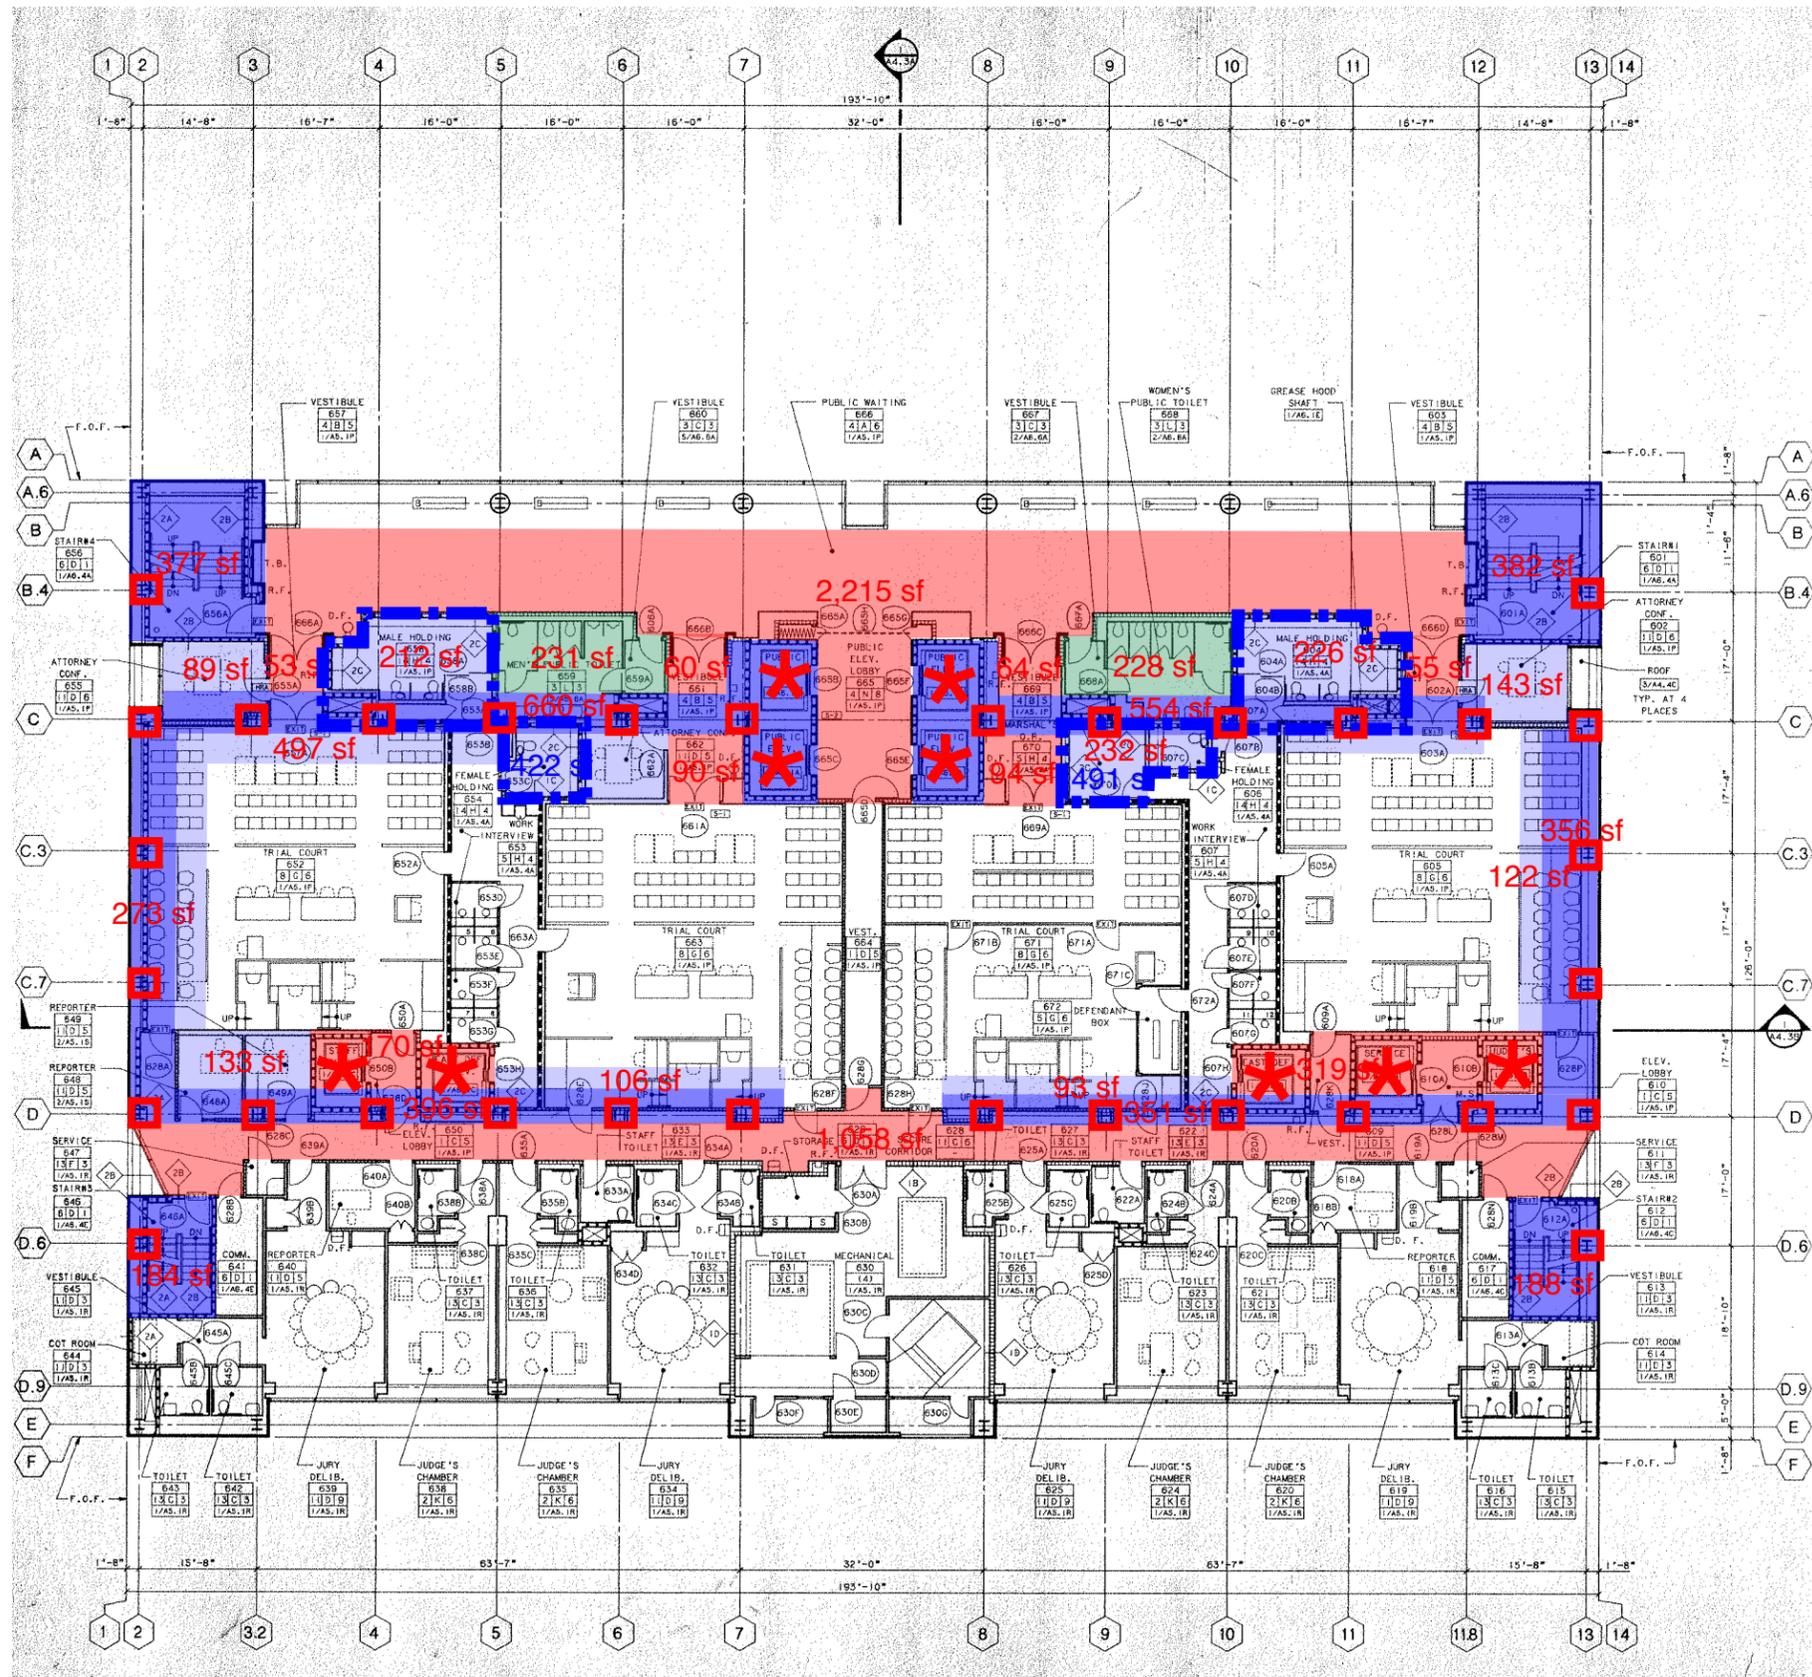
Sketch No: A1.06 SIXTH FLOOR

- STRUCTURAL RETROFIT FROM INTERIOR
- AREA OF REPAIR
- UPGRADES TO INTERIOR ACCESSIBLE PATH OF TRAVEL
- UPGRADES TO EXTERIOR ACCESSIBLE PATH OF TRAVEL
- ROOF REPAIR
- STRUCTURAL RETROFIT FROM EXTERIOR
- AREA OF FINISH UPGRADES
- UPGRADES TO TOILET ROOMS
- EXTERIOR REPAIR
- ELEVATOR

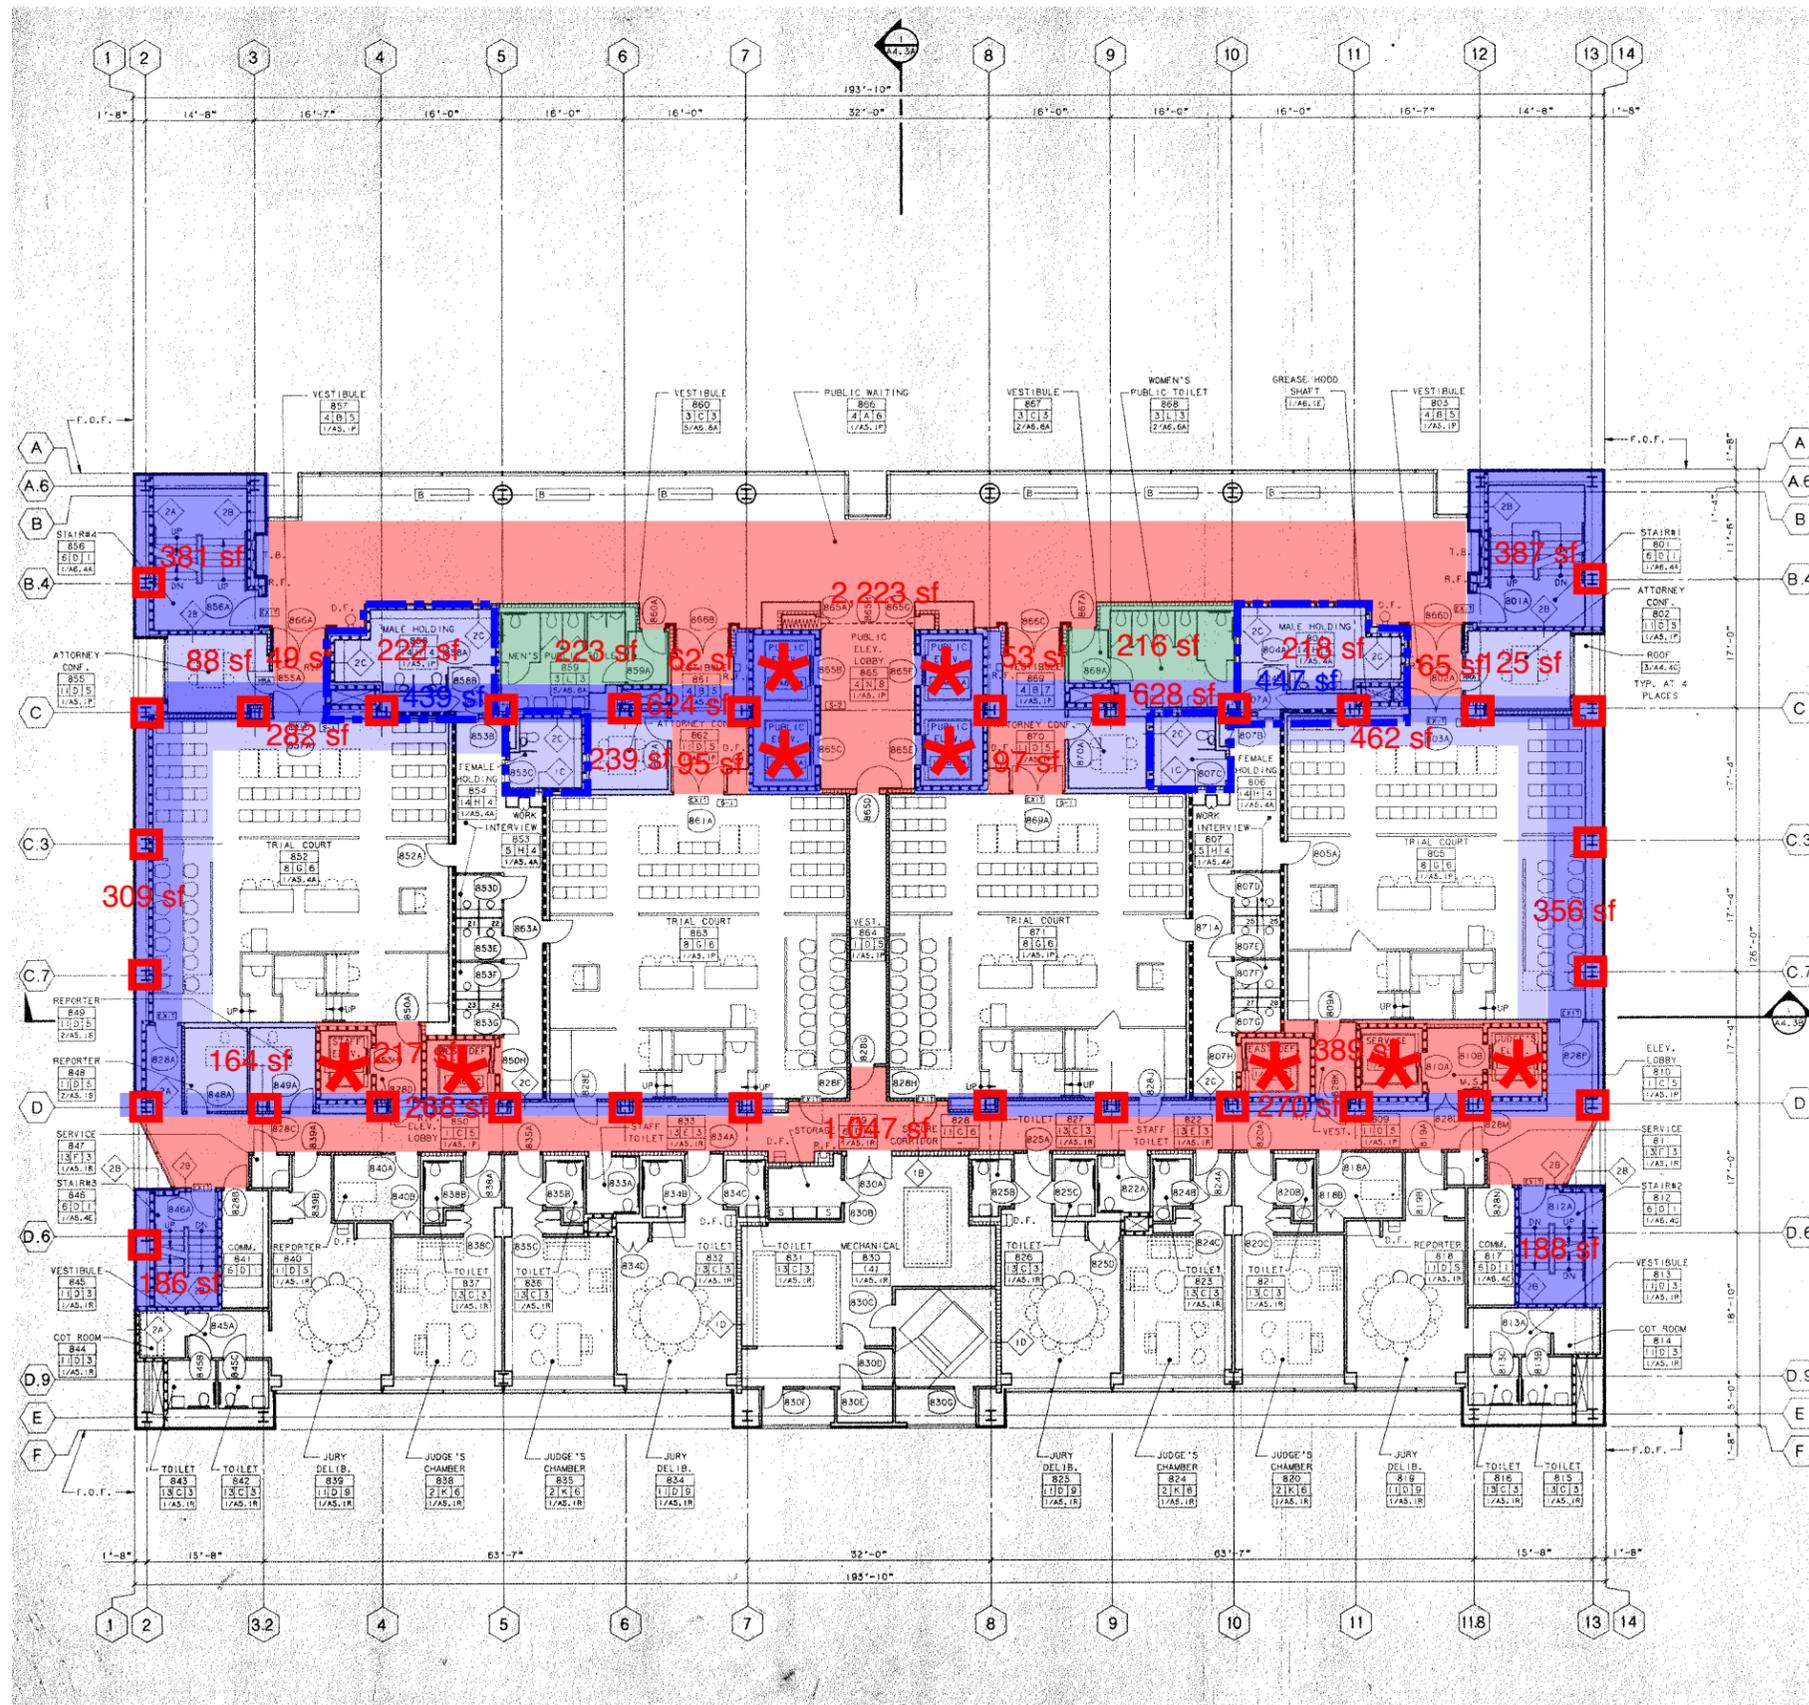
Sketch No:  
**A1.08 EIGHTH FLOOR**

- STRUCTURAL RETROFIT FROM INTERIOR
- AREA OF REPAIR
- UPGRADES TO INTERIOR ACCESSIBLE PATH OF TRAVEL
- UPGRADES TO EXTERIOR ACCESSIBLE PATH OF TRAVEL
- ROOF REPAIR
- - - STRUCTURAL RETROFIT FROM EXTERIOR
- AREA OF FINISH UPGRADES
- UPGRADES TO TOILET ROOMS
- EXTERIOR REPAIR
- ✱ ELEVATOR

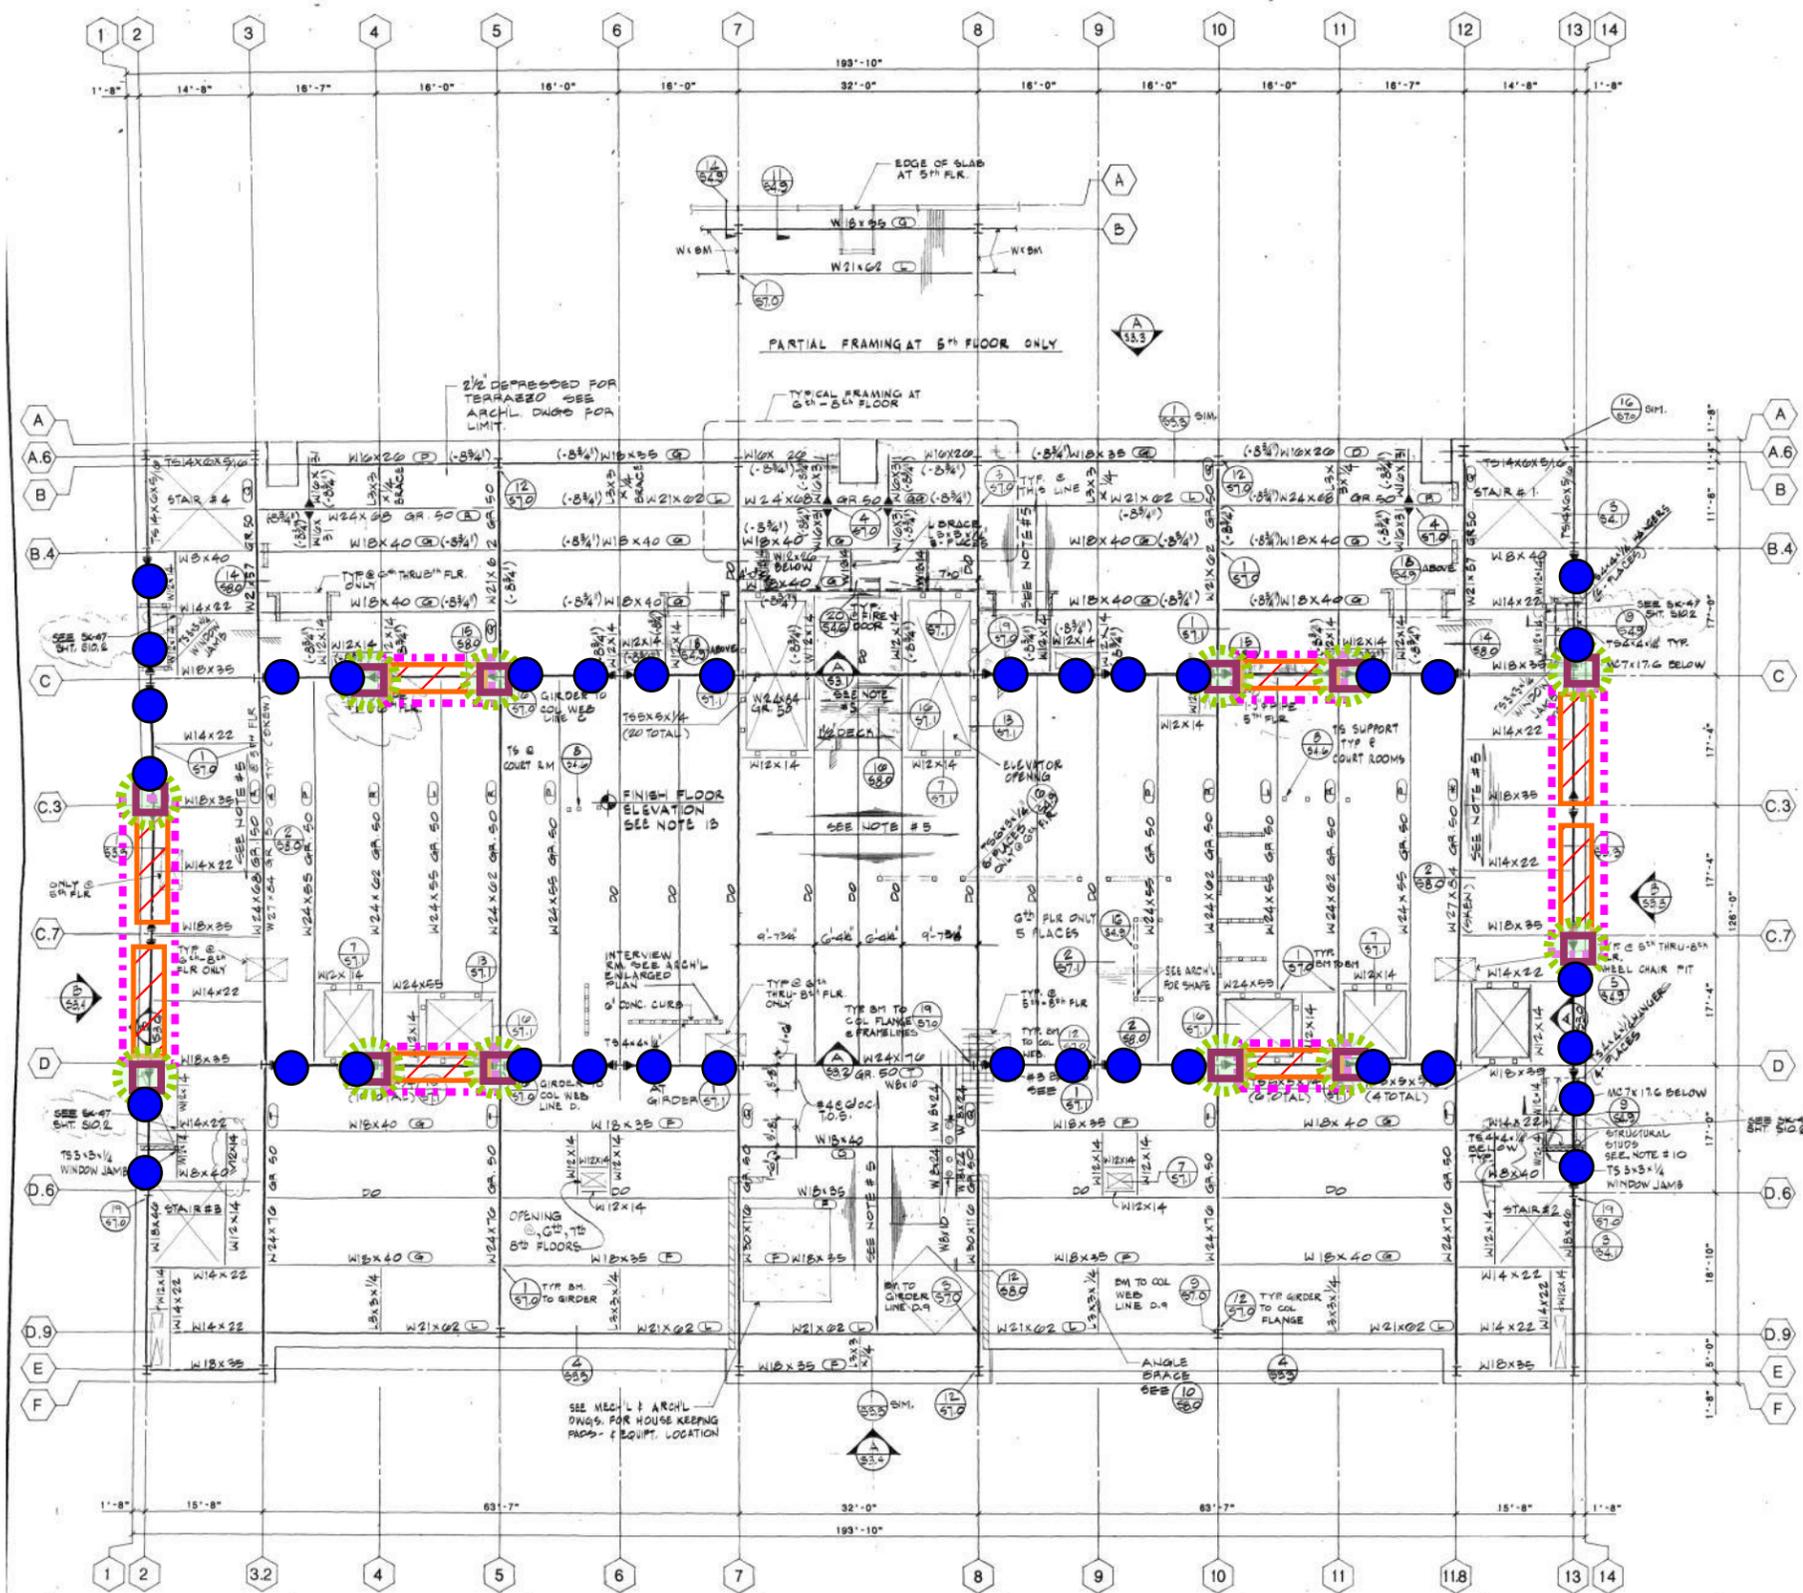
Job: Judicial Council	Job #: 259713
Title: 19-AX2 Van Nuys Courthouse West Seismic retrofit scheme	
Prepared By: NP	Page: S0
Sketch #: Structural notes	<b>ARUP</b>
Date: 2018-05-11	
Scale: NTS	
Original paper size: 11" x 17"

Item	Description of deficiency	Description of retrofit measure
1	Moment-resisting connections inadequate	Limit drift by adding buckling-restrained braces, 4 bays each direction, single diagonal pattern, up entire height of building. Strengthen beam above added brace. Retrofit connections to act as collectors along brace line.
2	Moment frame columns and beams are overstressed	Strengthen columns by welding plates to create box section. Strengthen beams above brace (see item 1).
3	Strong column, weak beam not achieved in all cases	Limit drift by adding braces (see item 1)
4	Column splices will not develop full strength	For end columns where high stresses are anticipated, upgrade existing splices.
5	Several beam members are non-compact sections	Nothing. Unlikely that this will be an issue.
6	Nonstructural: heavy cladding with unknown connection details on 60% of perimeter wall area; stairs unlikely to accommodate anticipated levels of drift; interior marble panels that may require replacement	Replace cladding and interior marble panels. Limit drift by adding braces (see item 1)

| Add buckling-restrained brace (BRBF) as single diagonal from L1 to Roof. Prior to adding brace, inspect and repair existing moment connection if already fractured. | 1 |
| Upgrade column splice at 3'-6" above L3, L5, L7, and L9 | 4 |
| Strengthen columns on end of added braced bays from L1 through L8 | 5 |

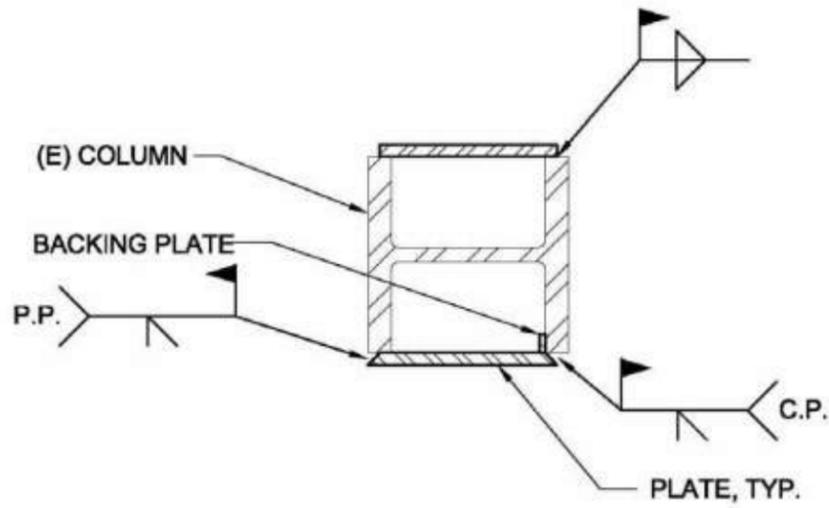
DETAIL 5: Strengthen Existing Column

**Note:**  
Welds shown indicate alternate possibilities of plate attachment.

**Figure 8.4.3-2: Box Section at Existing Column**

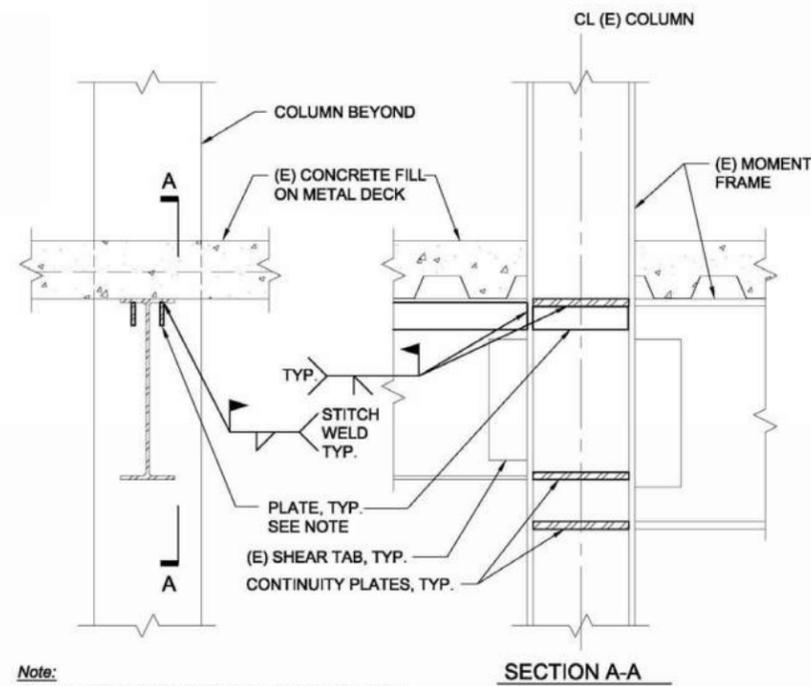
DETAIL 3: Collector Retrofit at Beam

**Note:**  
Plates may be interrupted at column by shear tab from transverse beam. Provide complete joint penetration welds from plates to shear tab.

**Figure 8.4.4-1: Plate Collectors at Existing Beam**

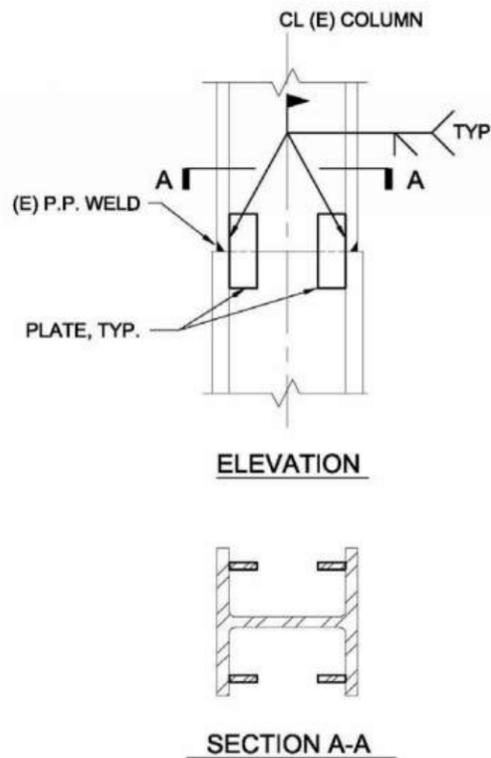
DETAIL 4: Column Splice Upgrade

**Figure 8.4.7-1: Welded Splice Upgrade at Existing Column**
