Seismic Renovation Project Feasibility Report

**EL MONTE COURTHOUSE
19-01**

PREPARED BY ARUP
JANUARY 22, 2019

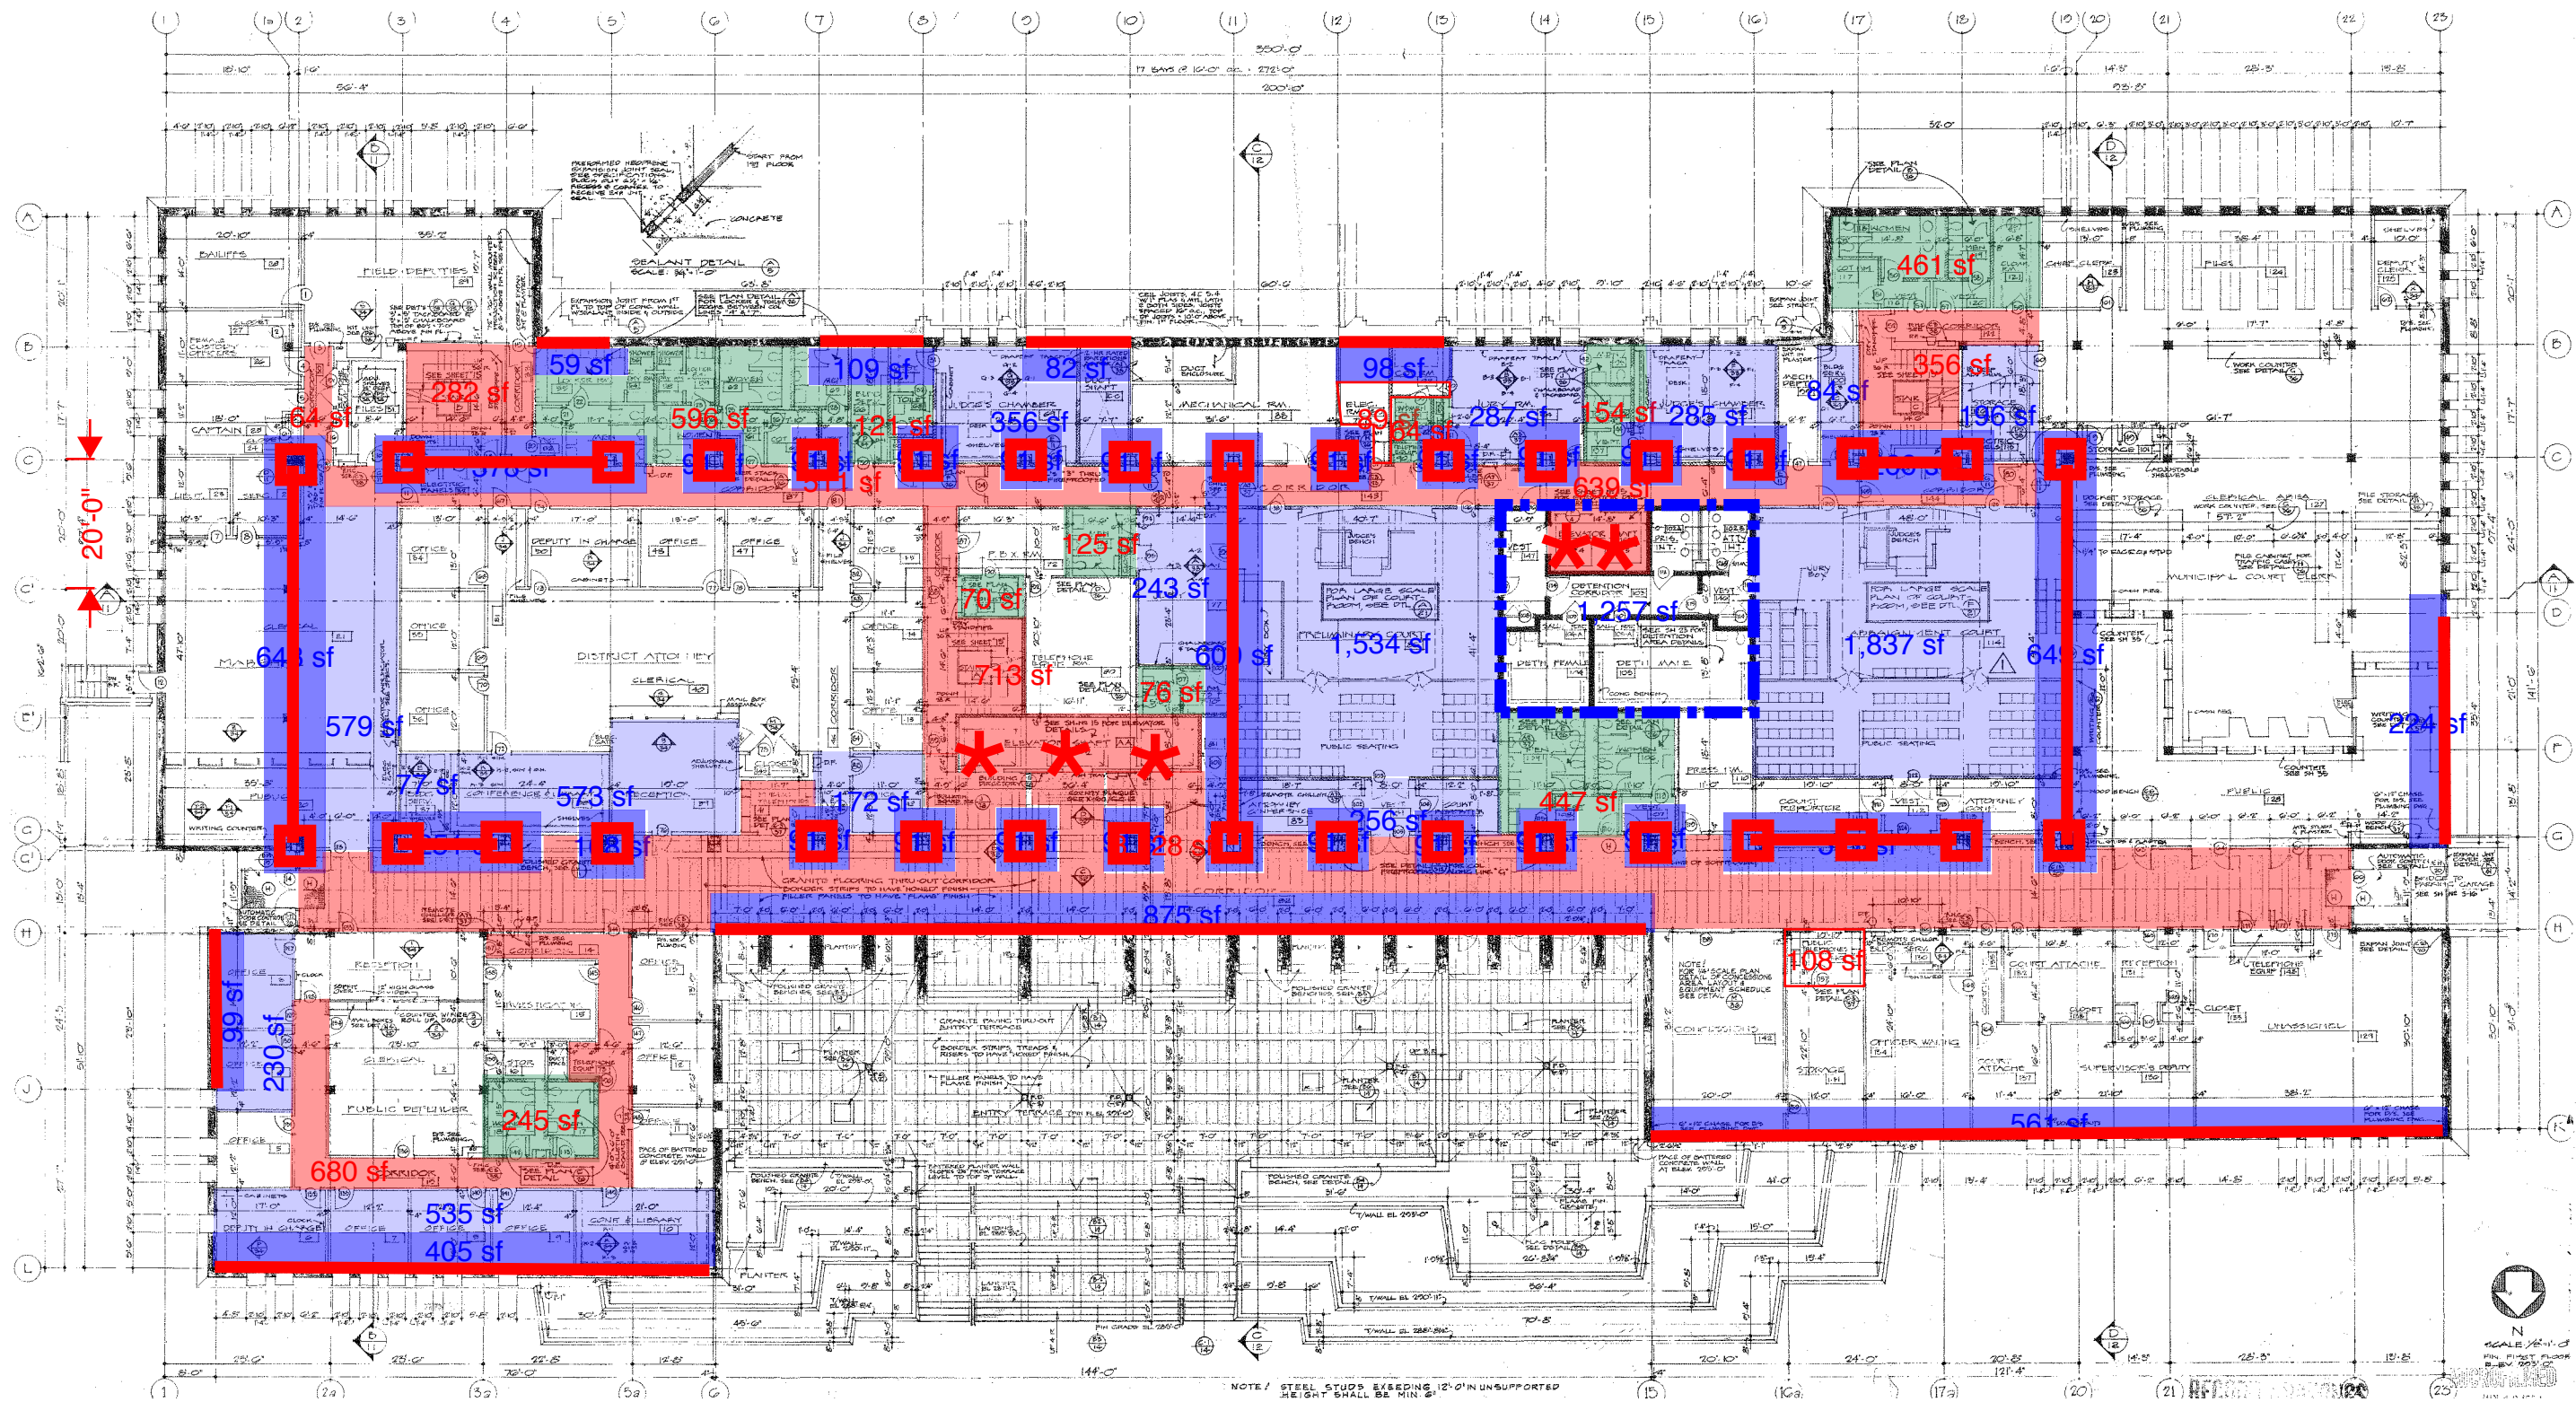
Sketch No:
A2.01 - FIRST FLOOR PLAN

Retrofit: EL MONTE
 Scale: NTS
 Description: ARCHITECTURAL UPGRADES

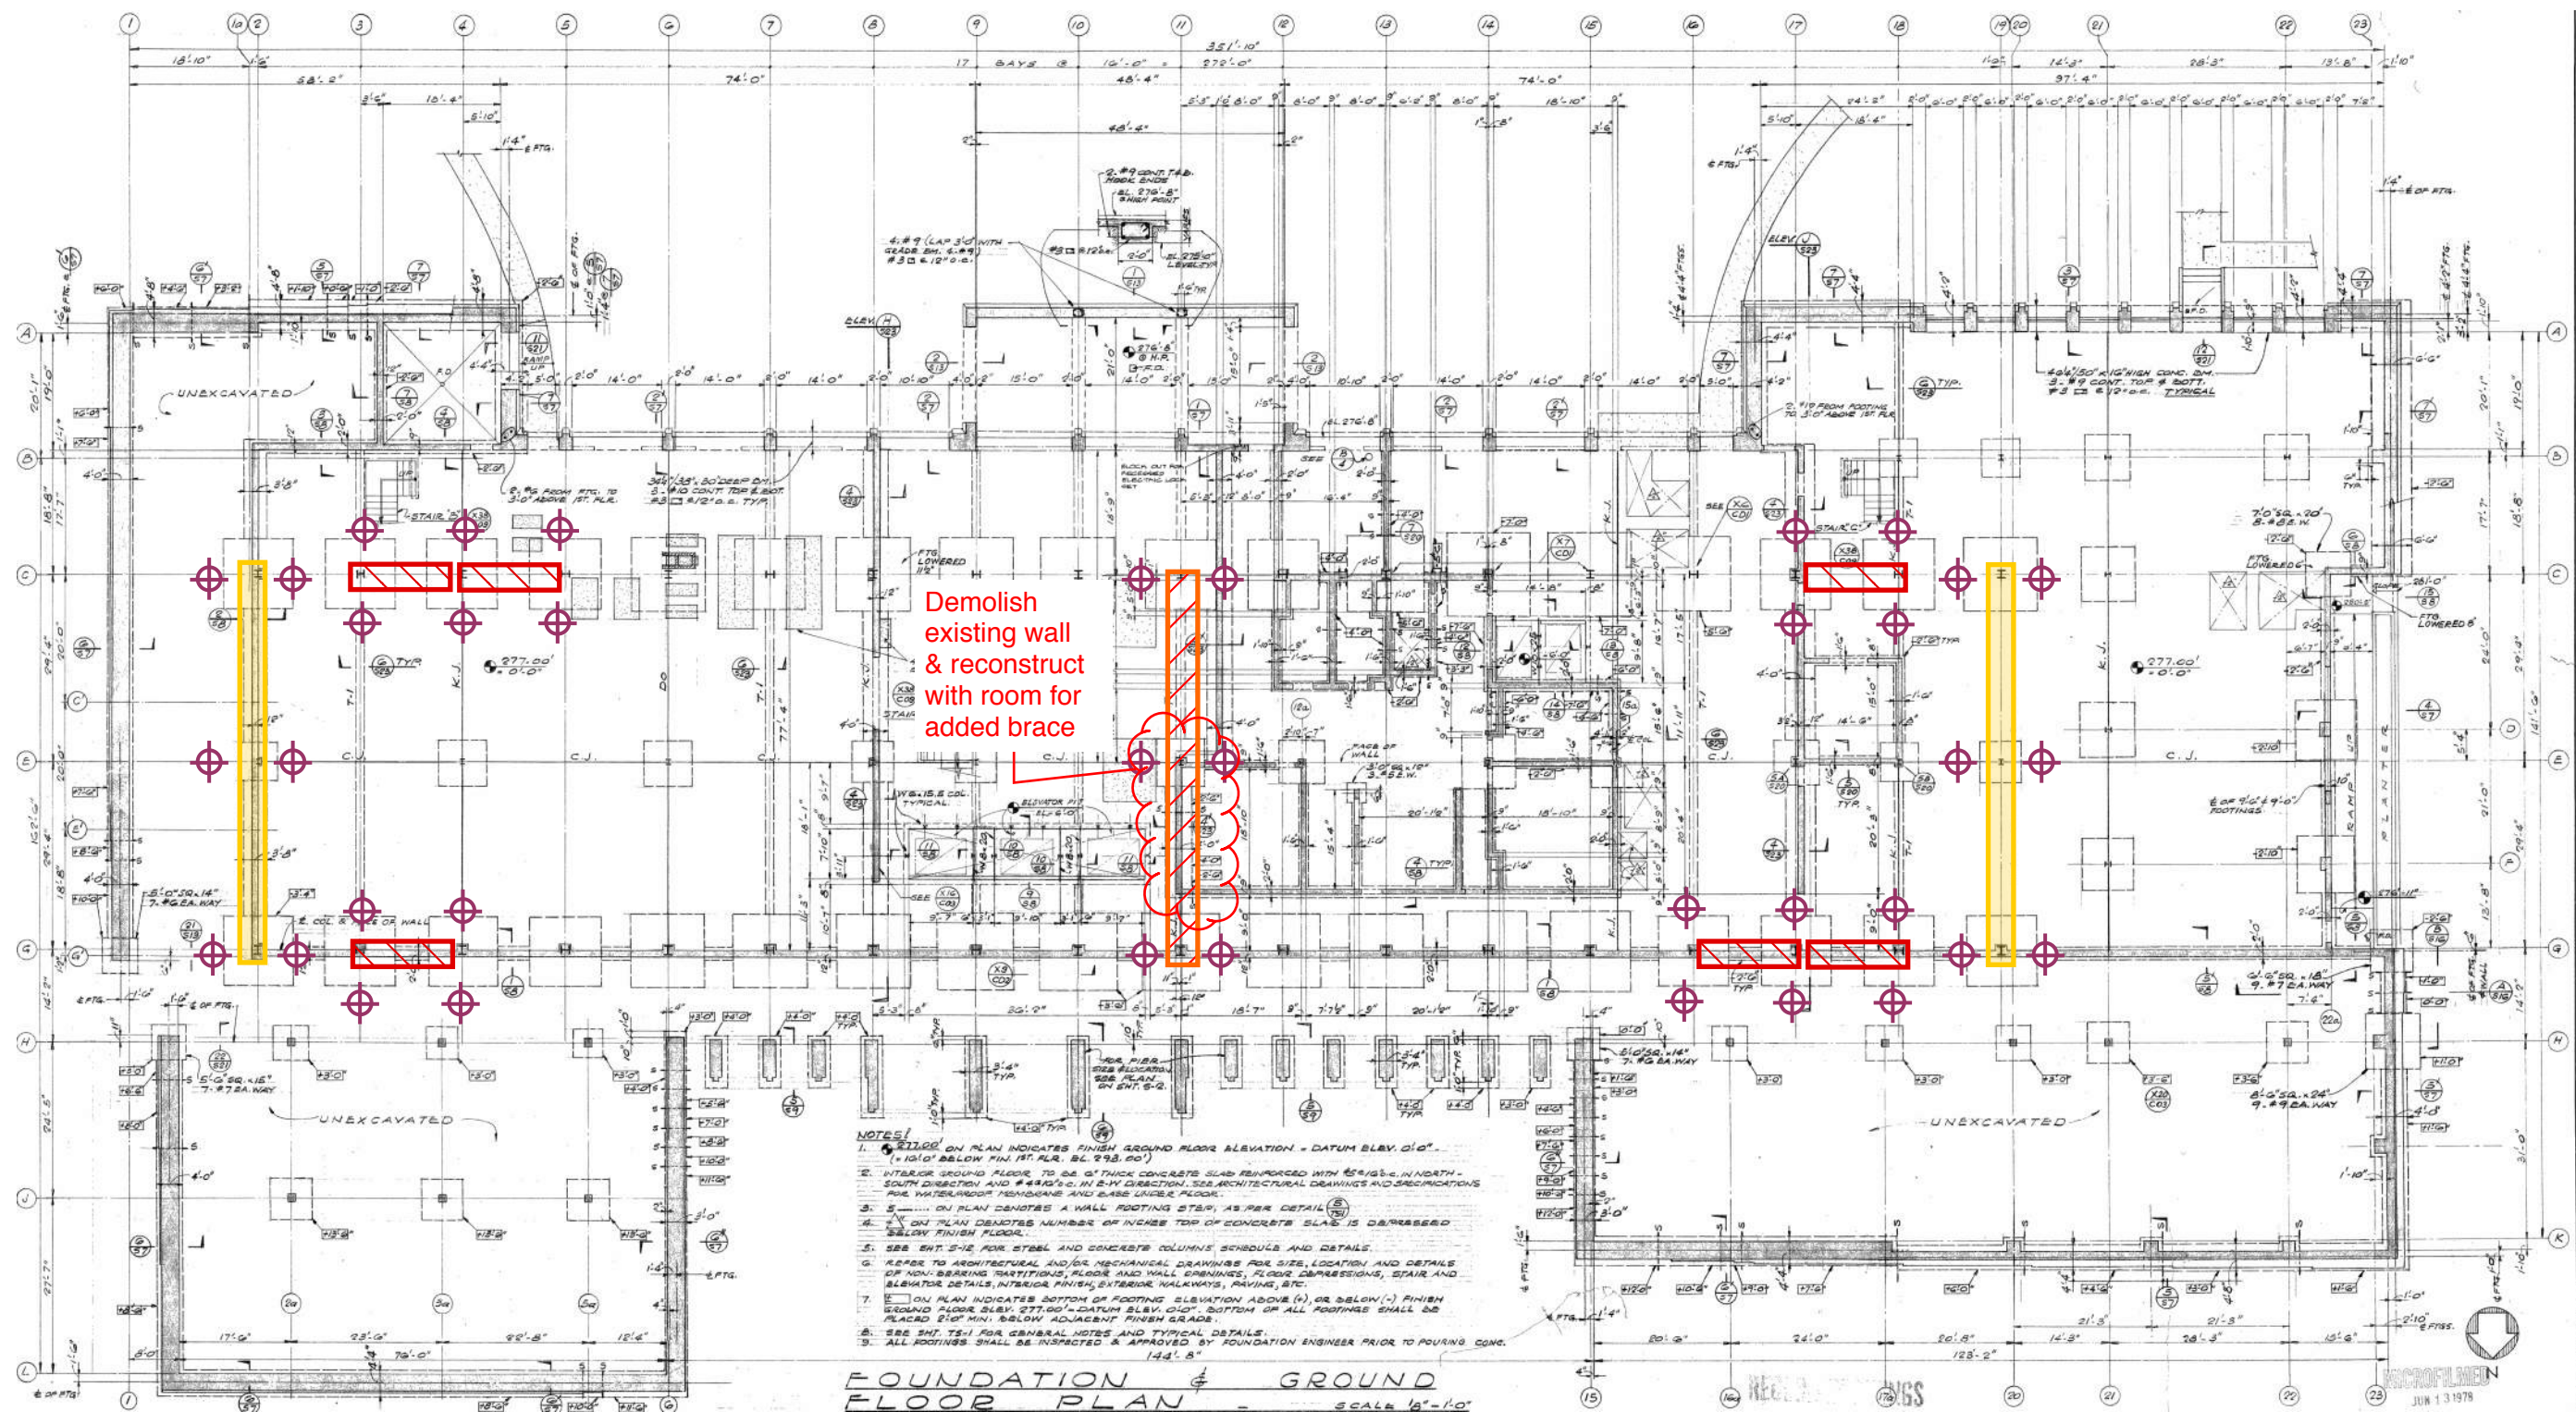
Job: Judicial Council	Job #: 259713
Title: 19-01 El Monte Courthouse	
Seismic retrofit scheme	
Prepared By: NP	Page: S2
Sketch #: Typical plan	
Date: 2018-05-16	
Scale: NTS	
Original paper size: 11" x 17"

Item	Description of deficiency	Description of retrofit measure
1	Interstory drifts are excessive	Limit drift by adding buckling-restrained braces, as indicated on the drawings. Strengthen beam above added brace. Retrofit connections to act as collectors along brace line. Add micropiles, pending geotechnical investigation.
2	Moment-resisting connections are inadequate	Limit drift by adding buckling-restrained braces (see description of item 1)
3	Panel zones are inadequate in some locations	Limit drift by adding buckling-restrained braces (see description of item 1)
4	Strong column, weak beam is not achieved in some cases	Limit drift by adding buckling-restrained braces (see description of item 1)
5	Concrete wall to diaphragm connection inadequate in shear	Strengthen wall to diaphragm connections at locations indicated on plan by adding continuous ledger angles.
6	Existing concrete walls are not continuous to foundation	From L1 to L2, add concrete wall at locations indicated on plan. Dowel into existing concrete.

7	Inadequate load path from low roof (concrete joists) to foundation	Add concrete shear walls, as indicated on the drawings from Ground to L1 and L1 to L2 on Line 2 and Line 19.
8	Heavy cladding may not be designed to accommodate anticipated level of drift	Replace 16,800 SF of precast concrete panels with lighter façade material designed to accommodate drift.
9	Interior heavy wall finished may not be designed to accommodate anticipated level of drift	Replace 21,048 SF of interior stone veneer or marble with lighter material designed to accommodate drift.

Demolish existing wall & reconstruct with room for added brace

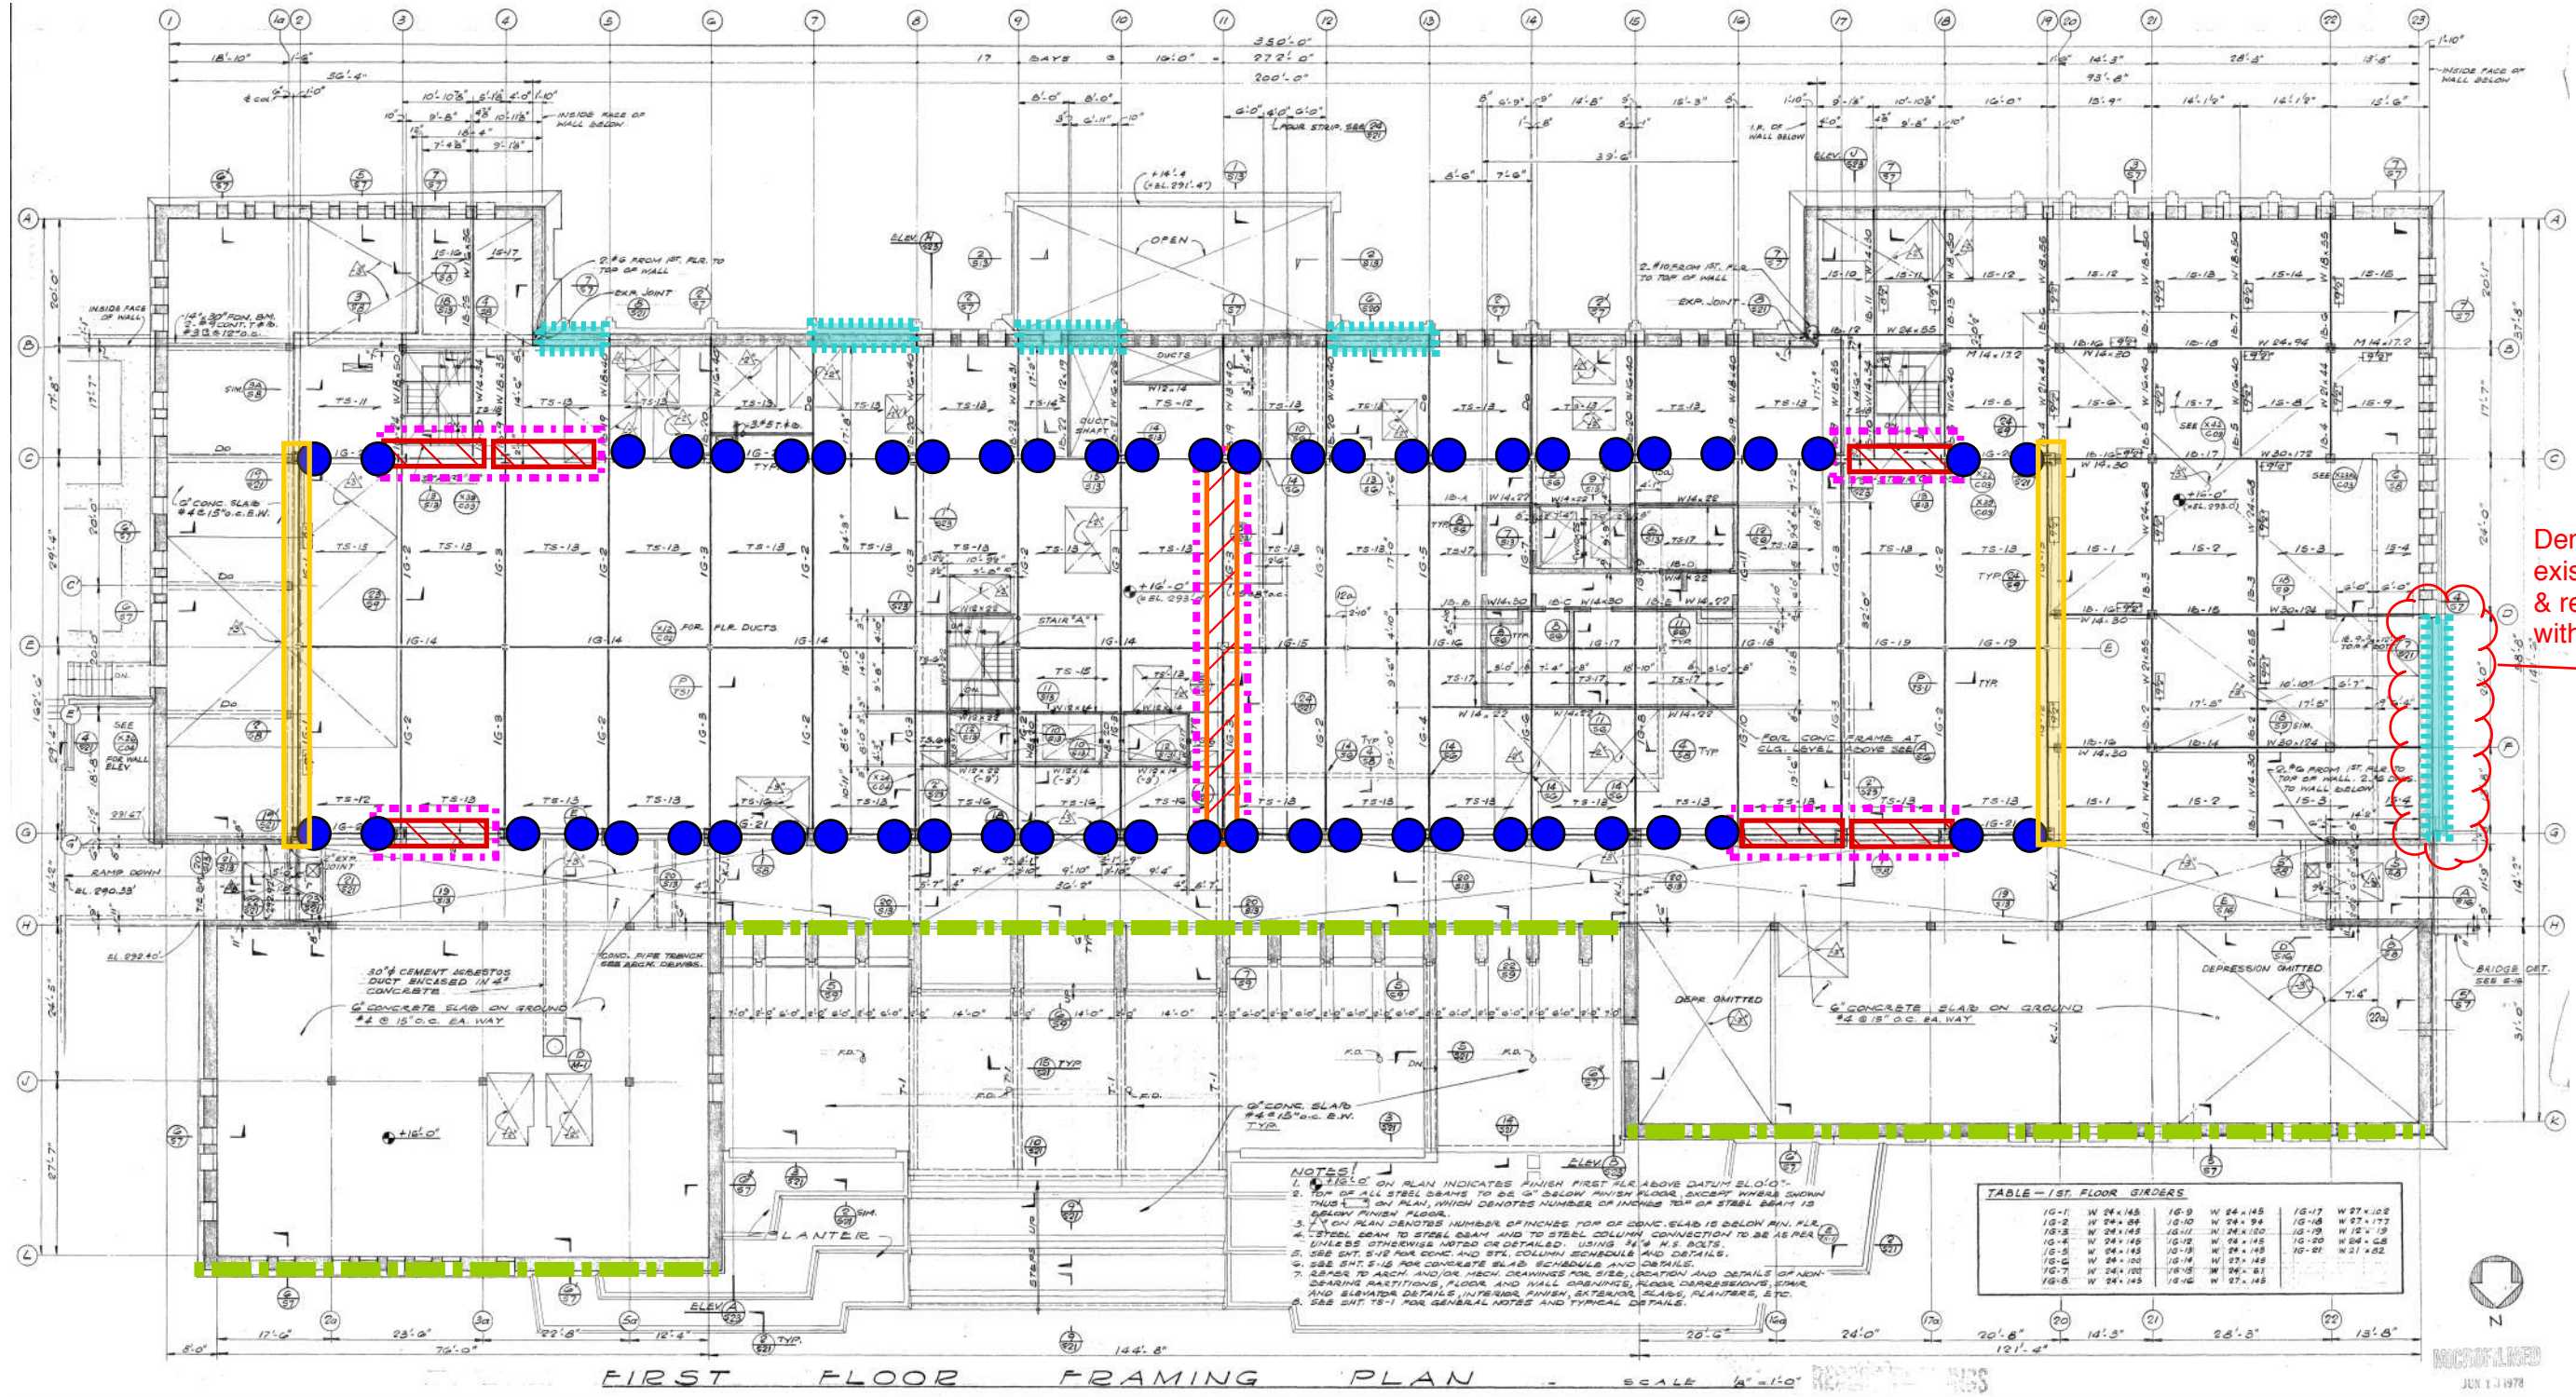
FIRST FLOOR FRAMING PLAN SCALE 1/4" = 1'-0"

Demolish existing wall & replace with new wall

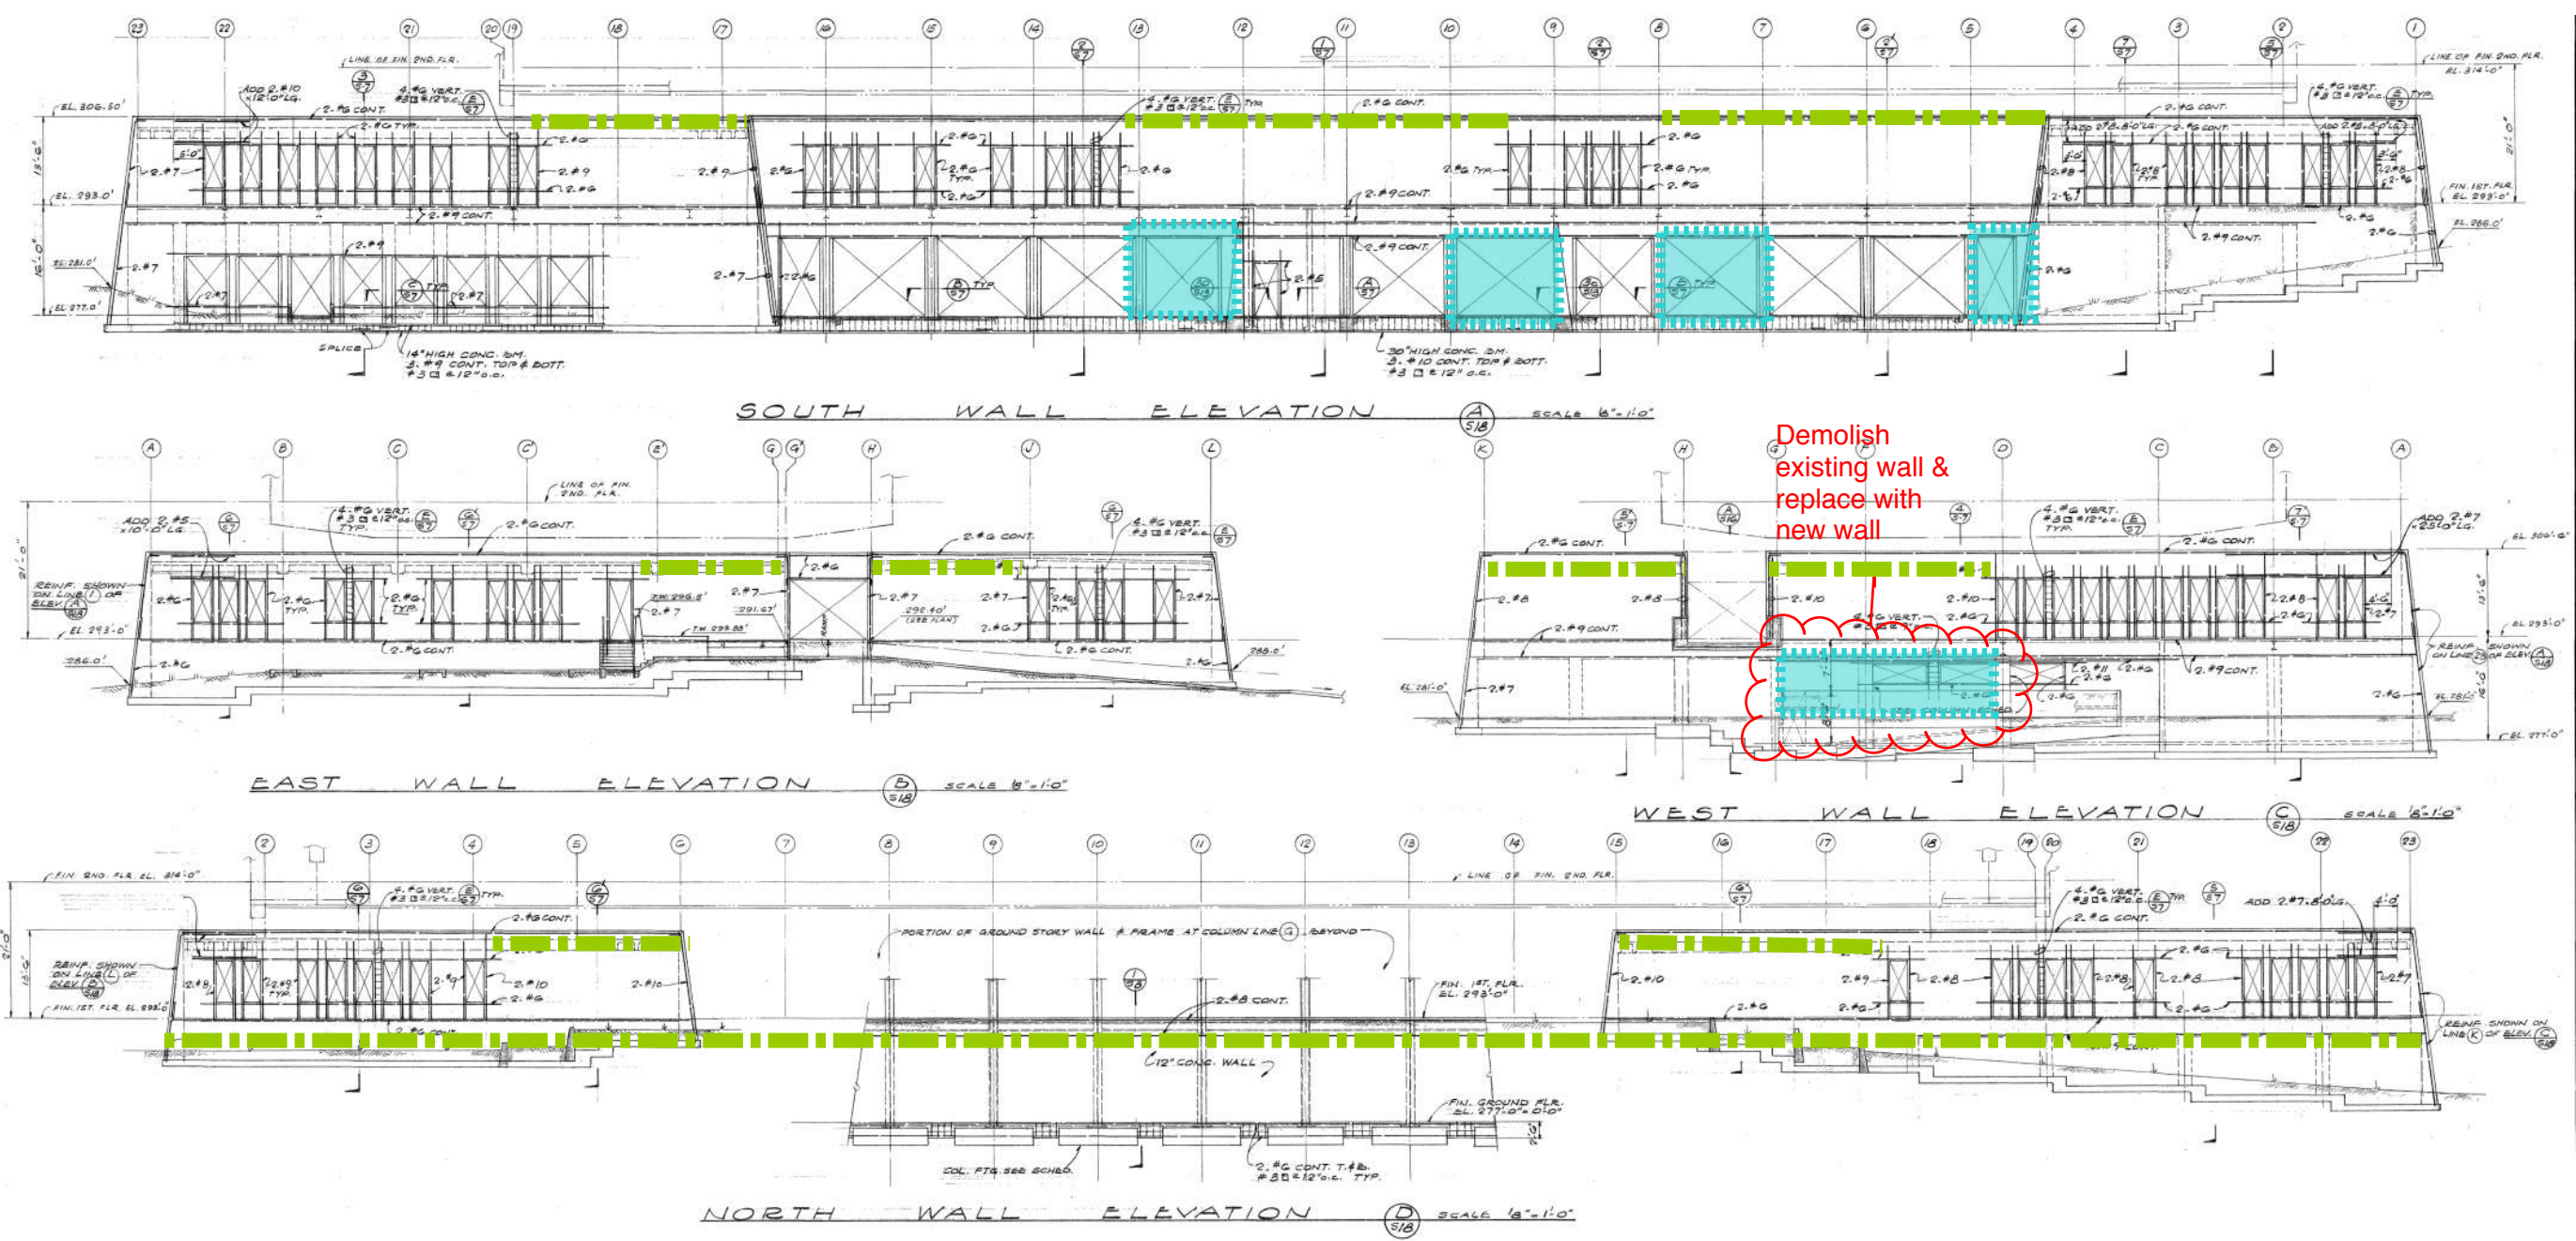
Add buckling-restrained brace (BRBF) in chevron pattern from ground to roof	1		Collector retrofit at beam-column connection from L1 through roof	3		Add shotcrete concrete wall up to existing steel beam, from Ground to L1, L1 to L2	6
	Add buckling-restrained brace (BRBF) as single diagonal from ground to roof	1		Strengthen concrete wall to diaphragm connection L2, Low Roof	4		New micro-piles. Actual number and layout of piles to be determined in retrofit design phase	7
	Strengthen beam above added brace, typ. above all added braces	2		Add concrete wall and dowel into existing concrete from L1 to L2	5

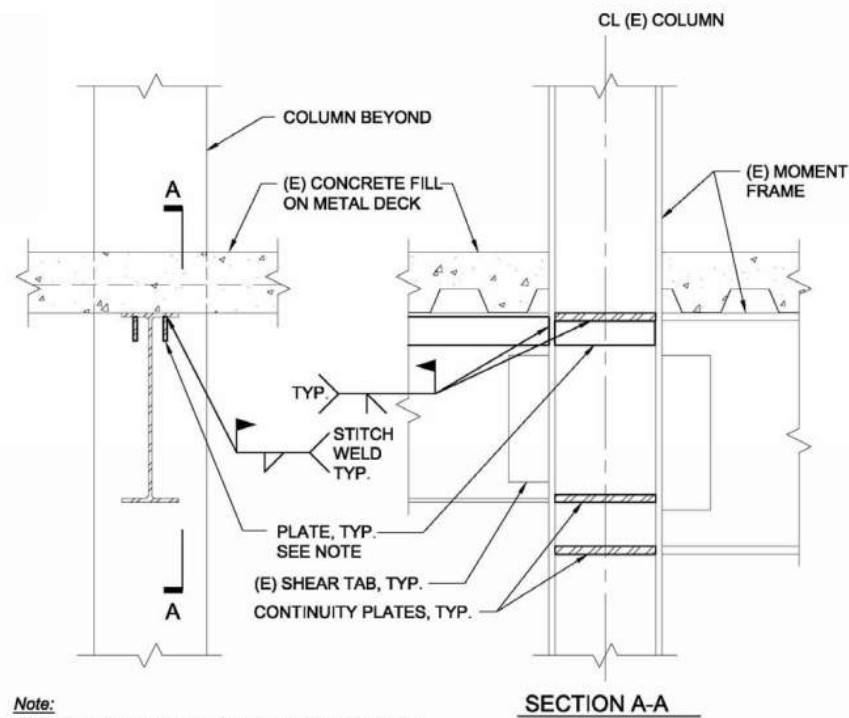
DETAIL 3: Collector Retrofit at Beam

Note:
Plates may be interrupted at column by shear tab from transverse beam. Provide complete joint penetration welds from plates to shear tab.

Figure 8.4.4-1: Plate Collectors at Existing Beam

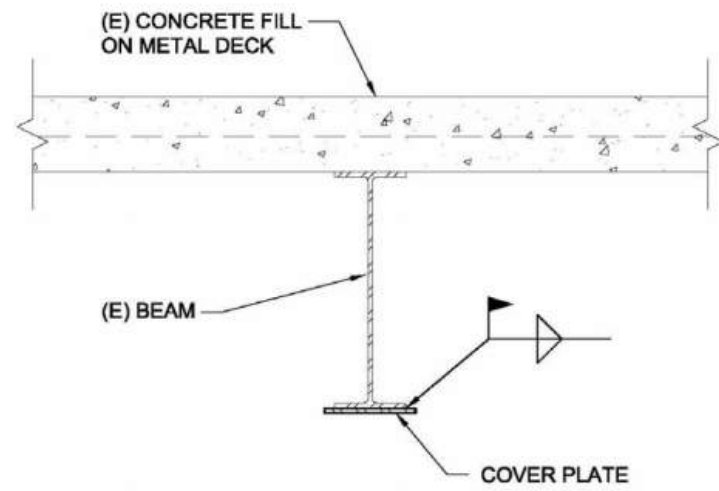
DETAIL 2: Beam Strengthening Detail

Figure 8.4.3-1: Cover Plate at Existing Beam

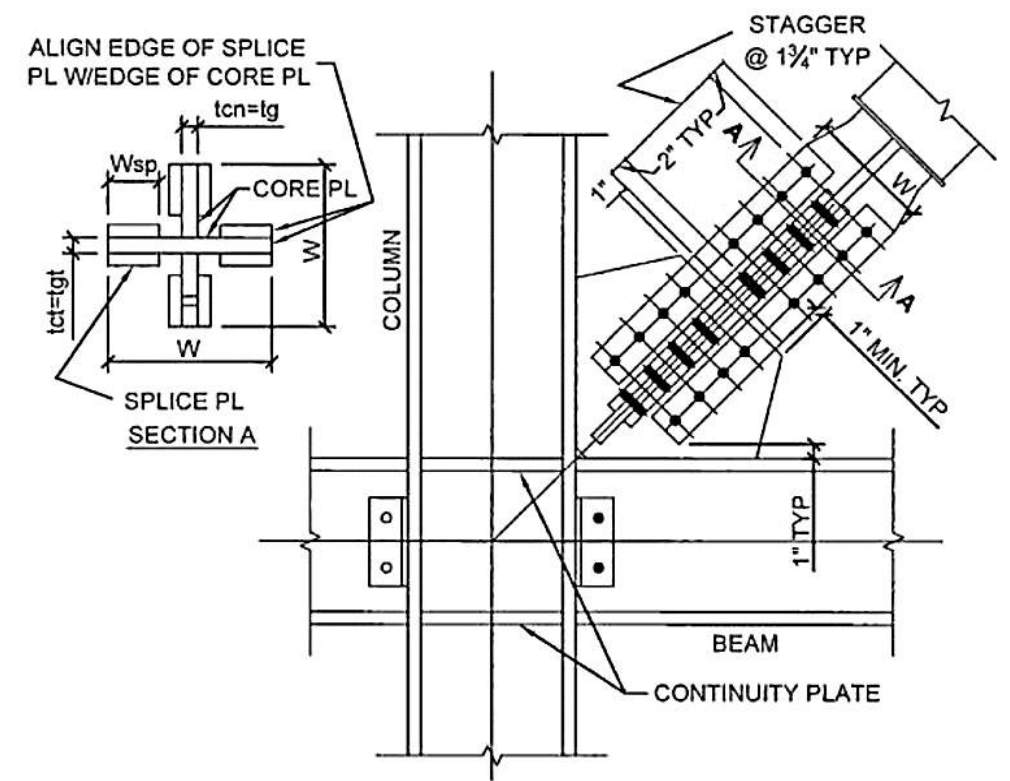
DETAIL 1: BRBF Connection Detail

DETAIL BY COREBRACE

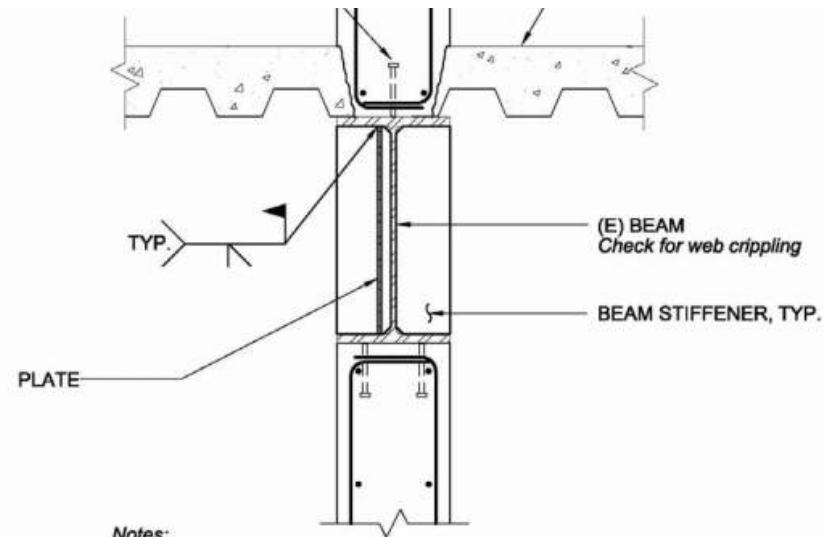
1. Detail is appropriate for shotcrete construction and more problematic for cast-in-place concrete construction due to concrete placement and vibrating challenges.
2. Shear in wall is transferred entirely through studs.
3. For deck perpendicular to beam condition, number of metal studs limited by deck flute spacing.

Figure 8.4.2-3: Discontinuous Wall at Existing Beam

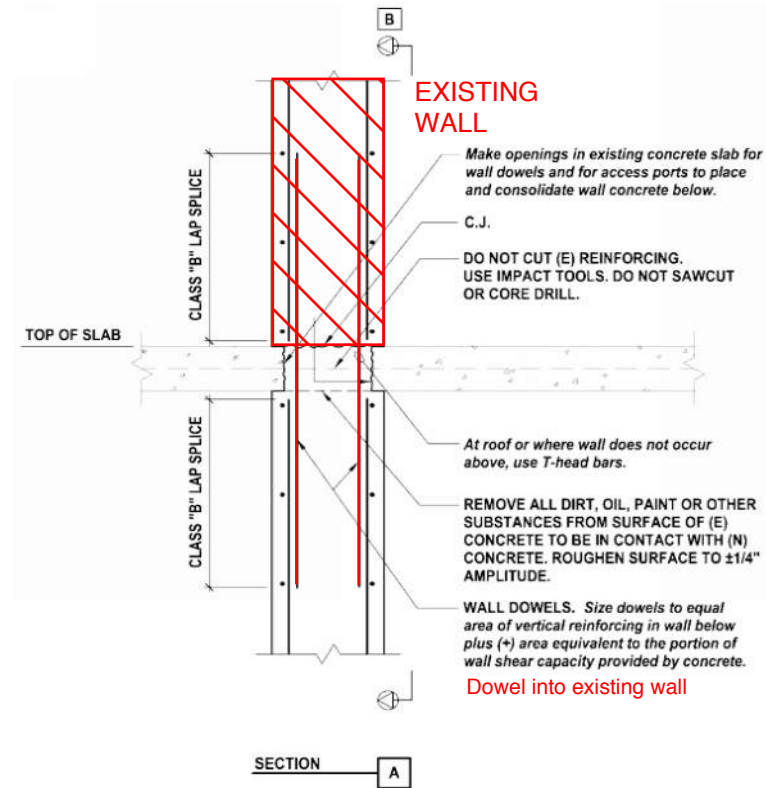
DETAIL 5: Added Concrete to Concrete Slab Detail

Figure 12.4.2-1A: Concrete Wall Connection to Concrete Slab

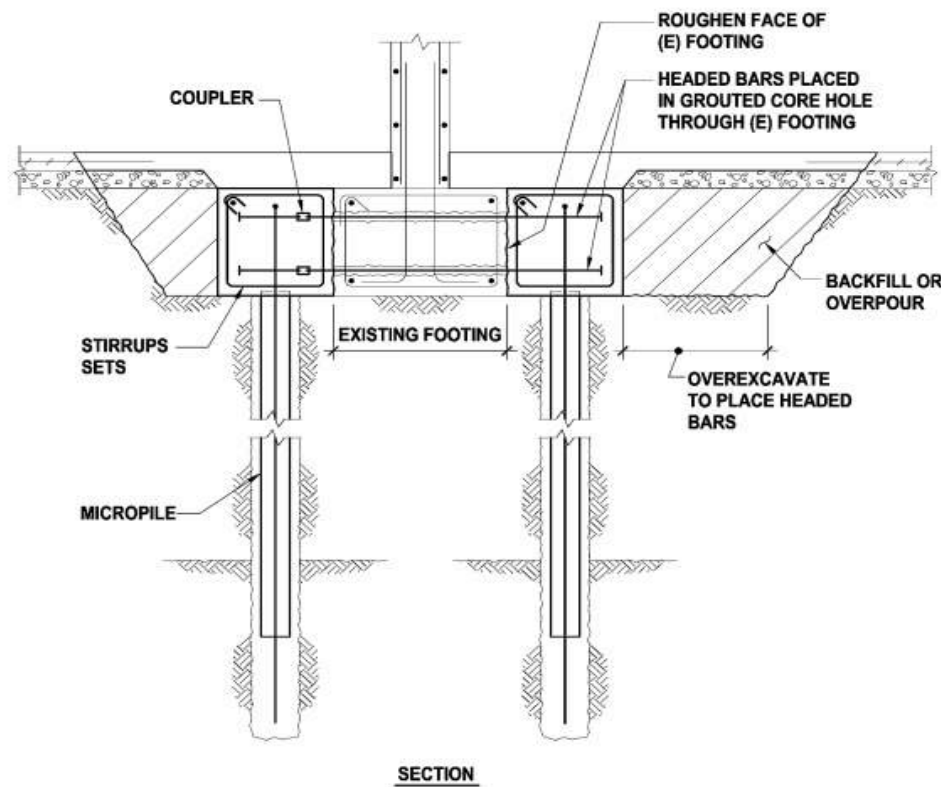
DETAIL 7: Micropile Enhancement Detail

Figure 23.7.2-1: Micropile Enhancement to Existing Strip Footing

New micro-piles. Actual number and layout of piles to be determined in retrofit design phase 7
- Detail number (see S8-S9)**

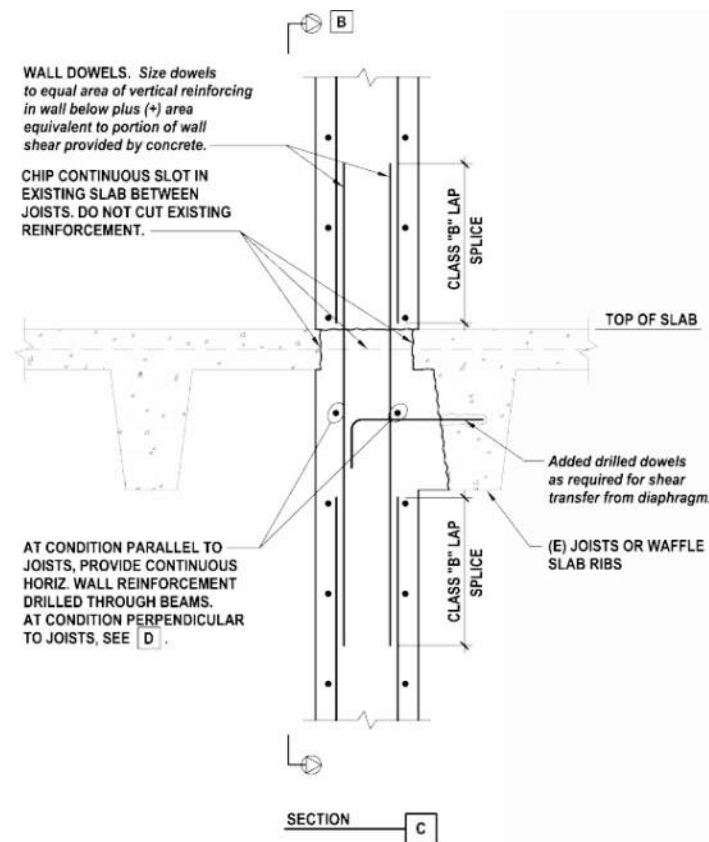
DETAIL 6A: Added Concrete to Concrete Joist Detail (Low Roof)

Figure 12.4.2-1C: Connection of Concrete Wall to Concrete Joists or Waffle Slab
