Seismic Renovation Project Feasibility Report

**NORTH JUSTICE CENTER
30-C1 C2**

1275 N. BERKELEY AVE.,
FULLERTON

PREPARED BY ARUP
JANUARY 22, 2019

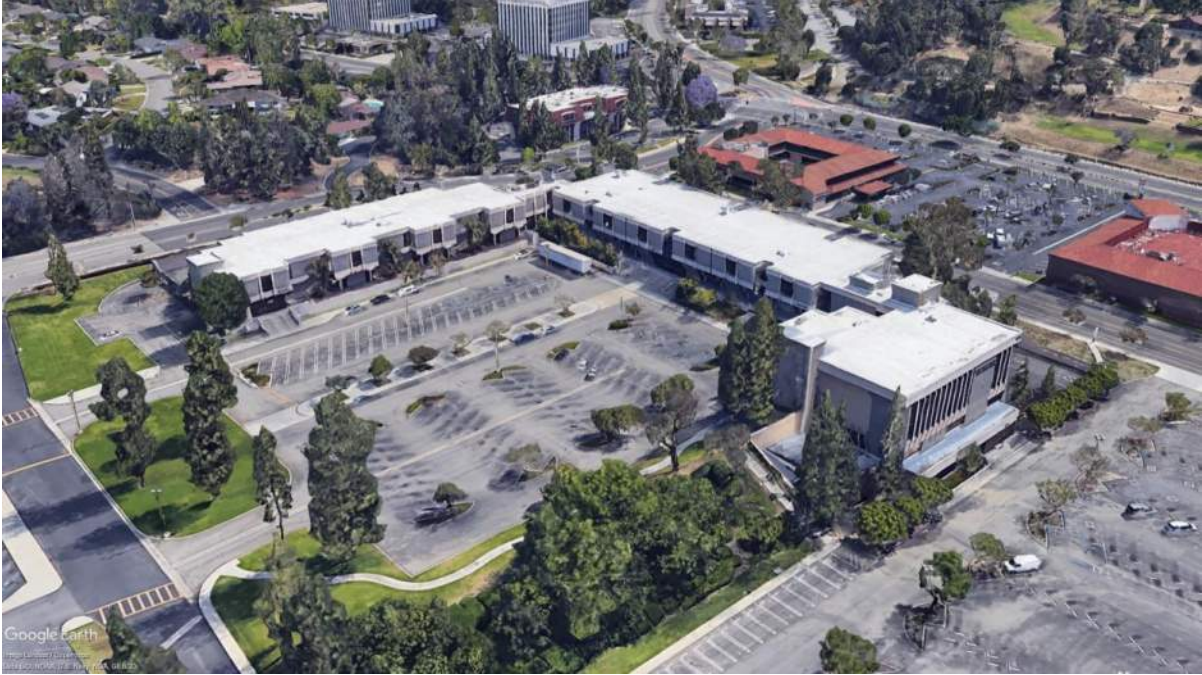
Figure 1. Satellite Image Showing an Overview of the Court Building (Source: Google Earth)

Figure 1 provides a satellite image of the court building showing its overall configuration and construction. Figure 2 provides a satellite image of the court building overlaid with information about each building segment.

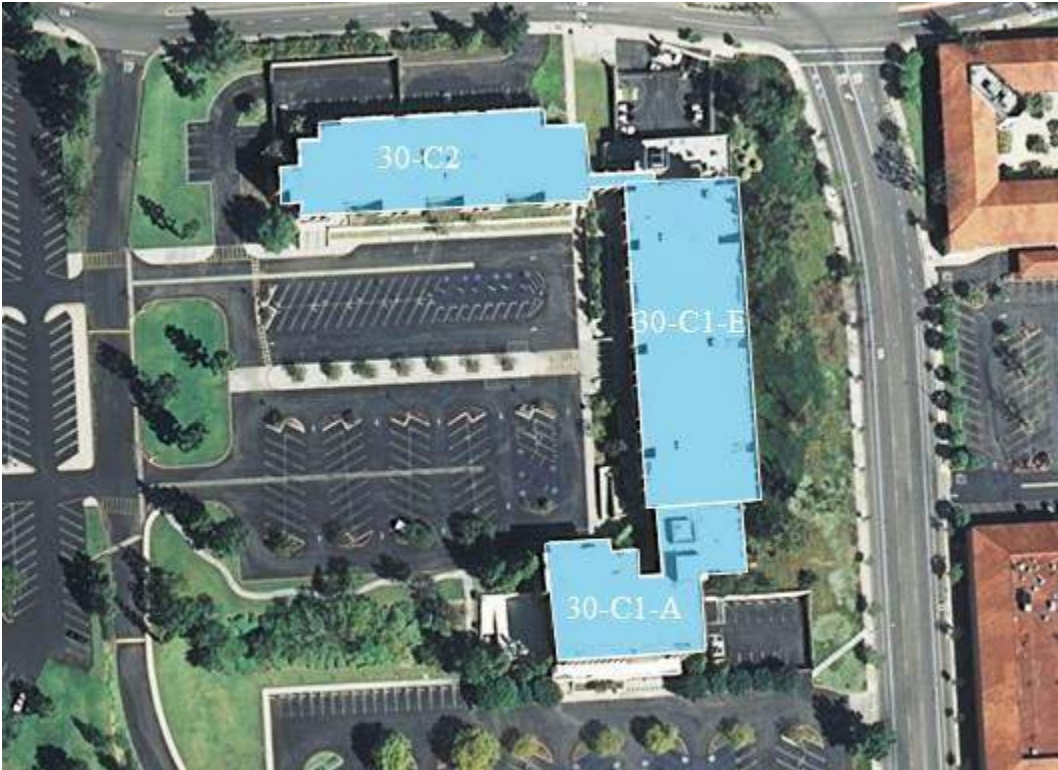
Figure 2. Satellite Image Showing Each Building Segment (Source: USGS)

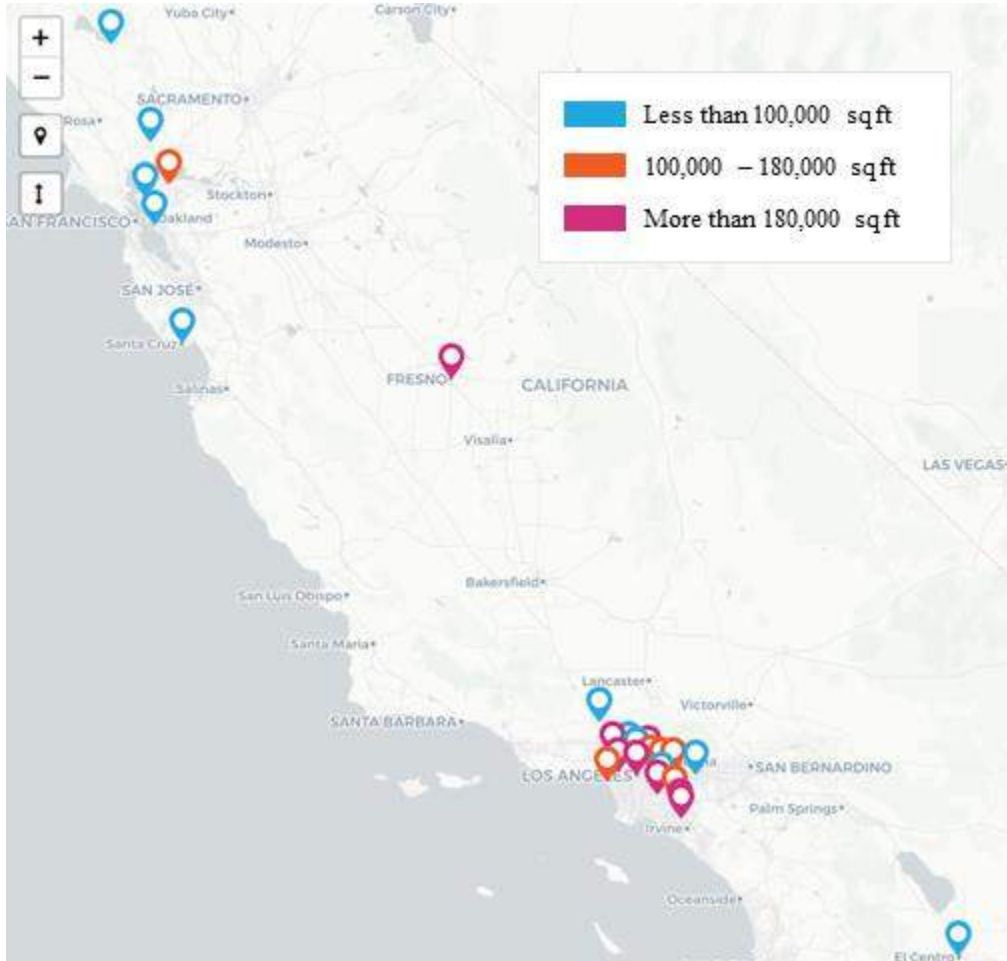
Figure 3. The 26 Court Buildings Assessed in This Seismic Renovation Feasibility Study

One court building was removed during the study due to a lack of structural and architectural drawings. The 26 court buildings studied have a total area of approximately five million gross square feet and comprise 43 building segments. Figure 3 shows the location and area of each court building. Blue pins indicate court buildings smaller than 100,000 square feet, orange indicates between 100,000 and 180,000 square feet, and purple indicates more than 180,000 square feet.

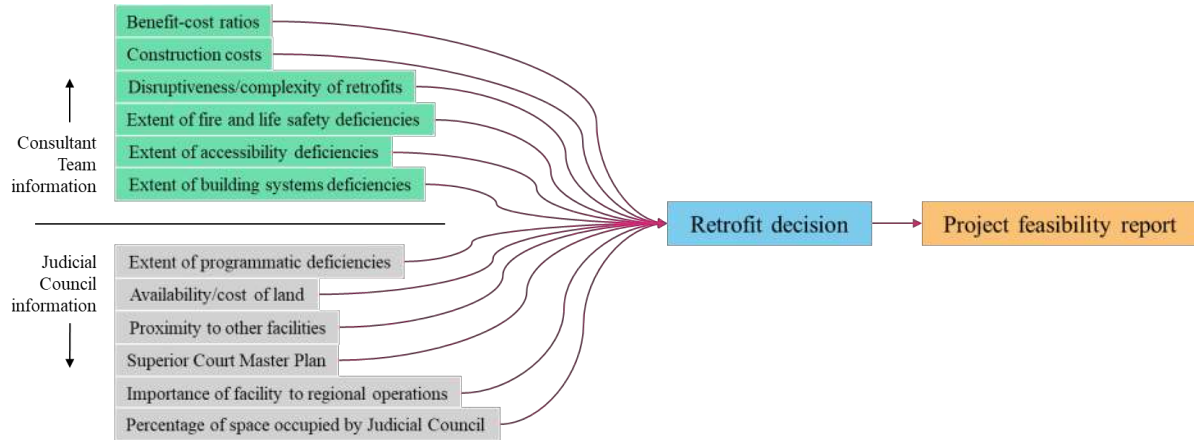
Figure 4. List of Factors Considered in Selection of Retrofit or Replacement Option

The benefit-cost ratio is one of many outputs used by the Judicial Council in selecting a retrofit or replacement option for each court building. Figure 4 summarizes the range of factors included in the decision-making process and distinguishes between those provided by the consultant team and those provided by the Judicial Council.

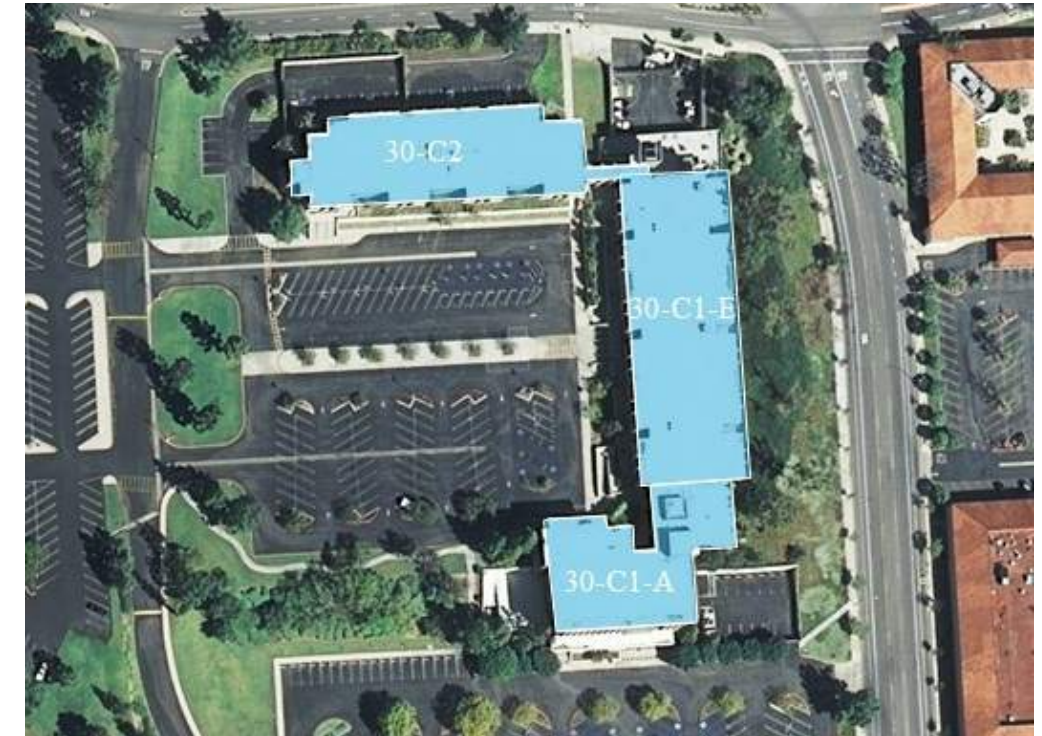
**Overall facility condition****Structural**

- C1-E: Perimeter precast concrete shear wall panels. Inadequate load path
- C1-E : Inadequate seismic separation between structures
- C1-E: X direction and Y direction wall thickness and reinforcing inadequate.

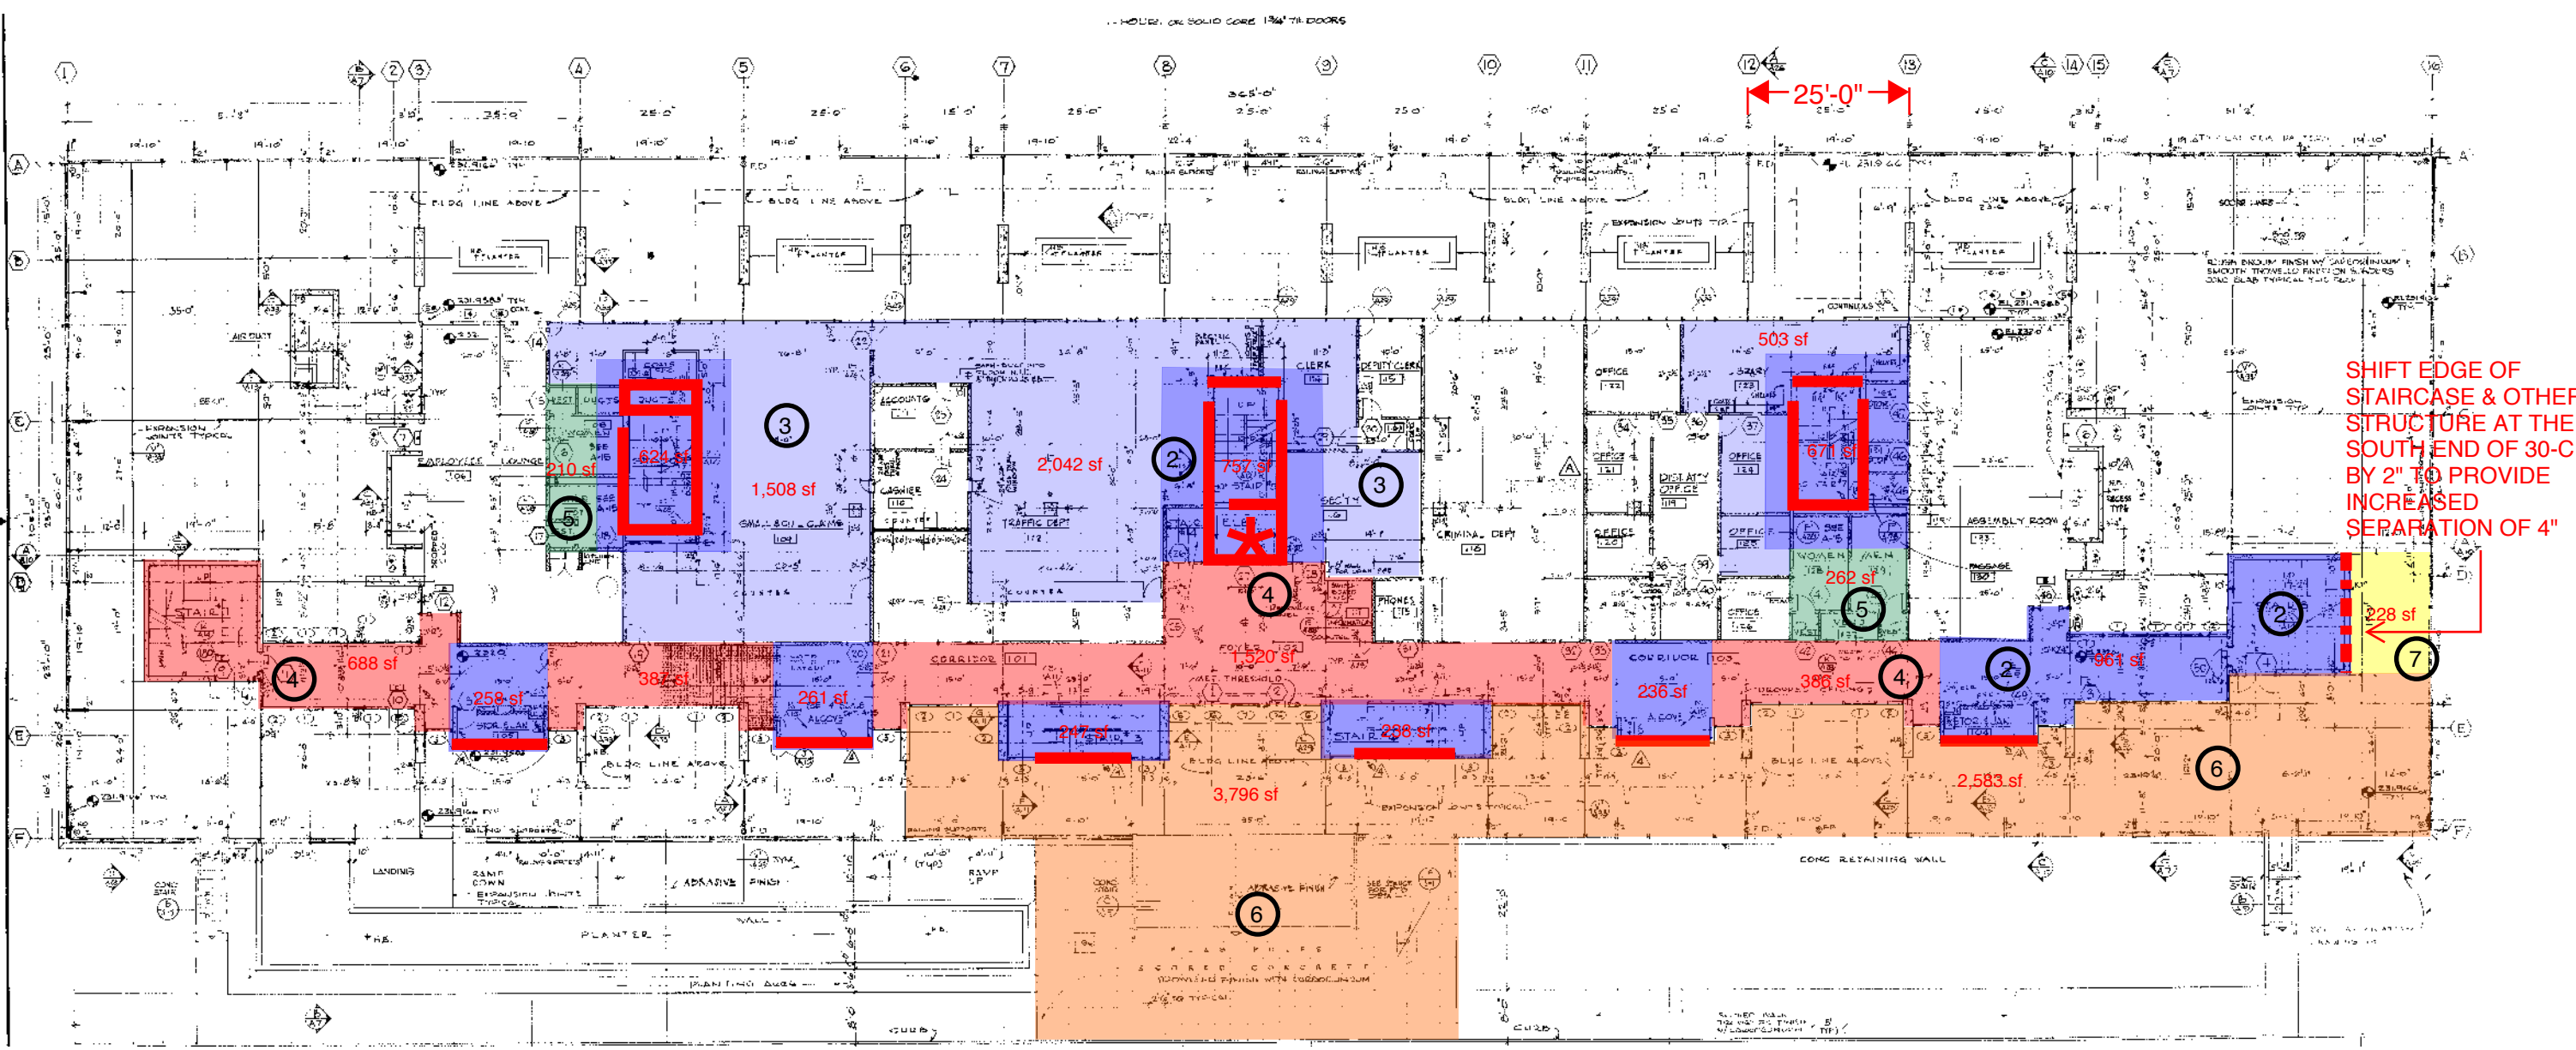
SHIFT EDGE OF STAIRCASE & OTHER STRUCTURE AT THE SOUTH END OF 30-C1 BY 2" TO PROVIDE INCREASED SEPARATION OF 4"

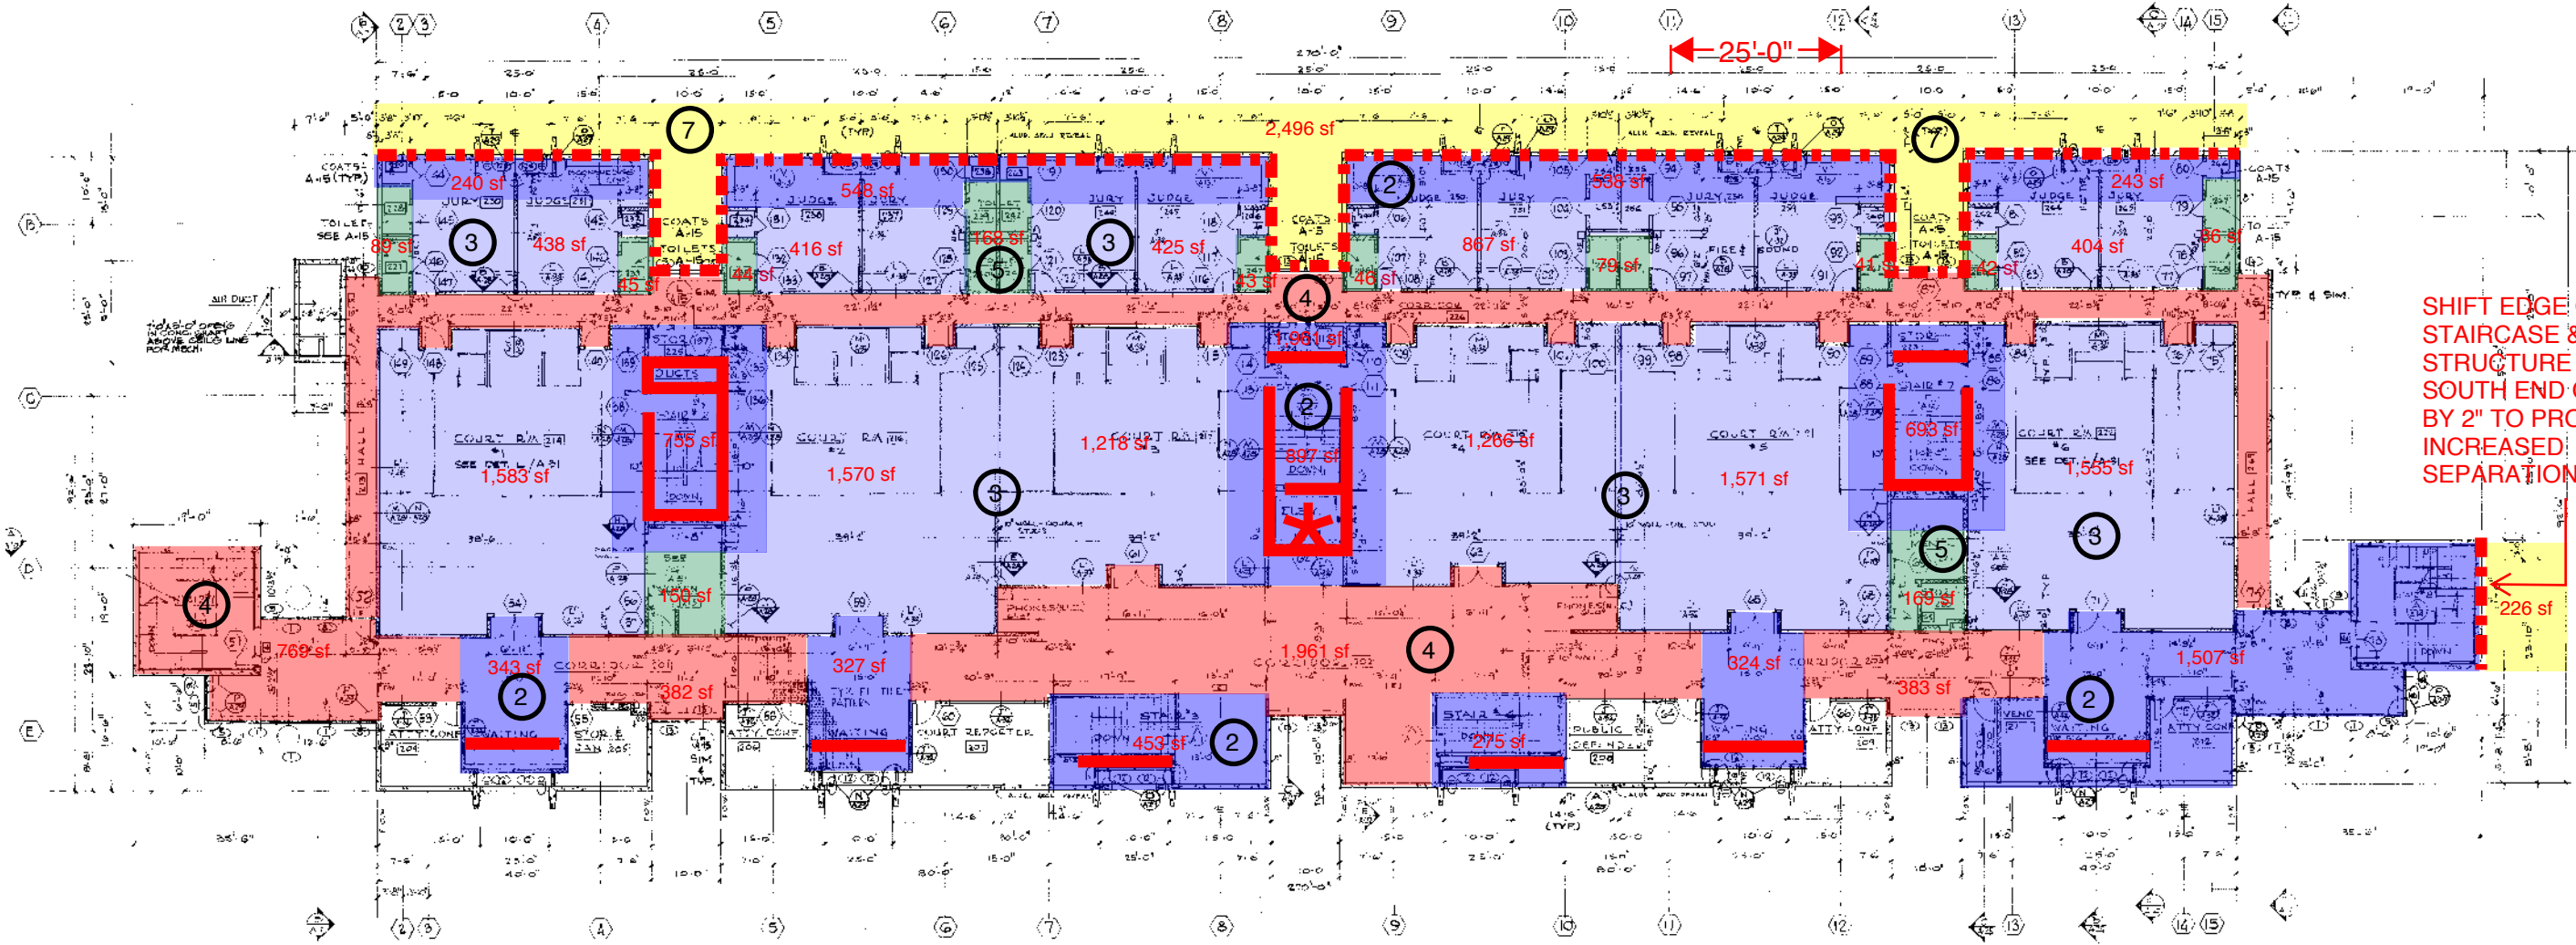
SHIFT EDGE OF STAIRCASE & OTHER STRUCTURE AT THE SOUTH END OF 30-C1 E BY 2" TO PROVIDE INCREASED SEPARATION OF 4"

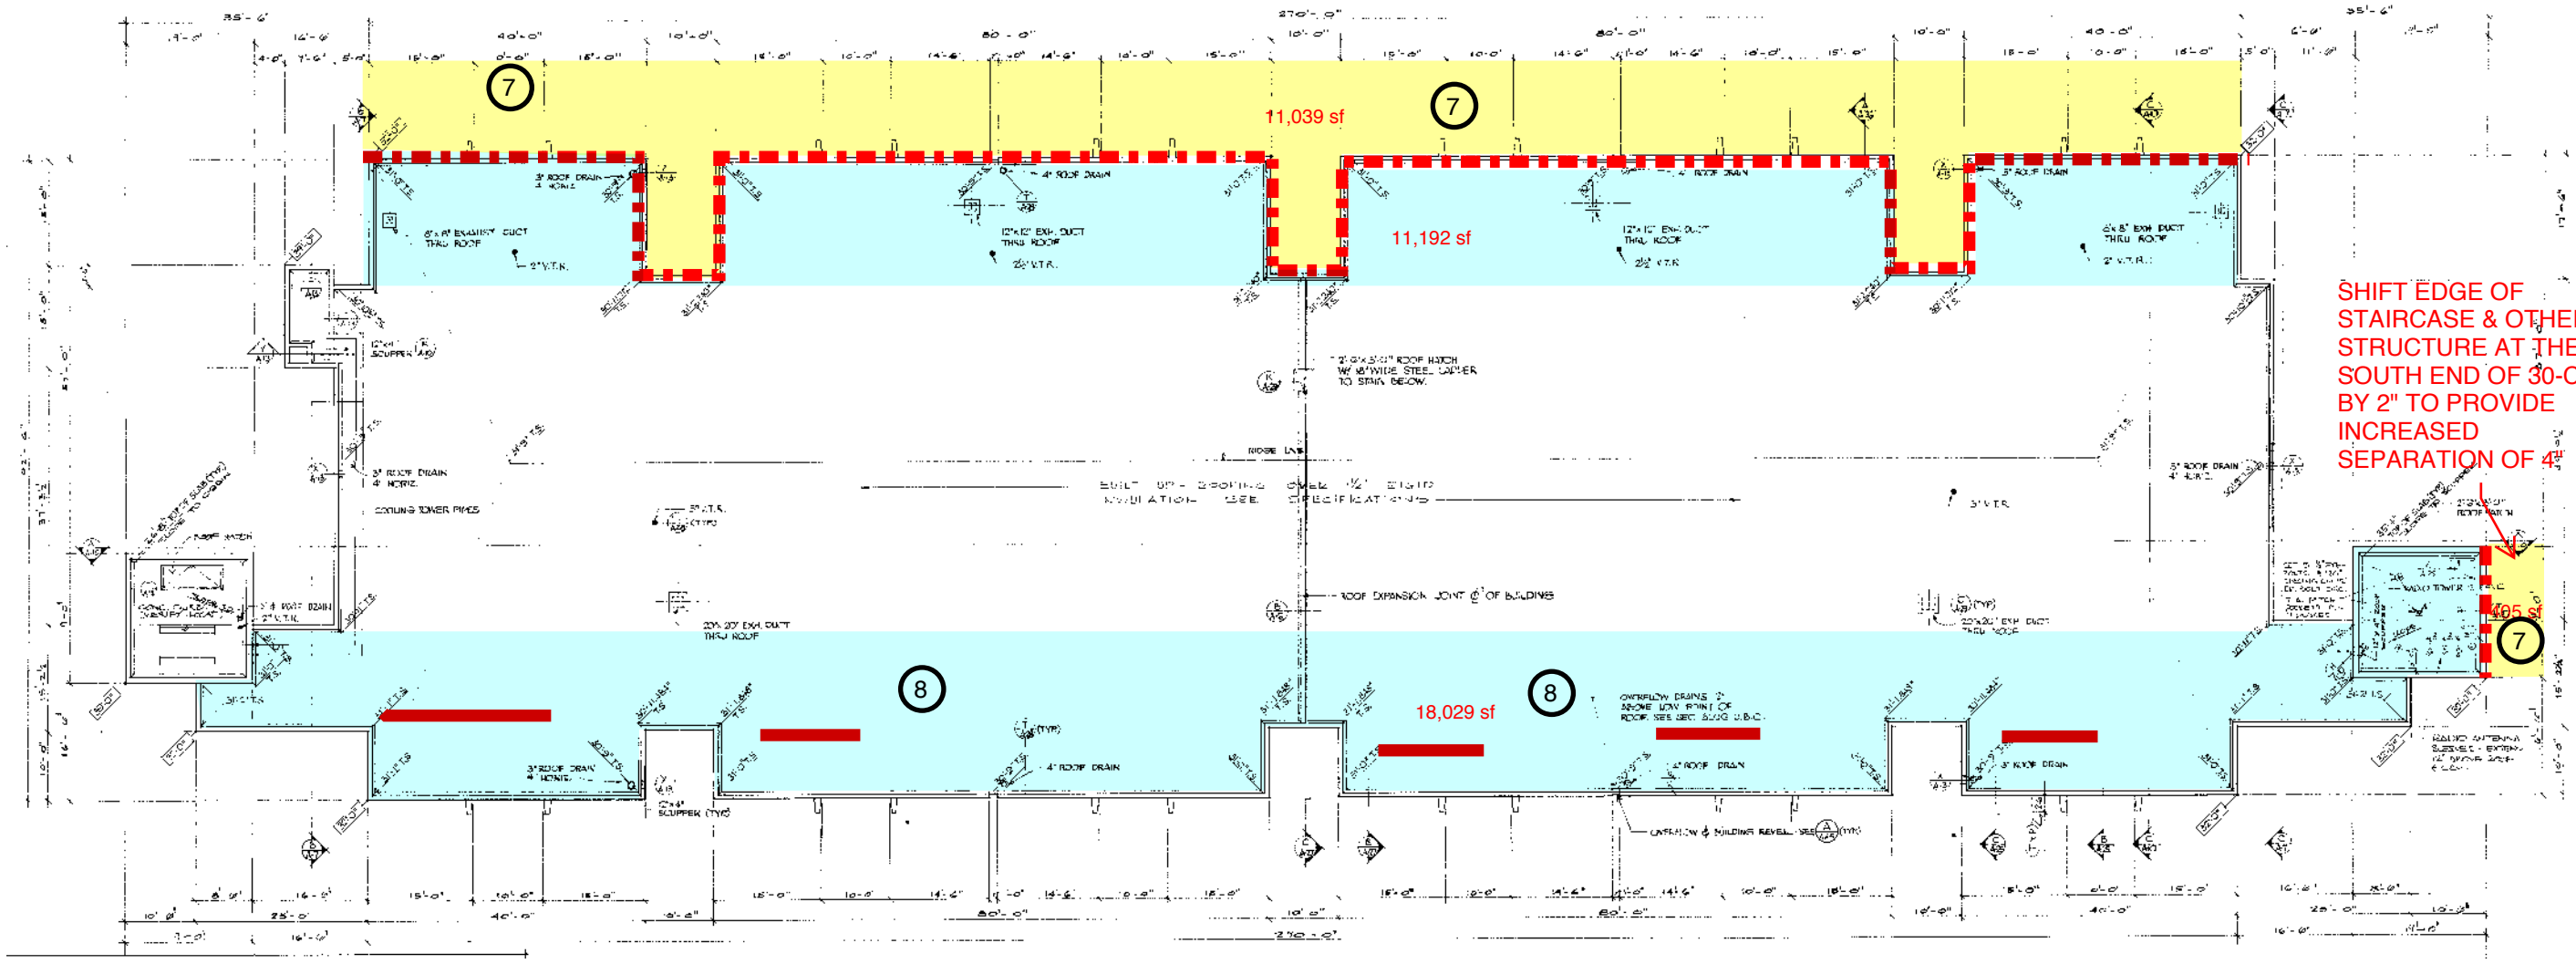
Sketch No: **A1.03 - SEG E. ROOF**

SHIFT EDGE OF STAIRCASE & OTHER STRUCTURE AT THE SOUTH END OF 30-C1 E BY 2" TO PROVIDE INCREASED SEPARATION OF 4"

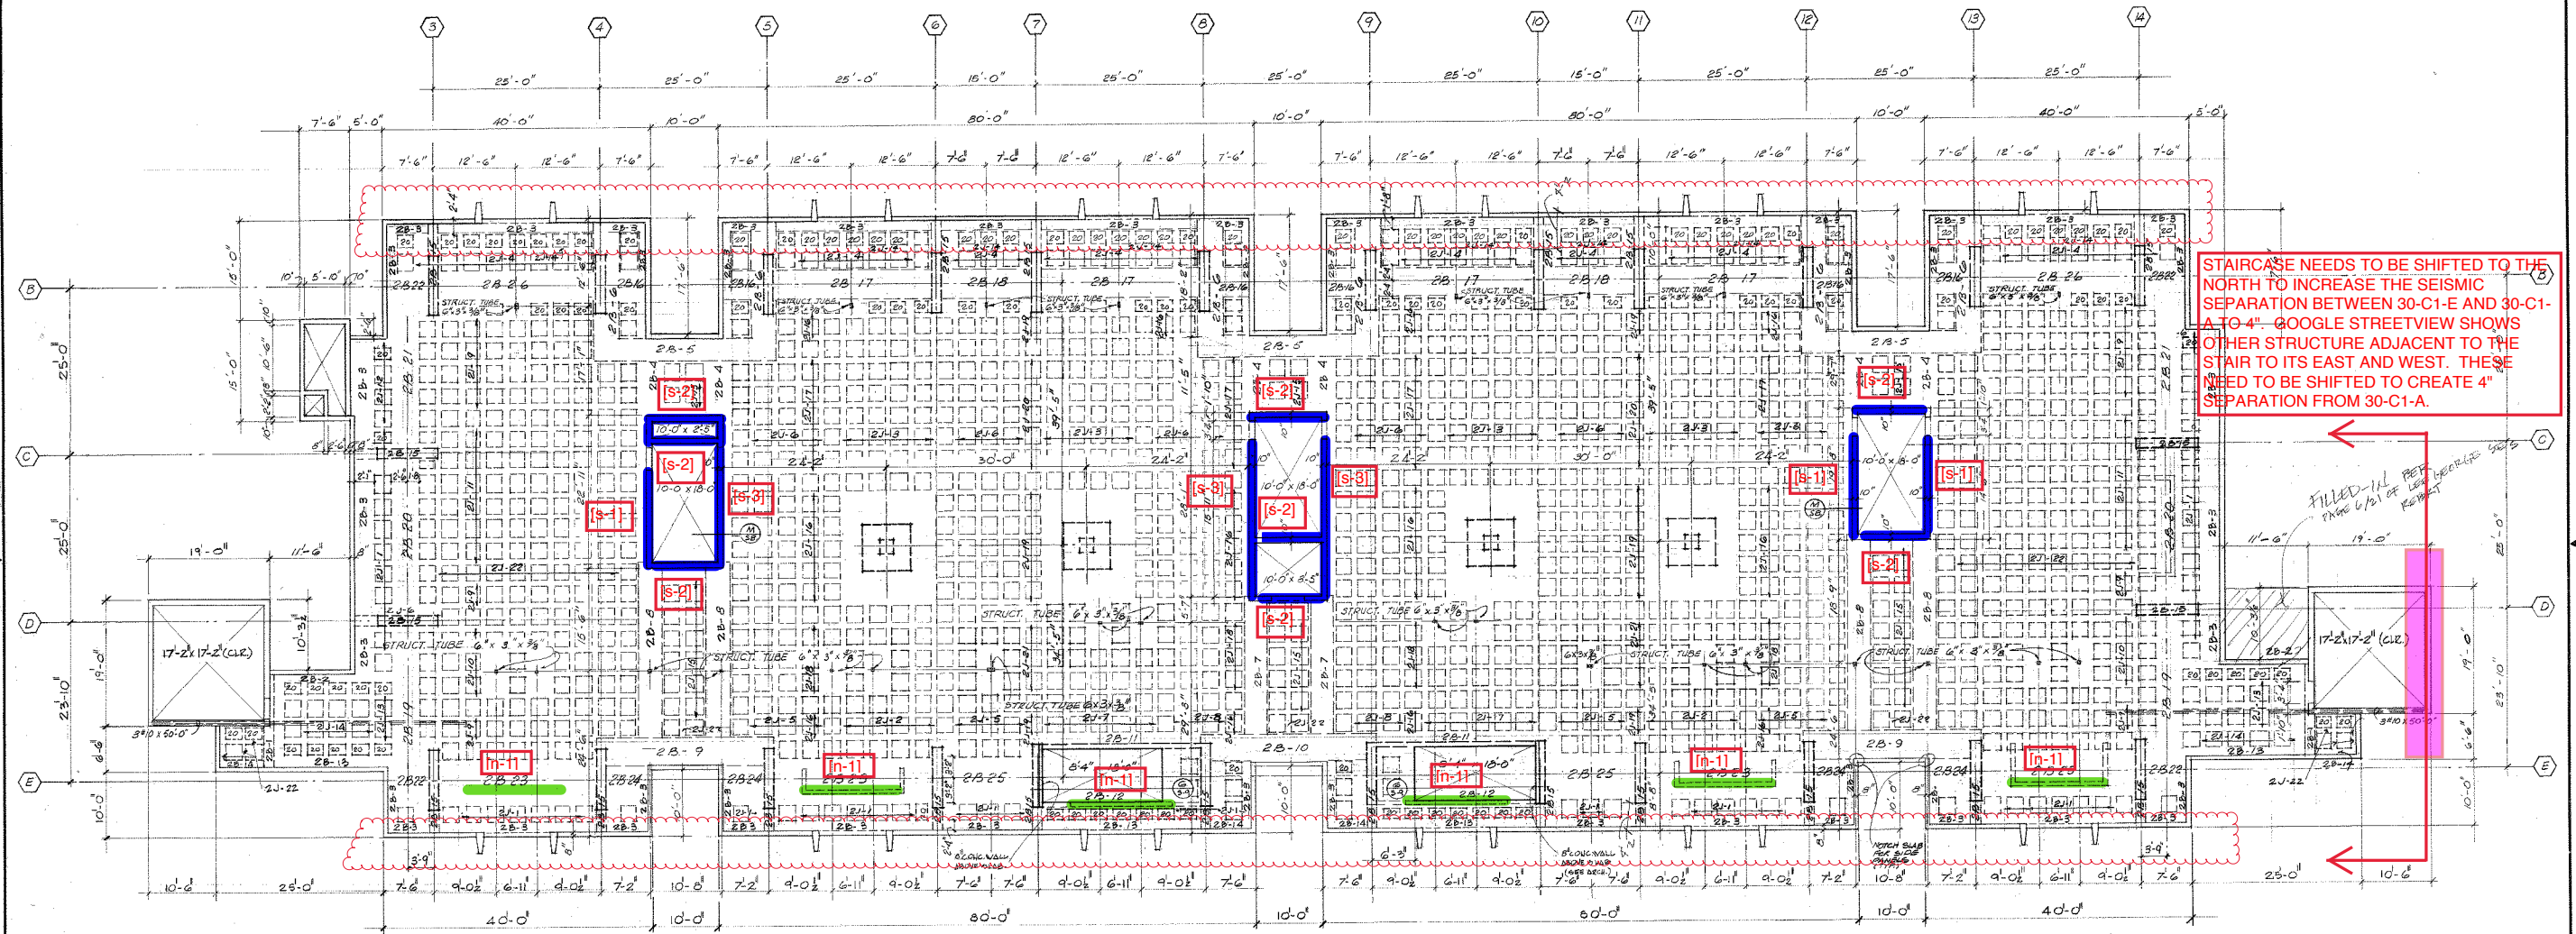
EXISTING CONCRETE SHEAR WALL TO BE STRENGTHENED

REMOVE PRECAST CONCRETE PANELS AND REPLACE WITH LIGHT-WEIGHT FACADE

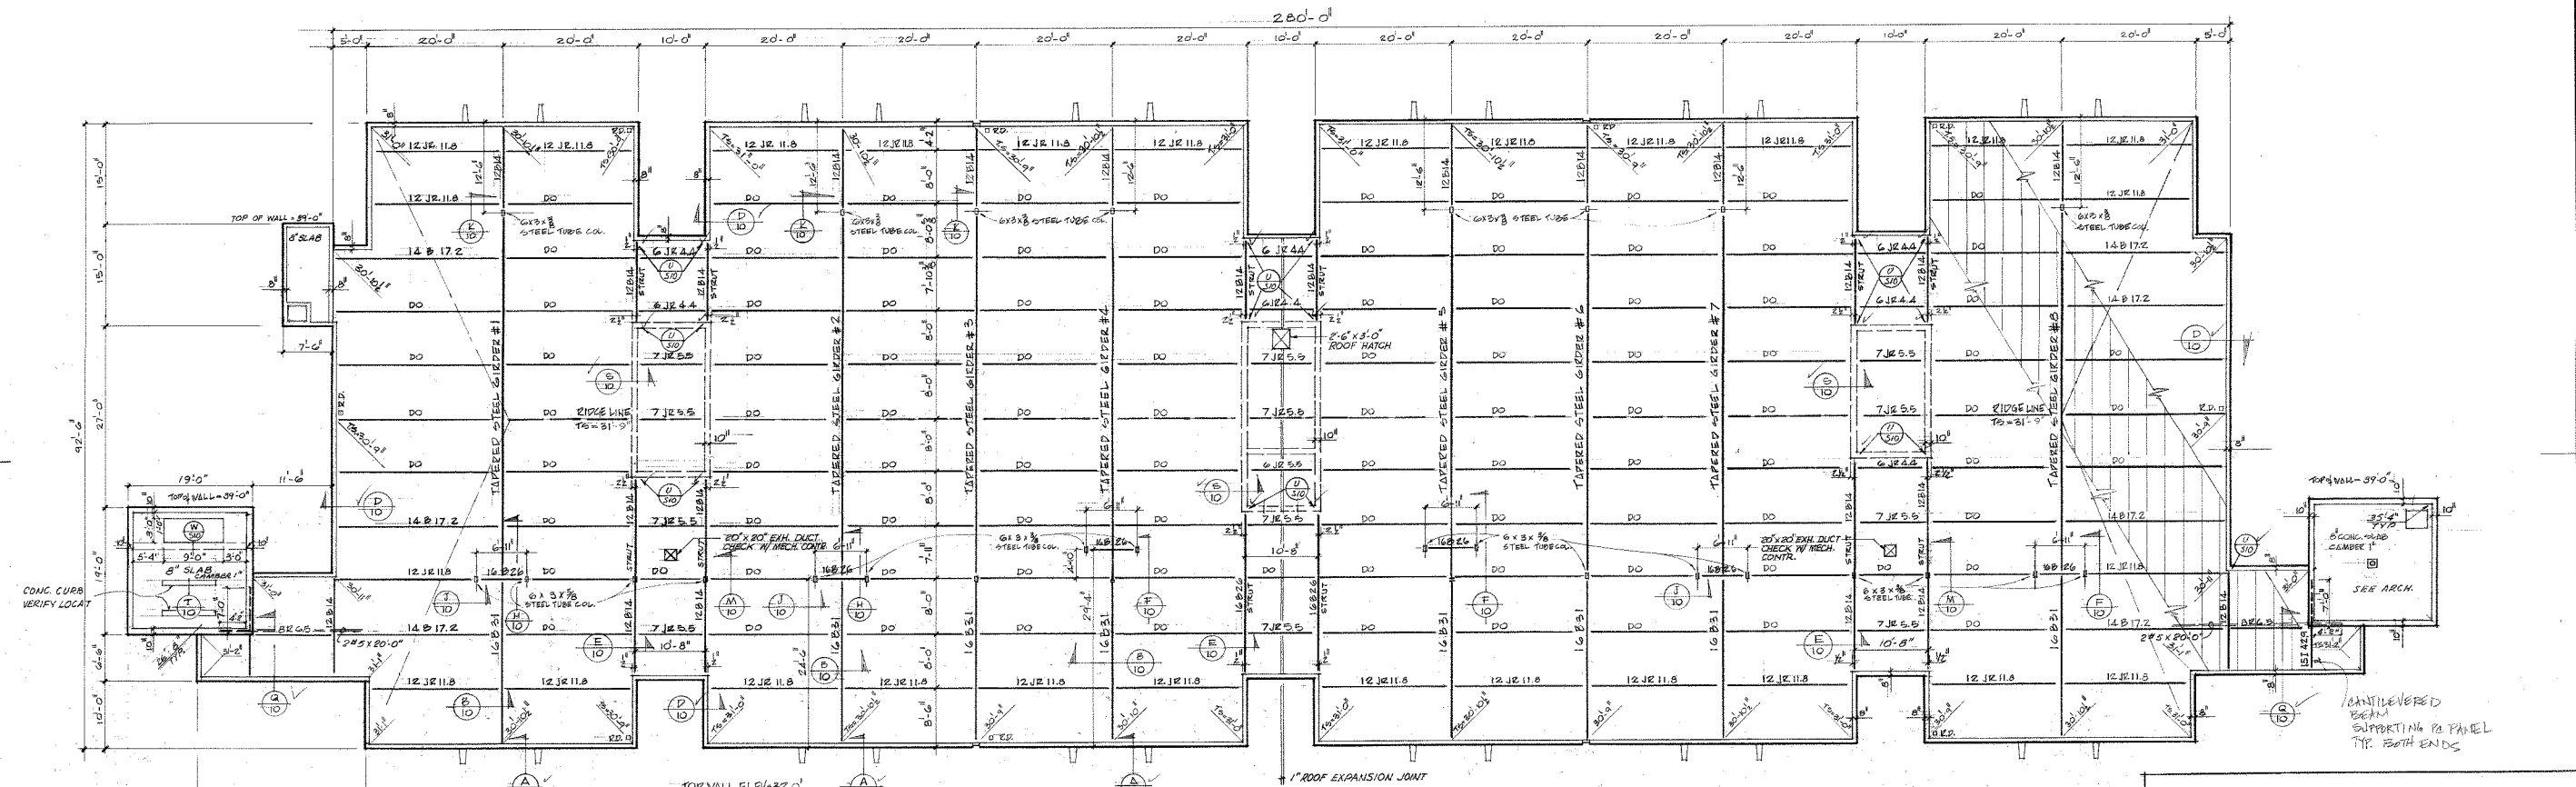
1. APPLY THE RETROFIT MEASURES SHOWN ON SECOND FLOOR PLAN (EXTEND ALL THE WALLS SHOWN ON SECOND FLOOR UP TO ROOF).

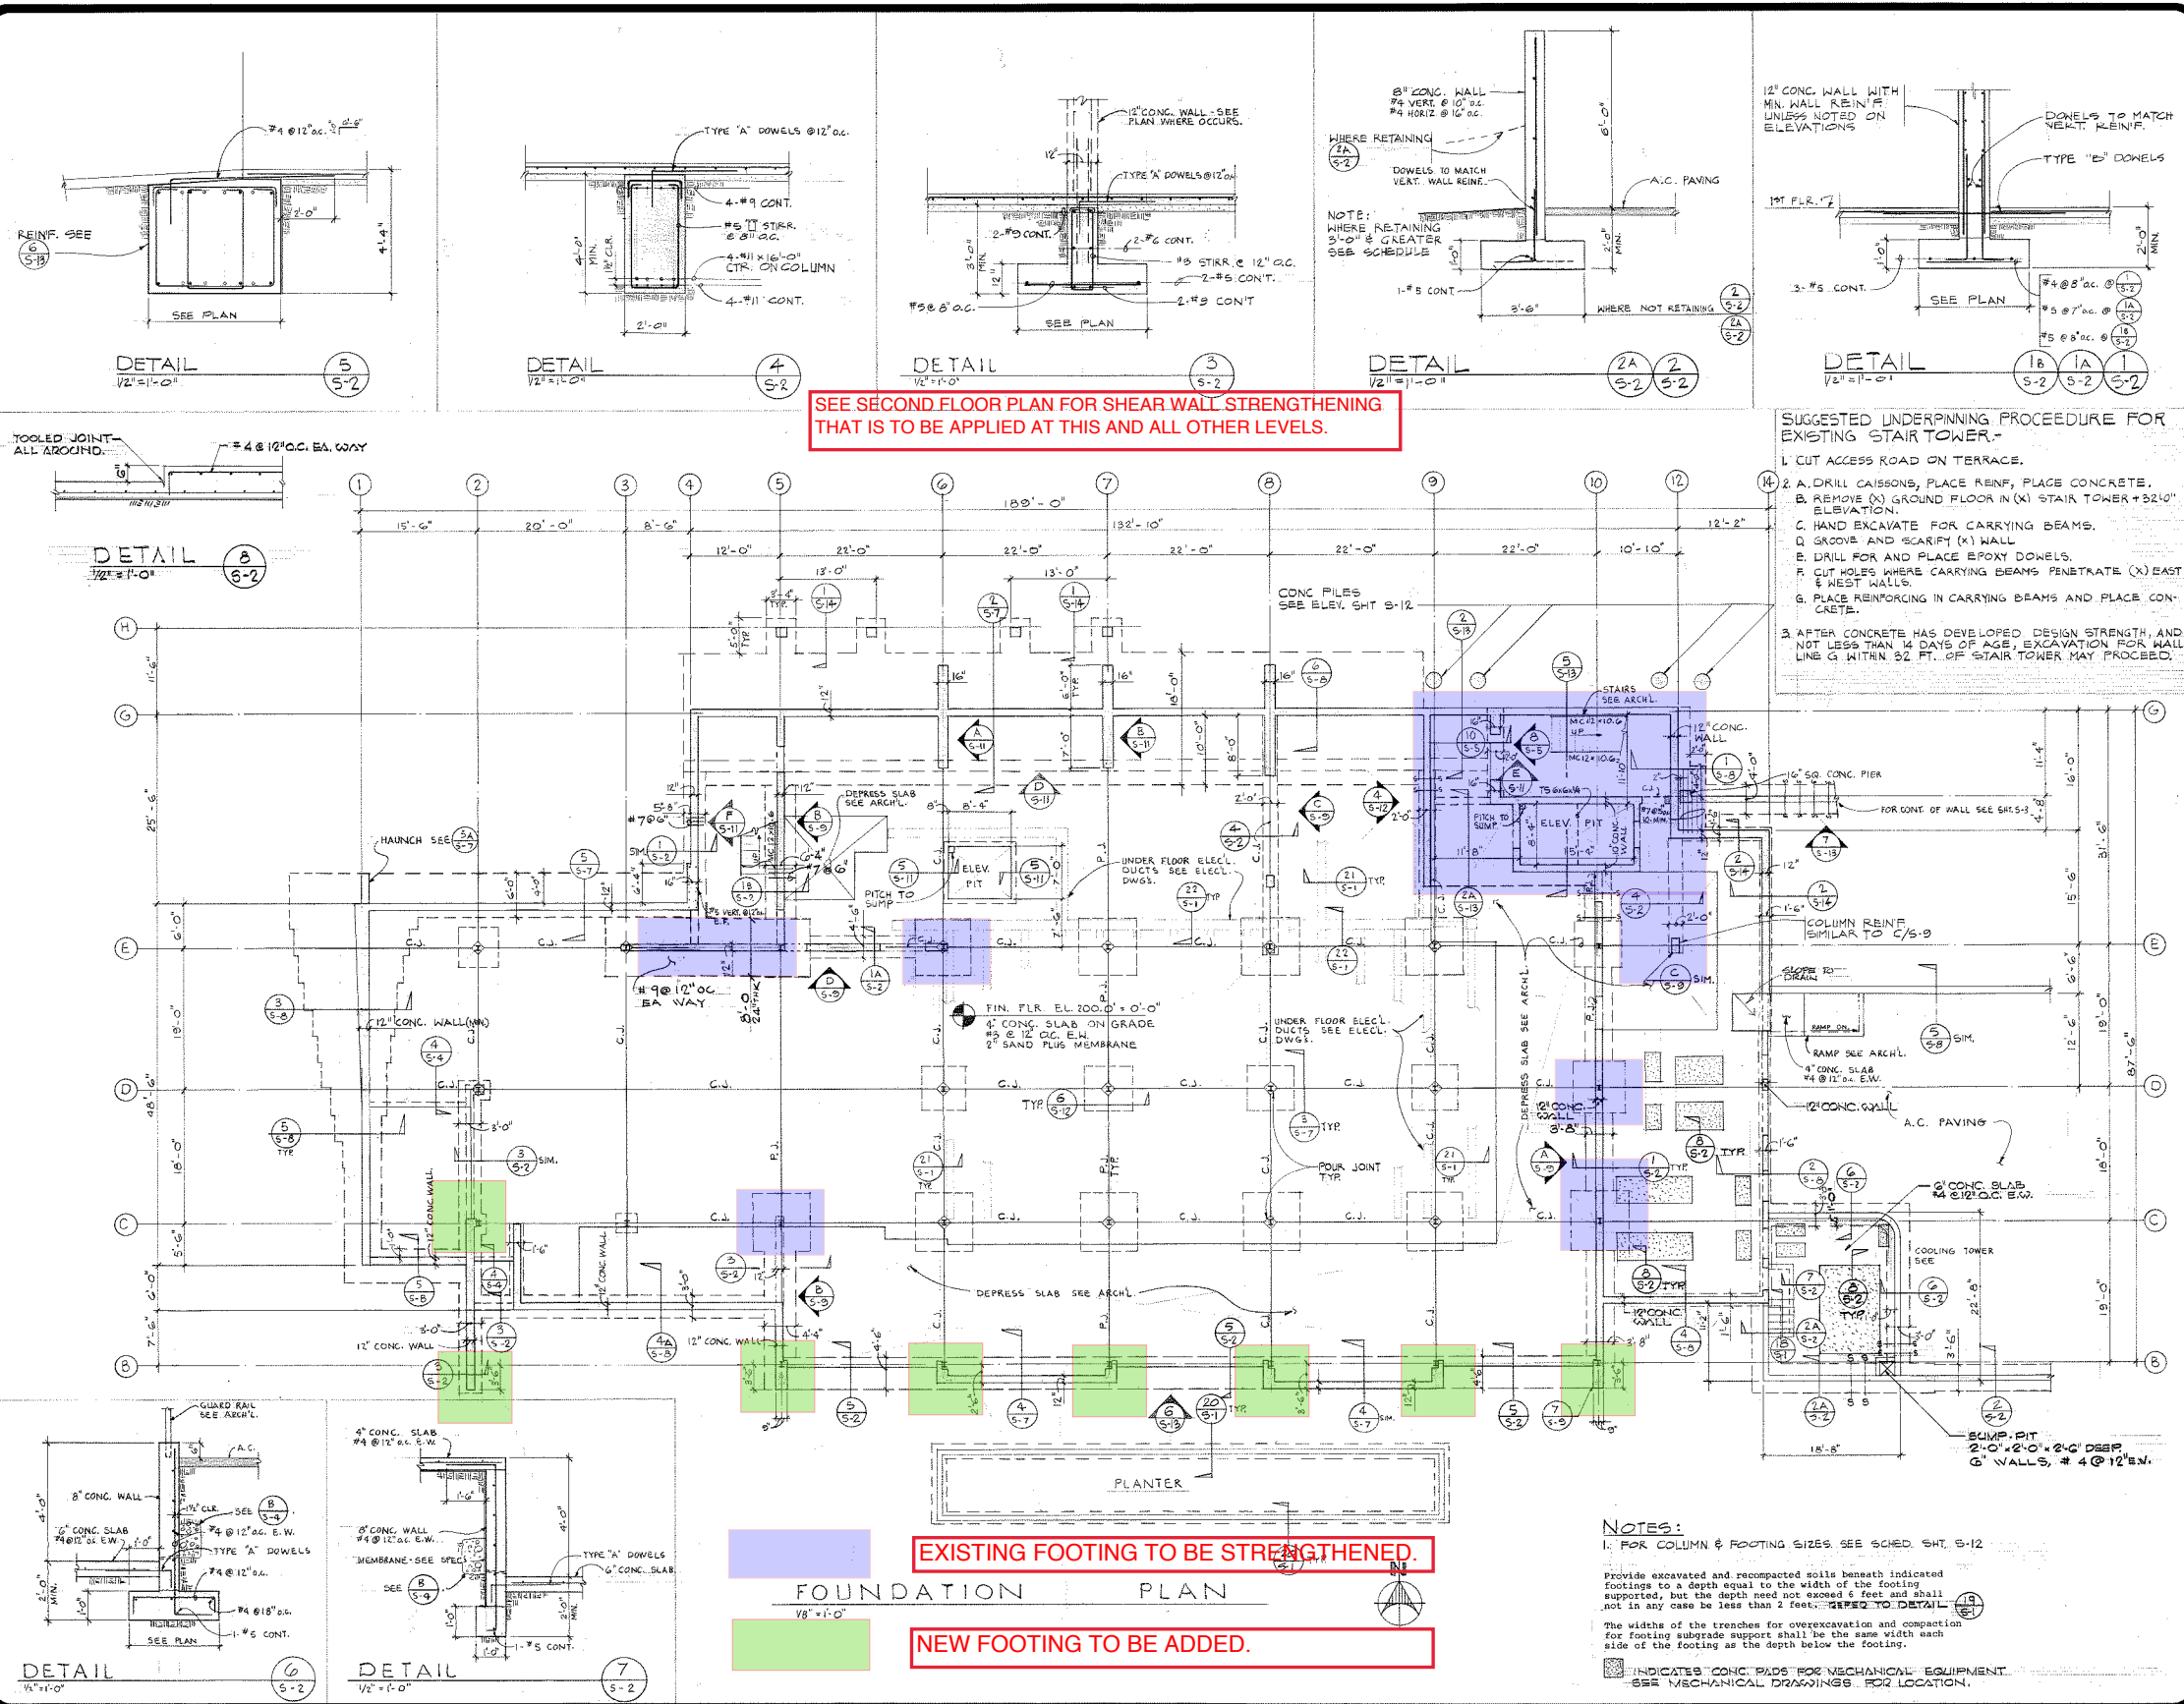
SEE SECOND FLOOR PLAN FOR SHEAR WALL STRENGTHENING THAT IS TO BE APPLIED AT THIS AND ALL OTHER LEVELS.

EXISTING FOOTING TO BE STRENGTHENED.

3	New foundations underneath retrofitted walls.	Add continuous footing underneath retrofitted walls per detail Fig. 23.6.2-1 of FEMA-547 (Detail 4).
4	Square footings at wall ends. Existing continuous strip footing below walls not adequate because of soil bearing overstress. To be confirmed by Geotechnical Investigation.	Add square footings at wall ends to supplement existing continuous wall footing at the locations shown on plan markup. Make allowance for (8)-15'x15'x3' square footings with 2% bottom reinforcement each way and 0.2% top reinforcement each way. Additionally, make allowance for widening spread footings marked on foundation plan by 5' and deepening by 1' with an added layer of #5@12" o.c. bottom reinforcement.
5	Combined spread footing under existing walls between grids 9-12 and E-G. Existing combined spread footing below walls not adequate because of soil bearing overstress. To be confirmed by Geotechnical Investigation.	Widen by 5', deepen by 2', and strengthen by adding a bottom layer of #5@12" rebar underneath existing combined spread footing at the North-East corner stair/elevator core (see Detail 6).
