Seismic Renovation Project Feasibility Report

**NORTH JUSTICE CENTER
30-C1 C2**

1275 N. BERKELEY AVE.,
FULLERTON

PREPARED BY ARUP
JANUARY 22, 2019

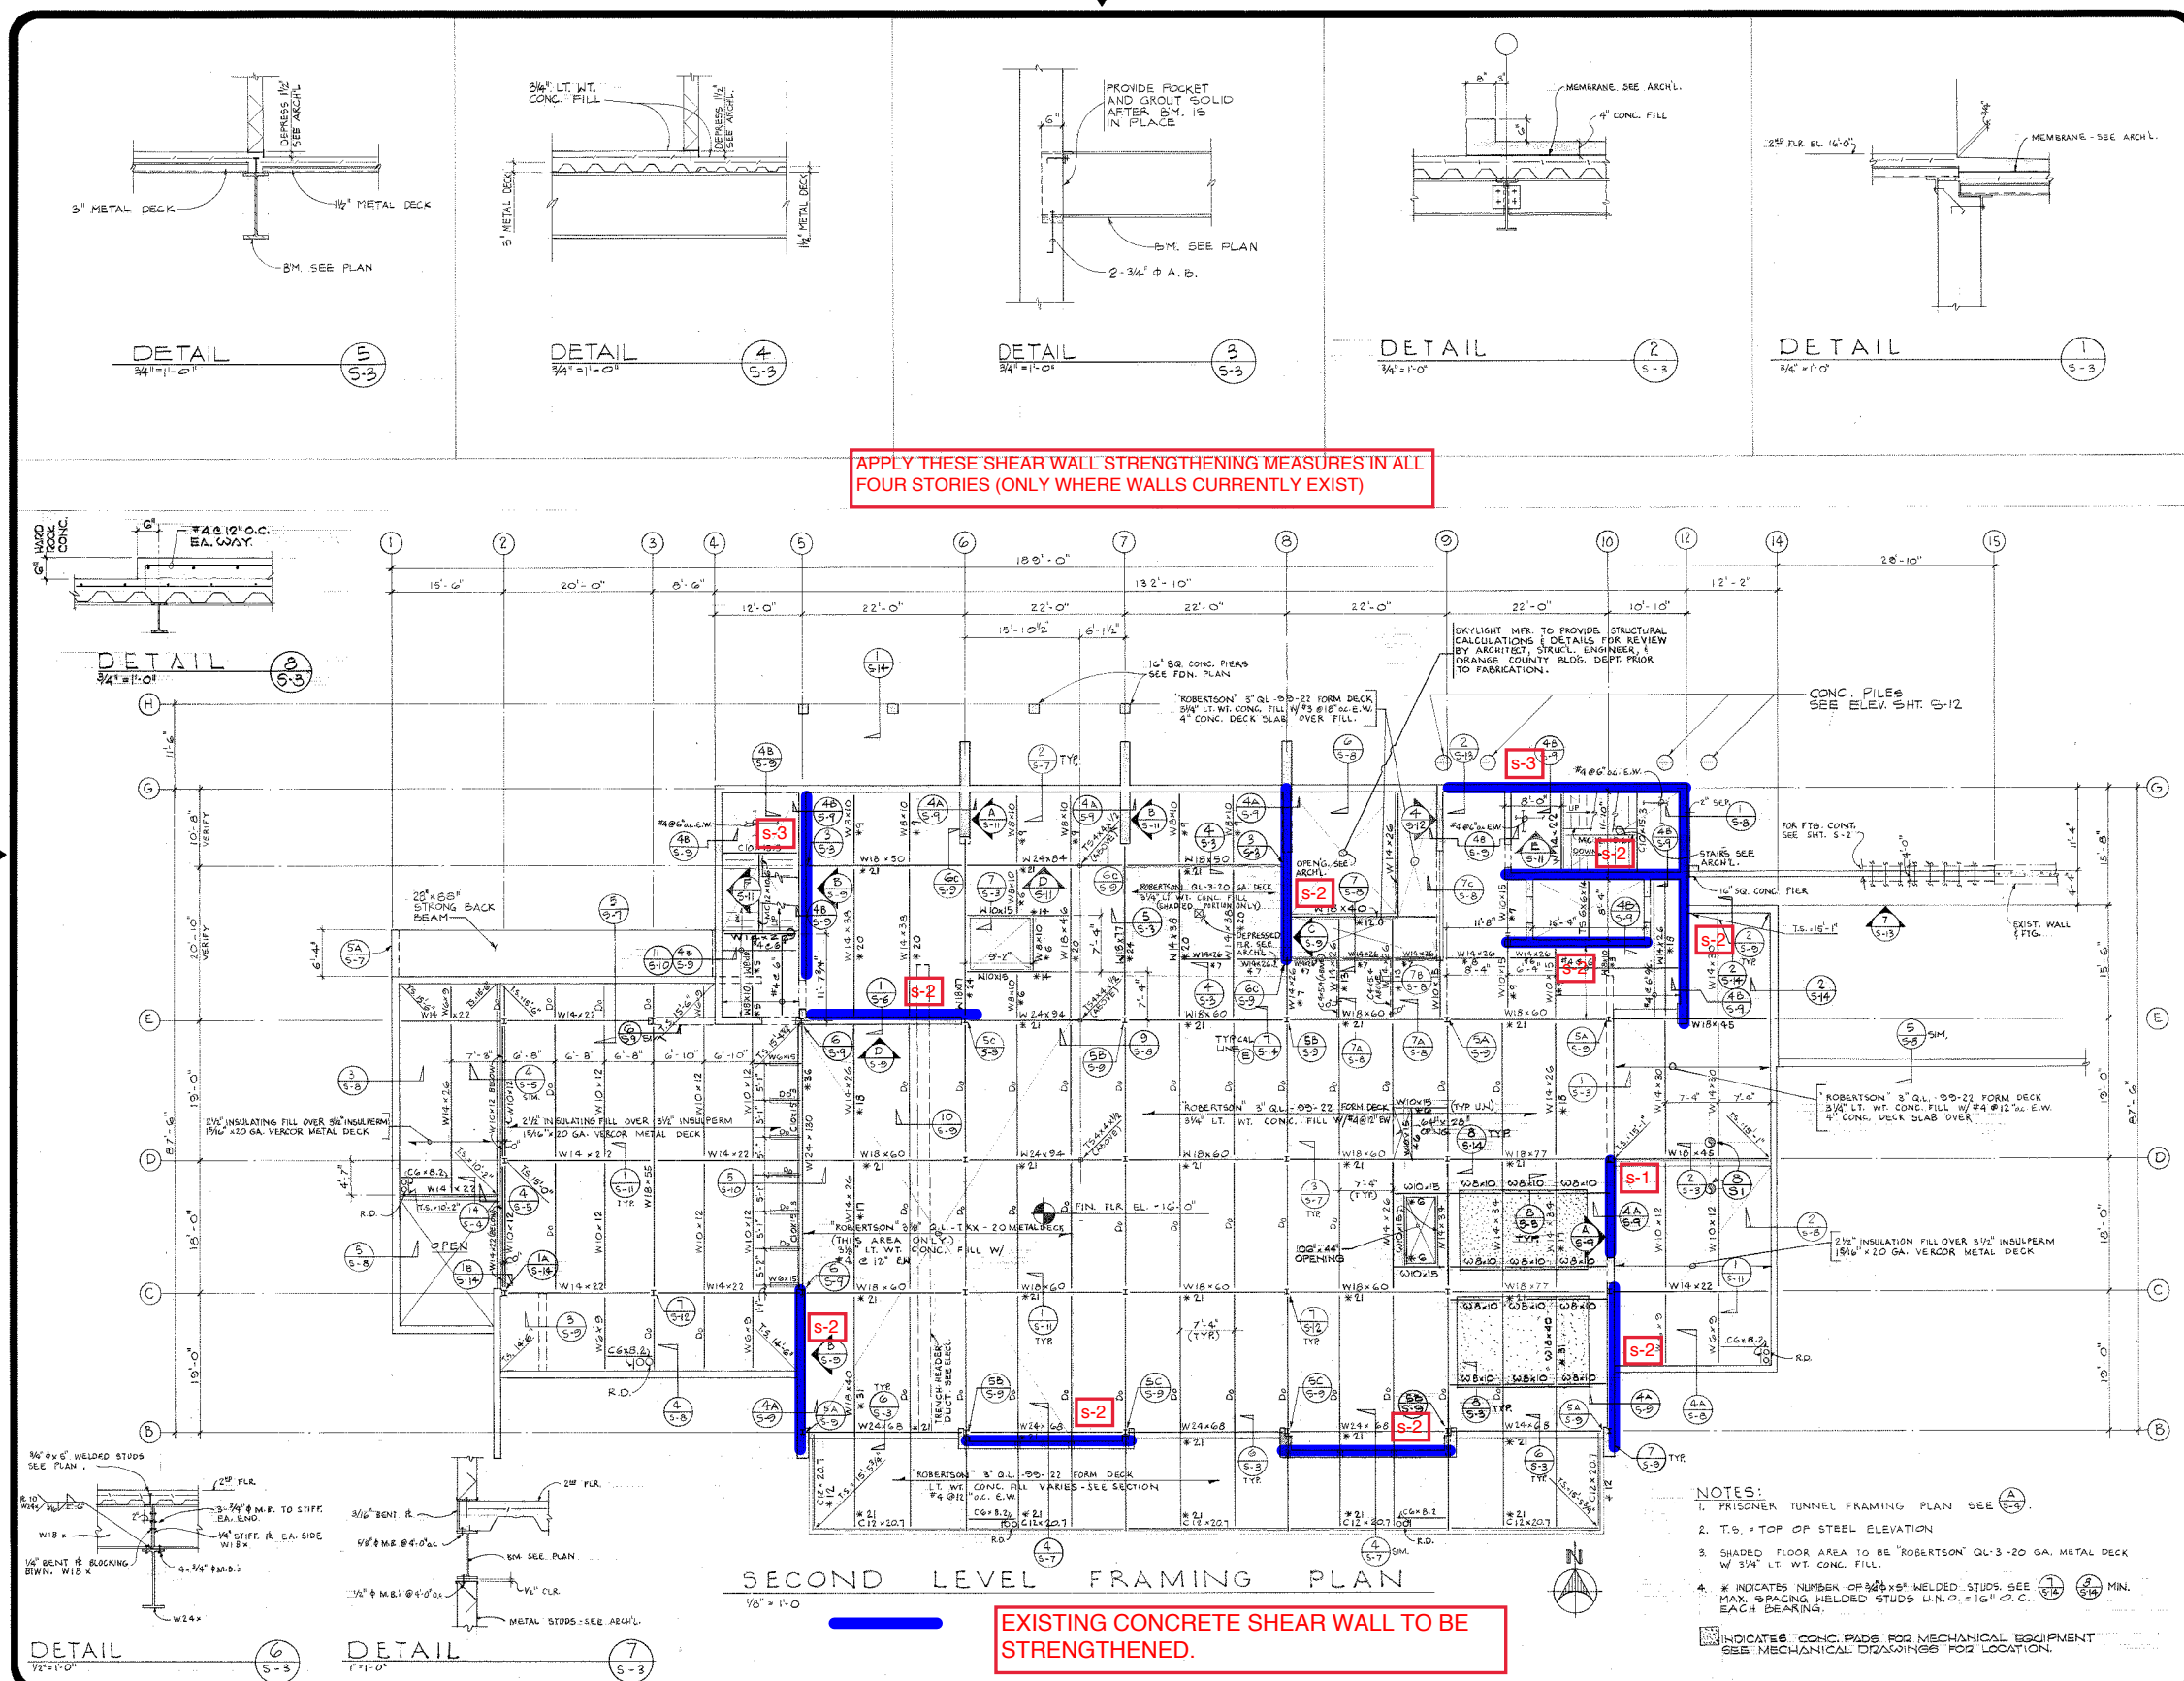
APPLY THESE SHEAR WALL STRENGTHENING MEASURES IN ALL FOUR STORIES (ONLY WHERE WALLS CURRENTLY EXIST)

EXISTING CONCRETE SHEAR WALL TO BE STRENGTHENED.

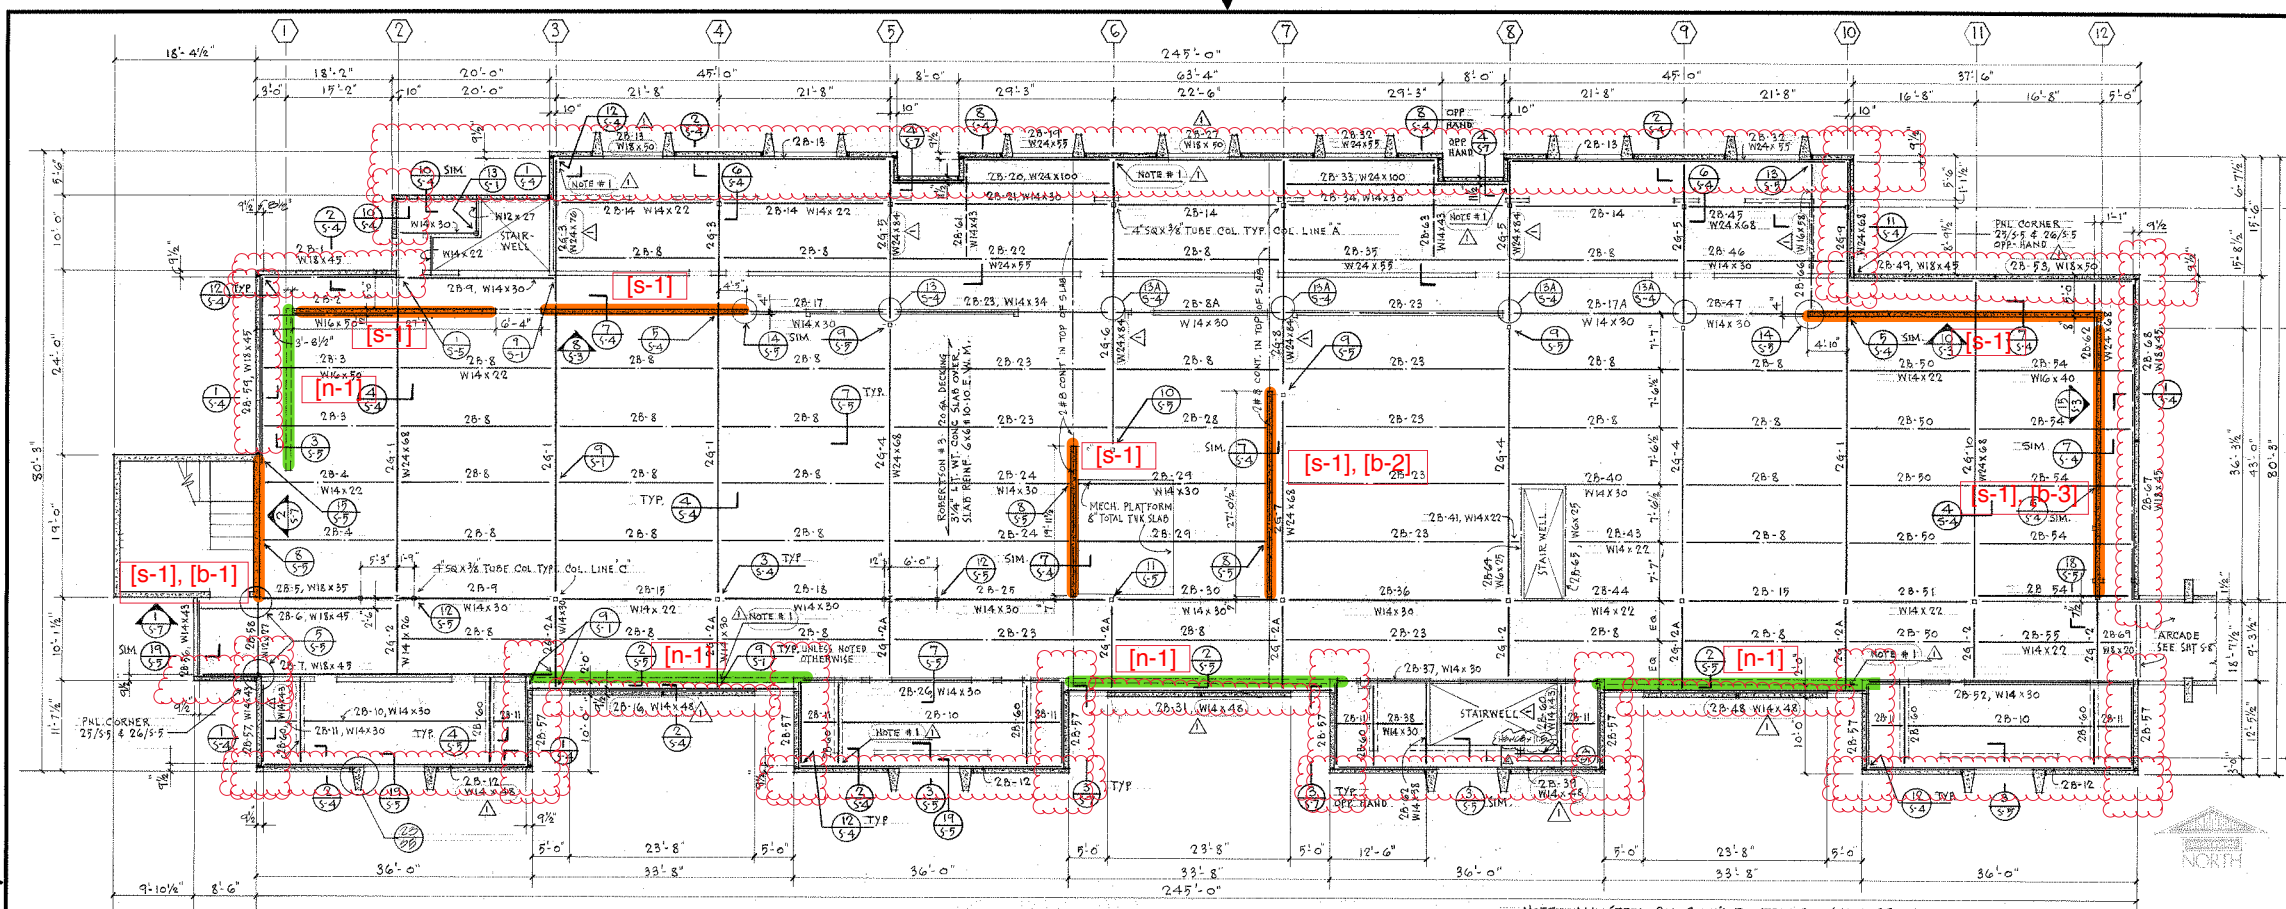
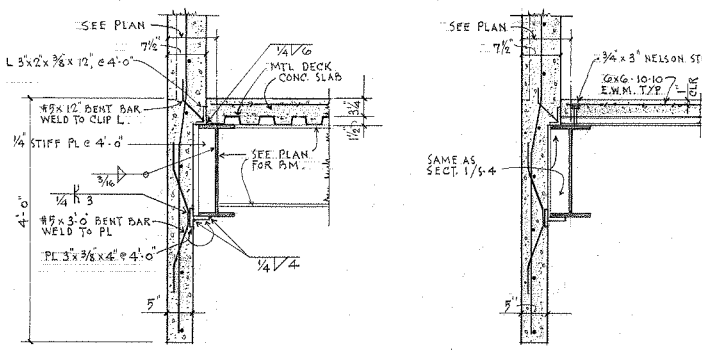
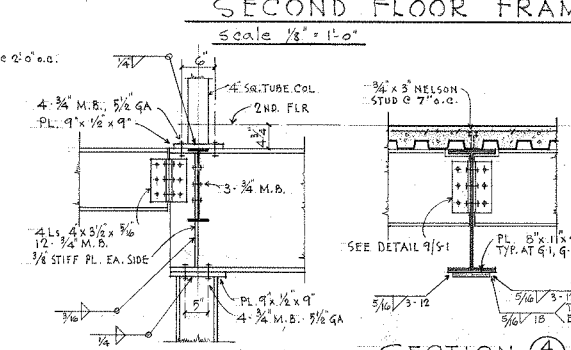
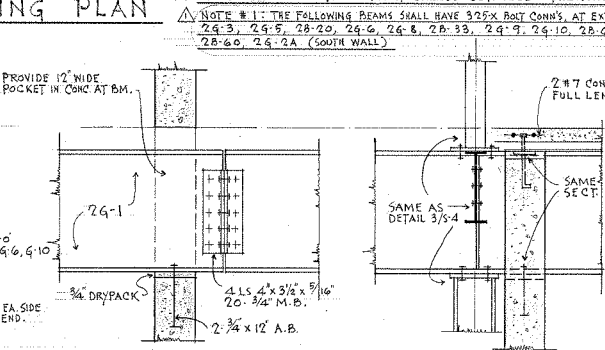
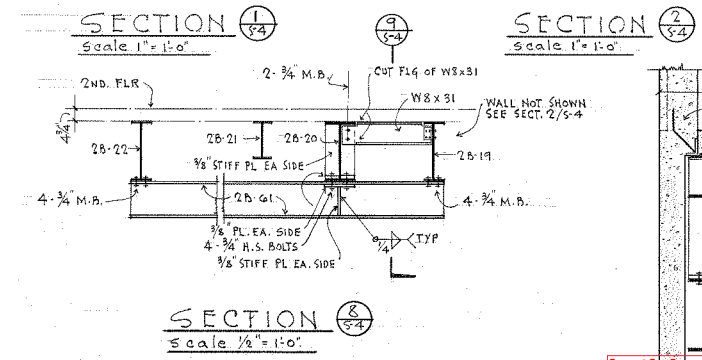
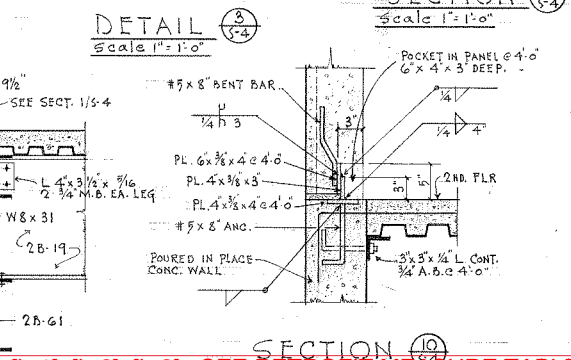
SECOND FLOOR FRAMING PLAN
Scale 1/8" = 1'-0"

[n-1], [s-1], [b-1], [b-2], [b-3]: SEE RETROFIT MEASURE TABLE
EXISTING CONCRETE SHEAR WALL TO BE STRENGTHENED

REMOVE PRECAST CONCRETE PANELS AND REPLACE WITH LIGHT-WEIGHT FACADE
NEW CONCRETE SHEAR WALL TO BE ADDED

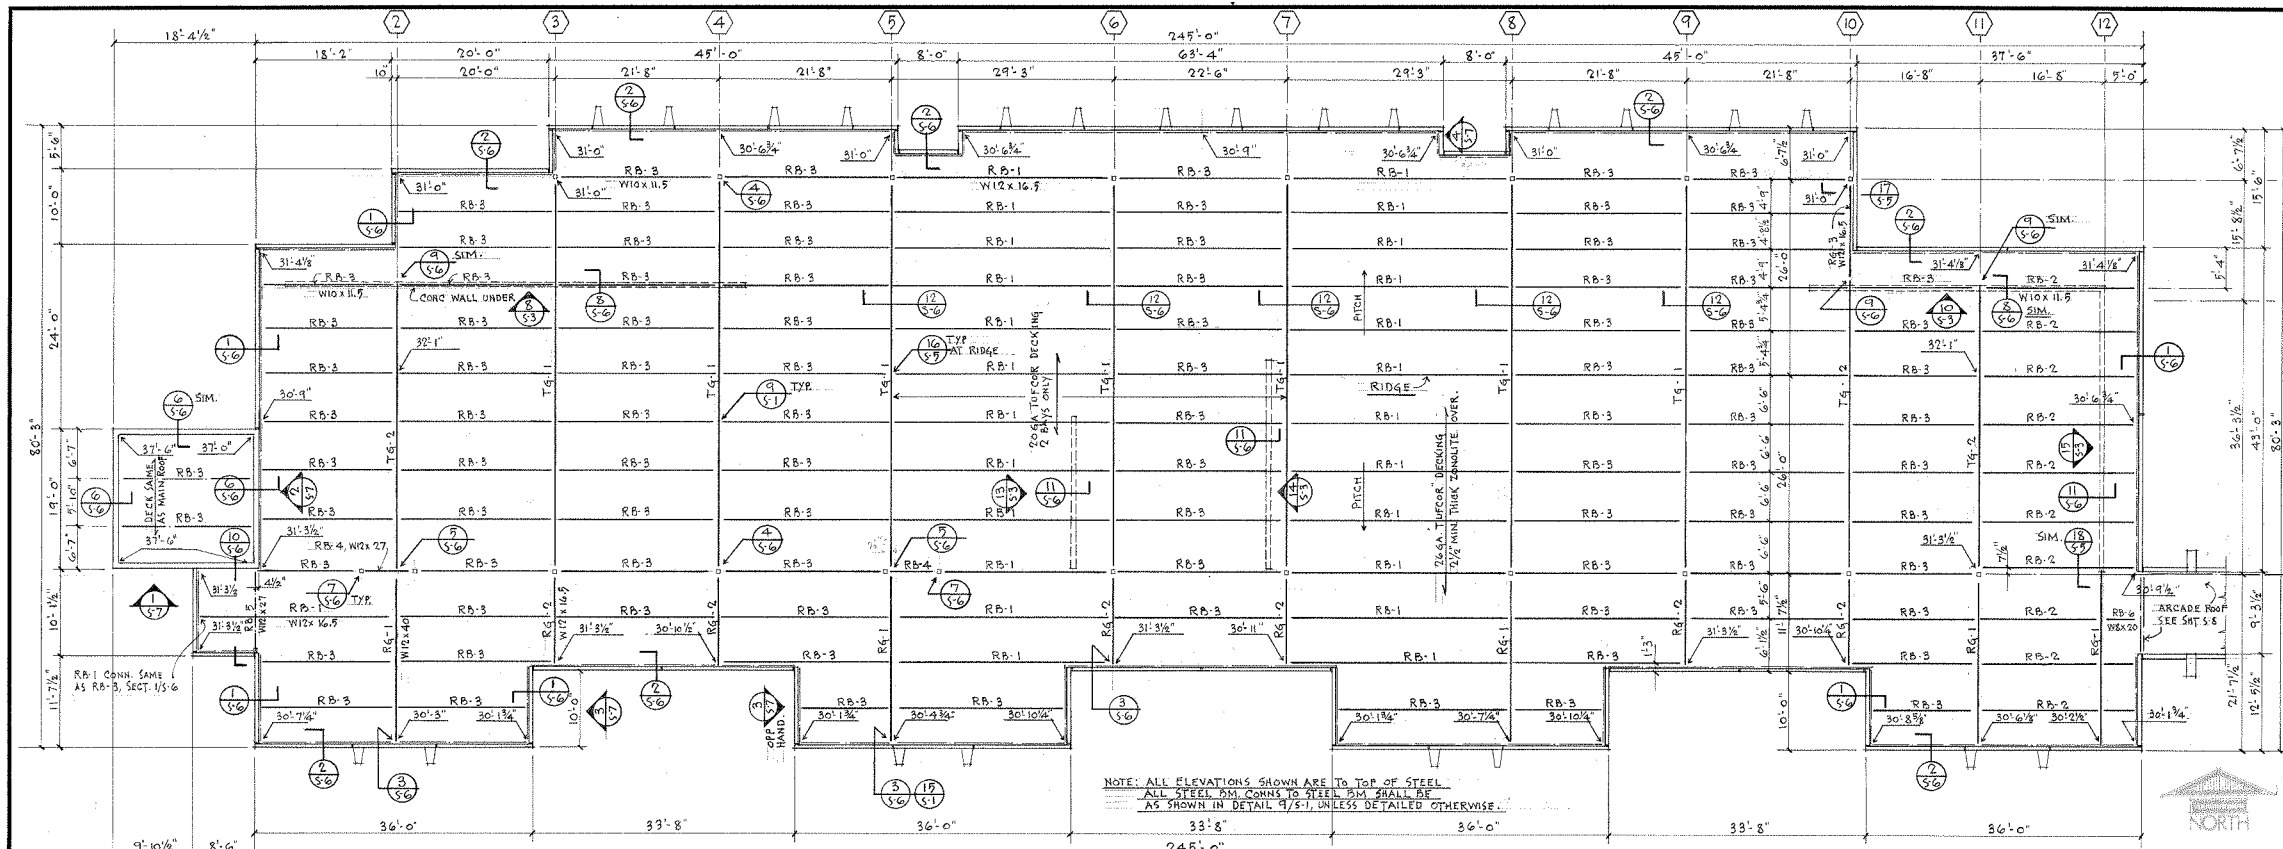
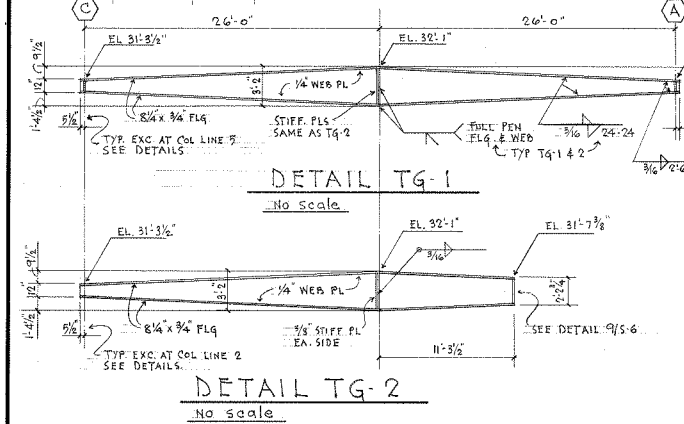
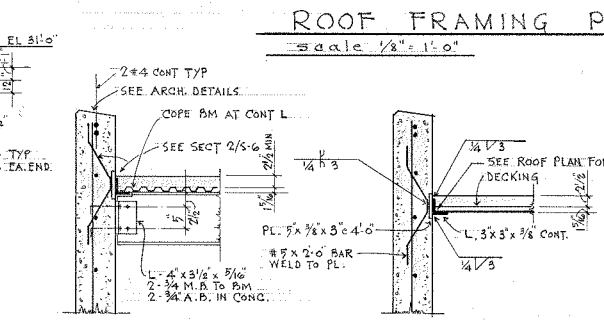
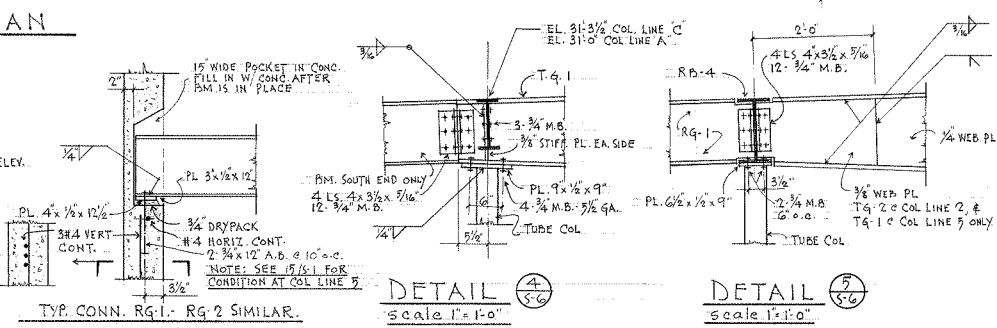
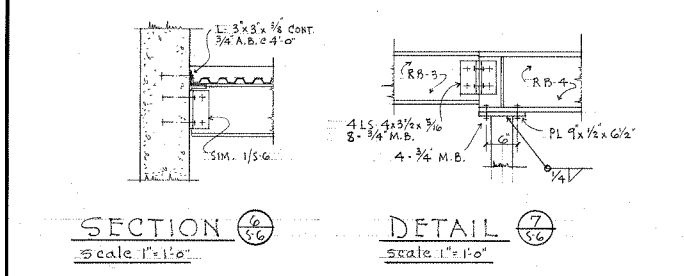
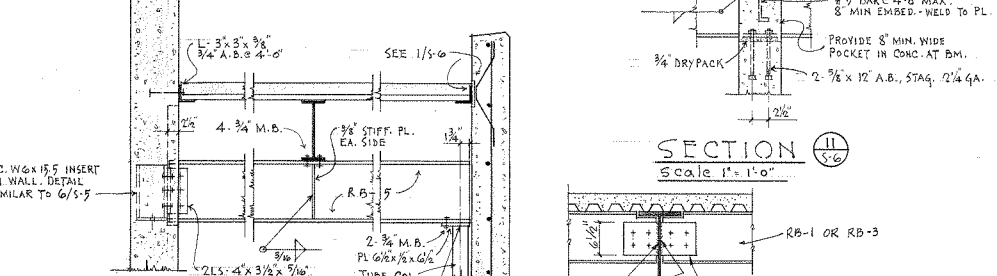
ROOF FRAMING PLAN
Scale 1/8" = 1'-0"

1. APPLY THE RETROFIT MEASURES SHOWN ON SECOND FLOOR PLAN (EXTEND ALL THE WALLS SHOWN ON SECOND FLOOR UP TO ROOF).
2. ADD AN FRP LAYER TO THE ROOF DIAPHRAGM AND ATTACH IT TO THE EXISTING ZONOLITE LAYER.

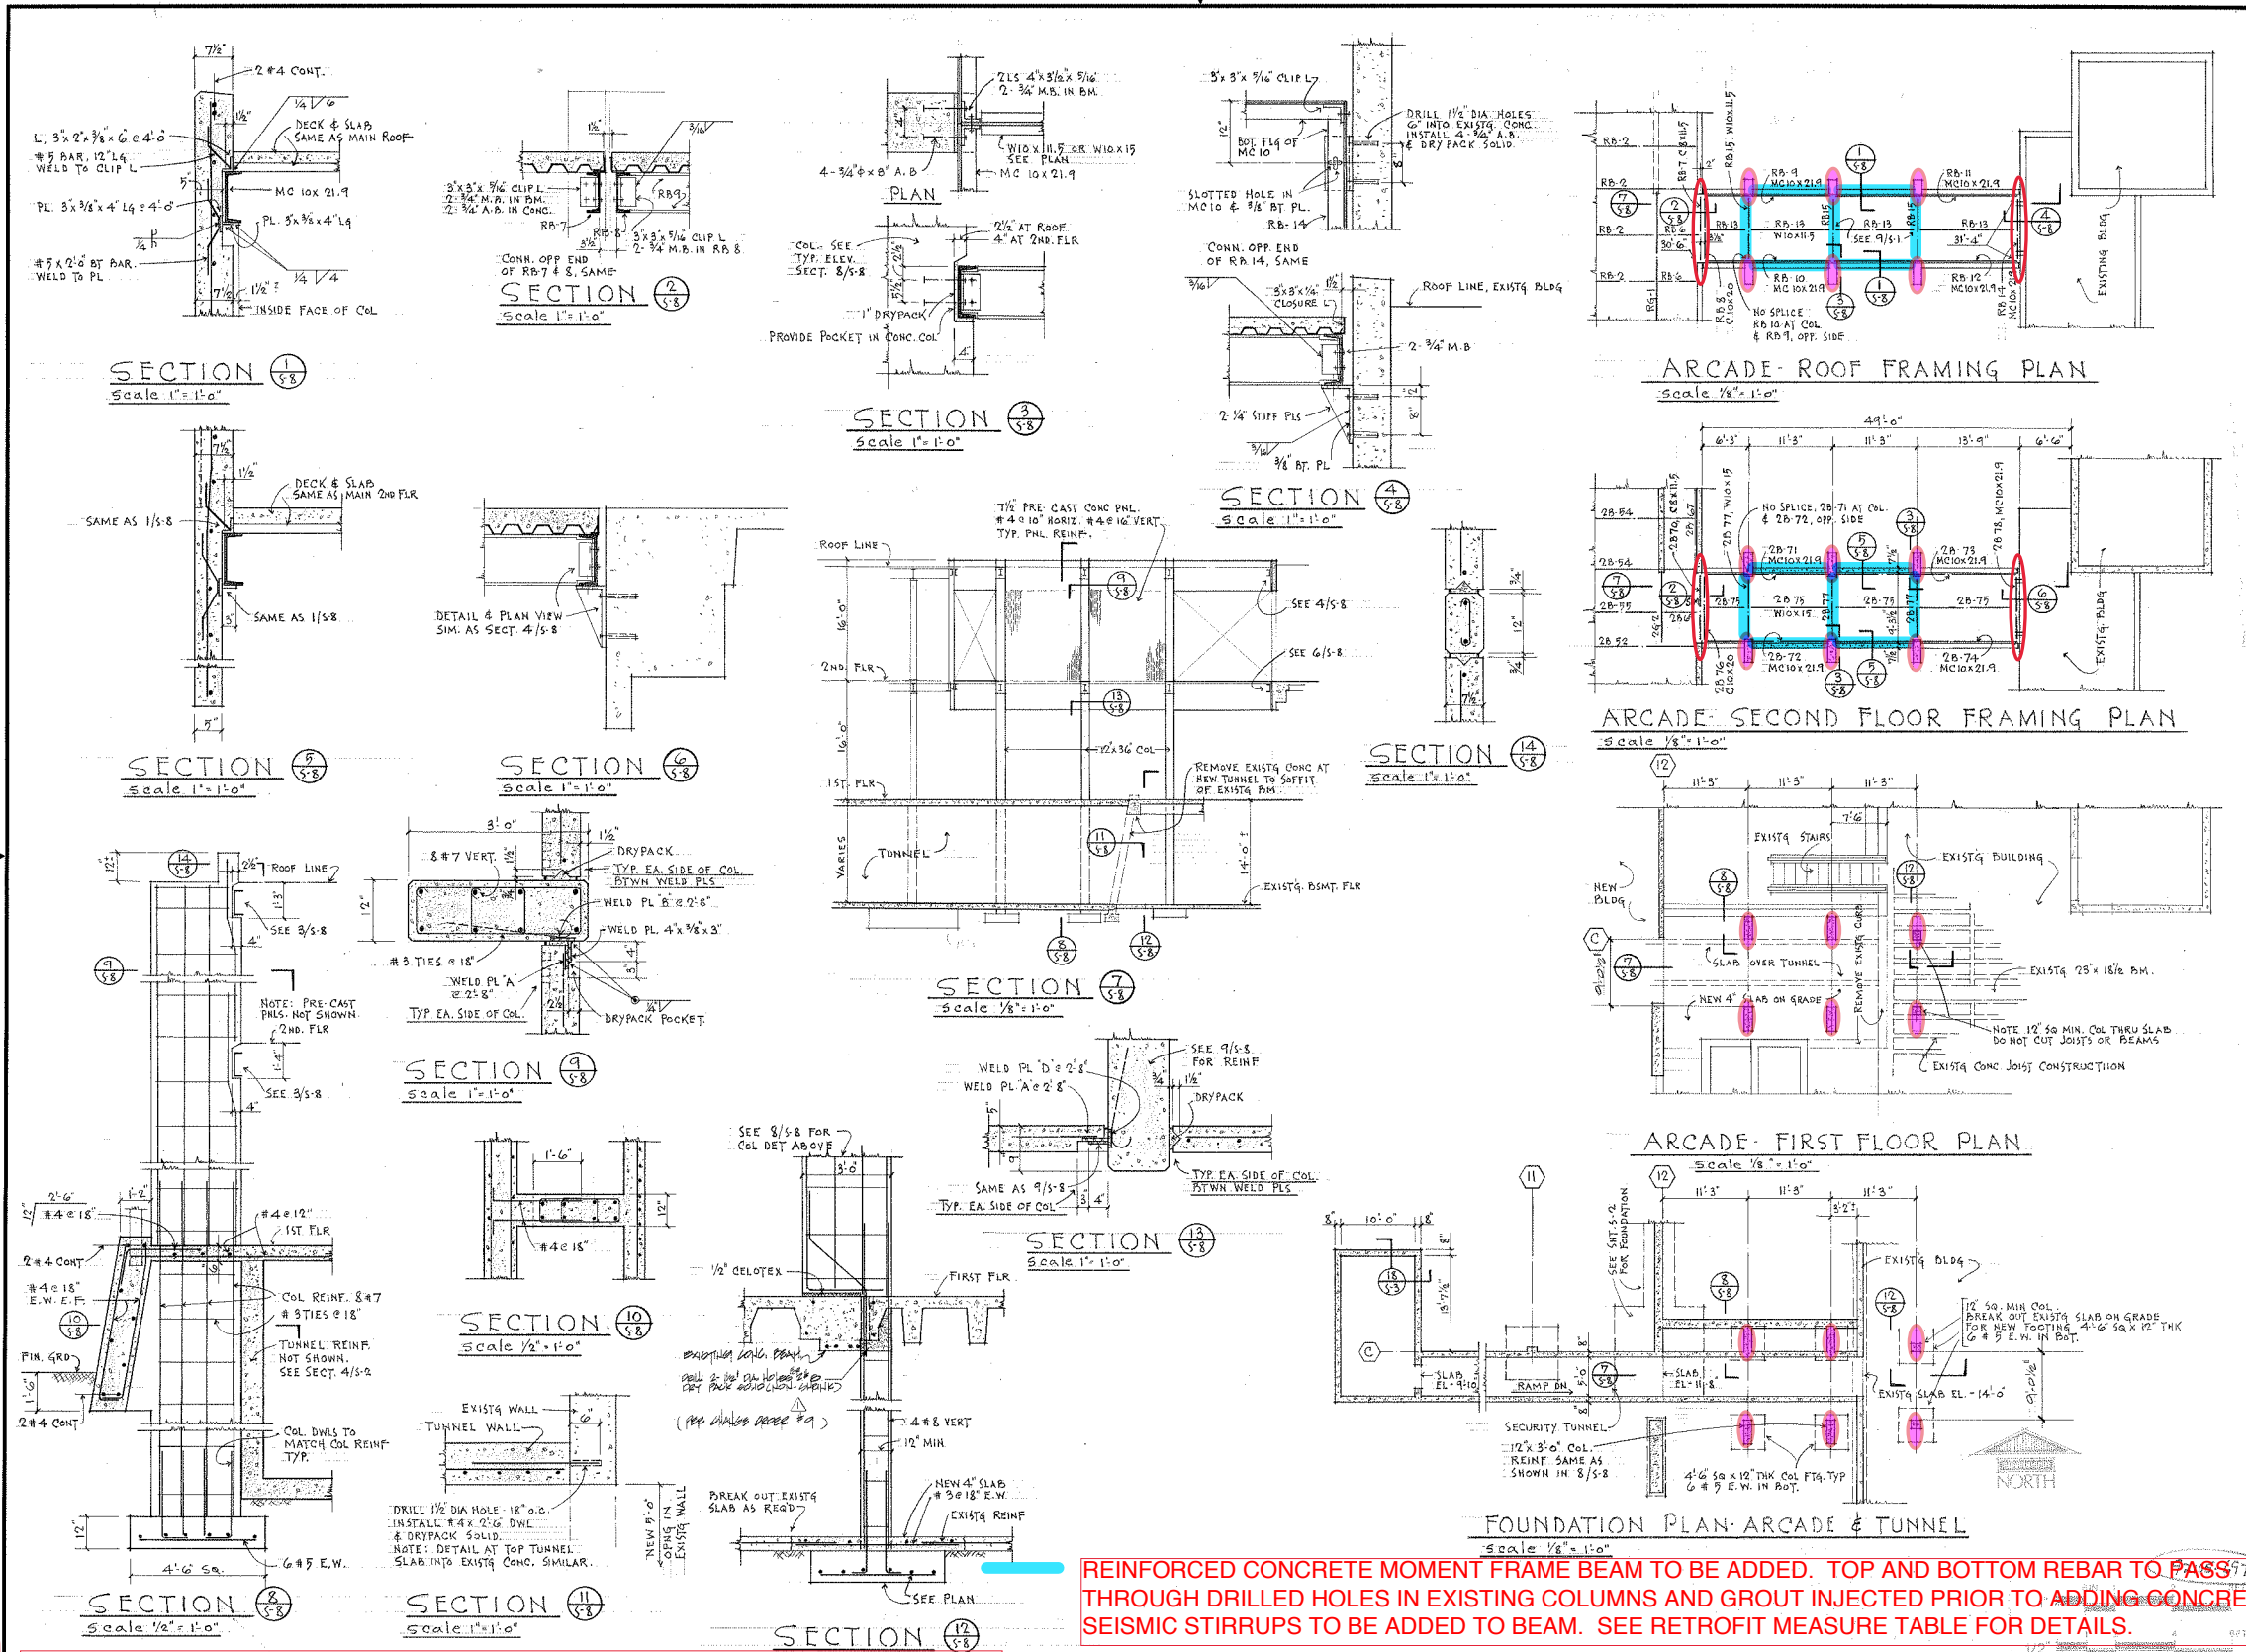
SEISMIC SEPARATION TO C2 SEGMENT AND SEISMIC DRIFT ALLOWANCE OF 1.5" TO BE INCREASED TO 4" TO PREVENT POUNDING. CONNECTIONS TO BE REVISED.

REINFORCED CONCRETE MOMENT FRAME BEAM TO BE ADDED. TOP AND BOTTOM REBAR TO PASS THROUGH DRILLED HOLES IN EXISTING COLUMNS AND GROUT INJECTED PRIOR TO ADDING CONCRETE. SEISMIC STIRRUPS TO BE ADDED TO BEAM. SEE RETROFIT MEASURE TABLE FOR DETAILS.

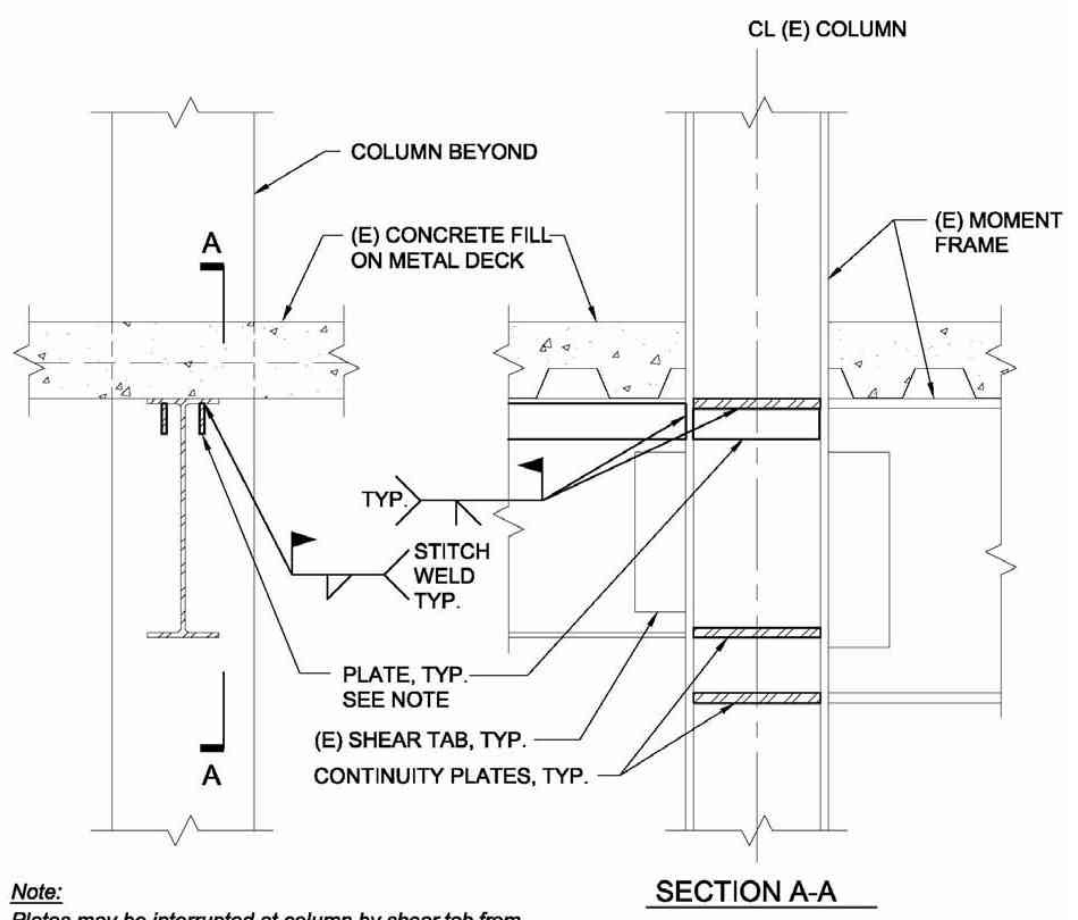
SECTION A-A

Note:
Plates may be interrupted at column by shear tab from transverse beam. Provide complete joint penetration welds from plates to shear tab.

Figure 8.4.4-1: Plate Collectors at Existing Beam

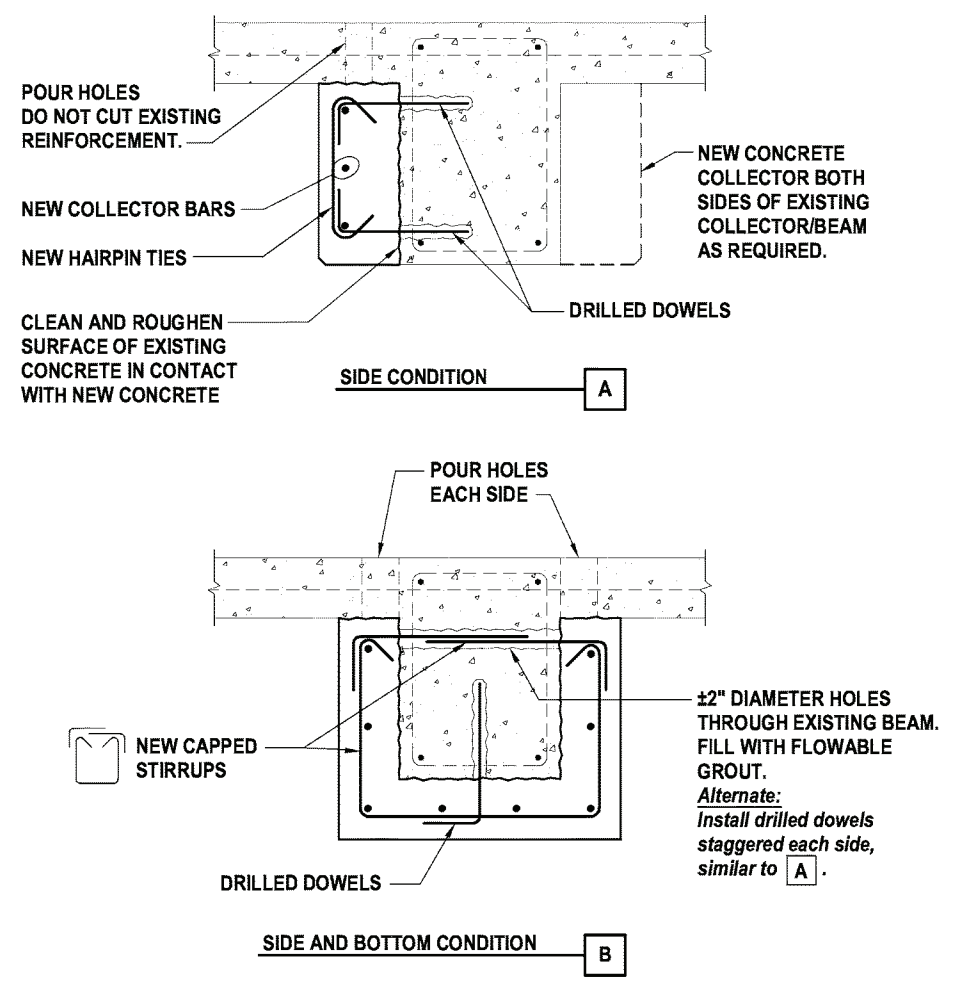
Figure 12.4.3-3: Concrete Collector at Existing Beam

DETAIL 3 (Source: FEMA-547): Collector Strengthening at Existing Steel and Concrete Beams

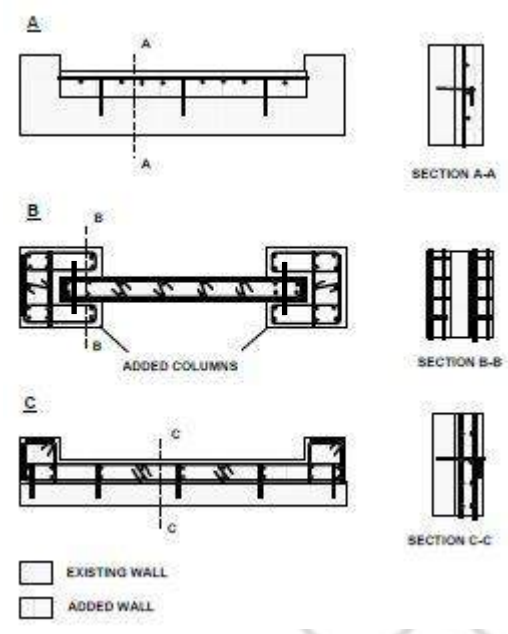
DETAIL 2 (Source: Aguilar, 1995): Conceptual Wall Retrofit With Shotcreting and/or Boundary Element Addition

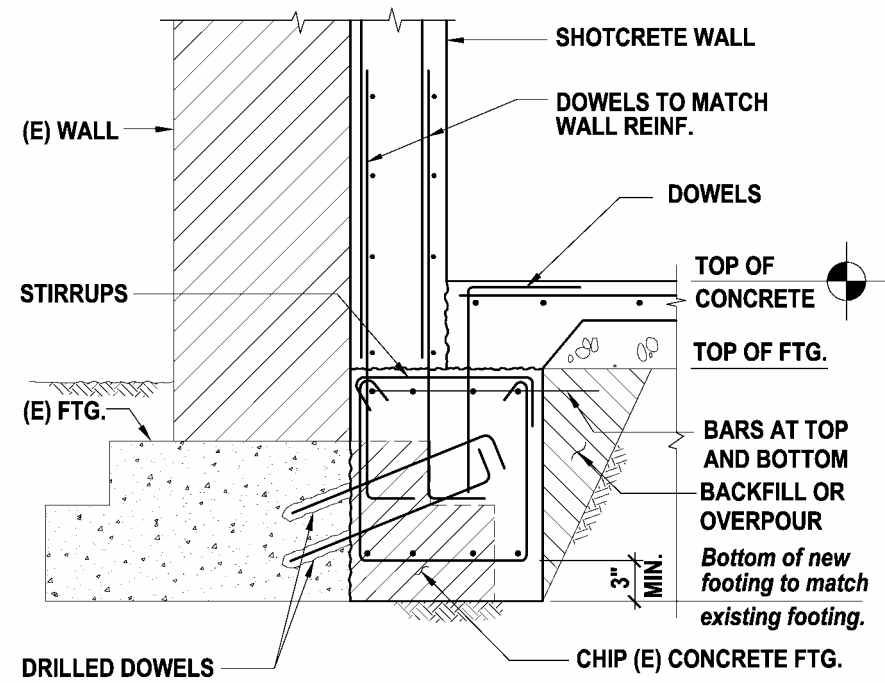
Figure 23.6.2-1: New Concrete Strip Footing Next to Existing Strip Footing

DETAIL 4 (Source: FEMA-547): New footing underneath shotcrete wall addition

3	New foundations underneath retrofitted walls.	Add continuous footing underneath retrofitted walls per detail Fig. 23.6.2-1 of FEMA-547 (Detail 4).
4	Square footings at wall ends. Existing continuous strip footing below walls not adequate because of soil bearing overstress. To be confirmed by Geotechnical Investigation.	Add square footings at wall ends to supplement existing continuous wall footing at the locations shown on plan markup. Make allowance for (8)-15'x15'x3' square footings with 2% bottom reinforcement each way and 0.2% top reinforcement each way. Additionally, make allowance for widening spread footings marked on foundation plan by 5' and deepening by 1' with an added layer of #5@12" o.c. bottom reinforcement.
5	Combined spread footing under existing walls between grids 9-12 and E-G. Existing combined spread footing below walls not adequate because of soil bearing overstress. To be confirmed by Geotechnical Investigation.	Widen by 5', deepen by 2', and strengthen by adding a bottom layer of #5@12" rebar underneath existing combined spread footing at the North-East corner stair/elevator core (see Detail 6).

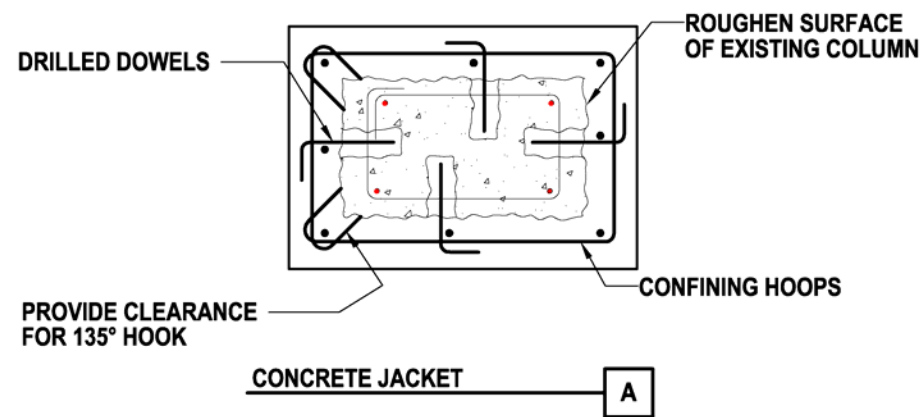
DETAIL 5 (Source: FEMA-547): Concrete column strengthening

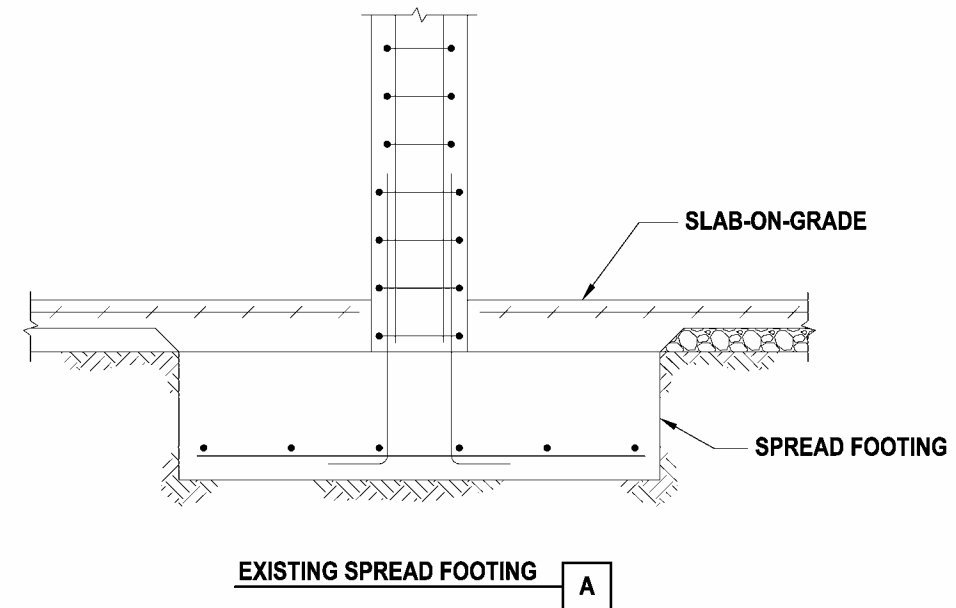
1. Establish existing layers and organize with new bars so existing bars are not cut.
2. Hole for bar without coupler can be smaller.
3. Check new bar capacity at location (B). Check existing bar capacity at location (A).

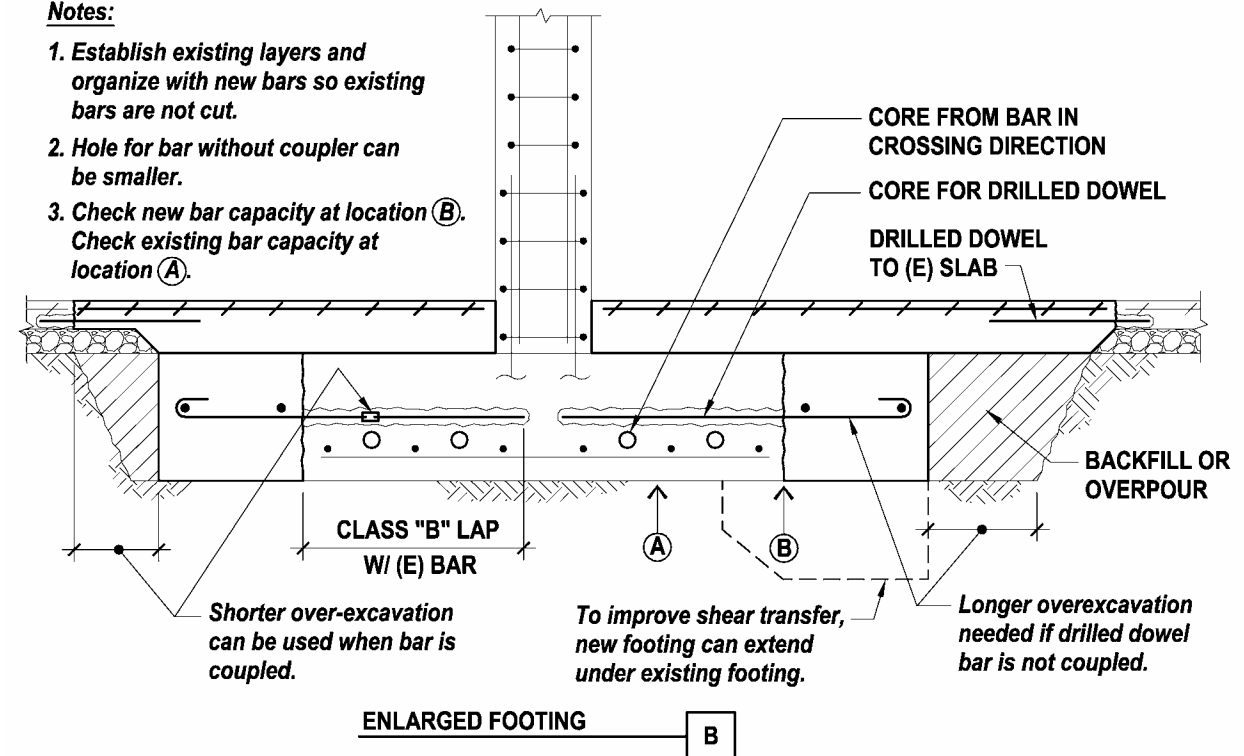
Figure 23.7.3-1: Enlarge Existing Spread Footing

DETAIL 6 (Source: FEMA-547): Enlarging existing spread footing
